September 16, 2009
GZA File No. 01.0170142.00

Re: Task 3 Dam Assessment Report
Project #0-381
Allen Steam Station Coal Ash Retention Dam
Belmont, North Carolina

EXECUTIVE SUMMARY

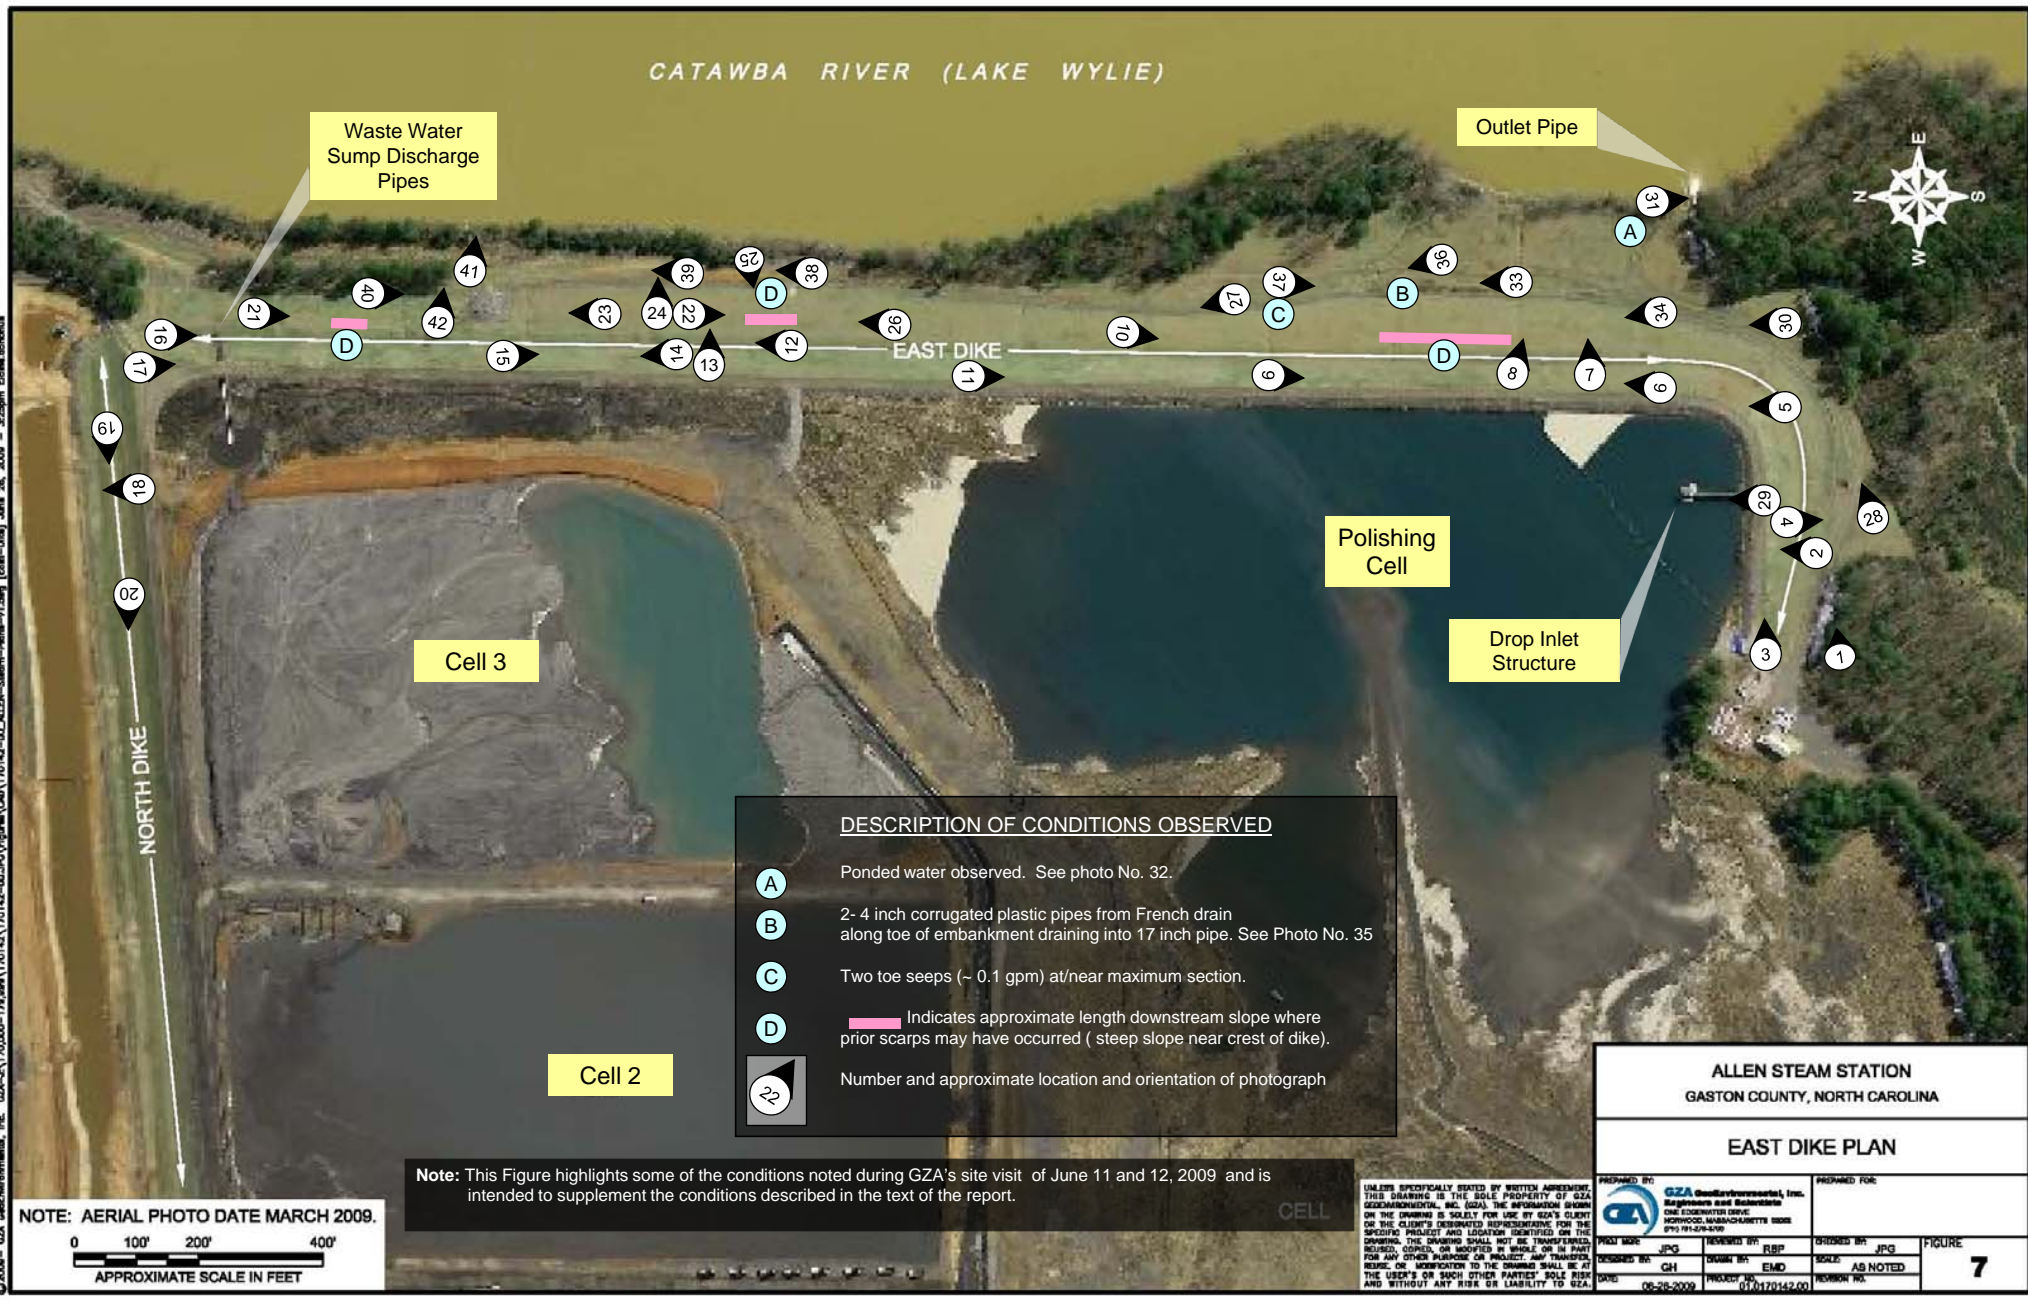
- A** Pounded water observed. See photo No. 32.
- B** 2- 4 inch corrugated plastic pipes from French drain along toe of embankment draining into 17 inch pipe. See Photo No. 35
- C** Two toe seeps (~ 0.1 gpm) at/near maximum section.
- D** Indicates approximate length downstream slope where prior scarps may have occurred (steep slope near crest of dike).
- 22** Number and approximate location and orientation of photograph

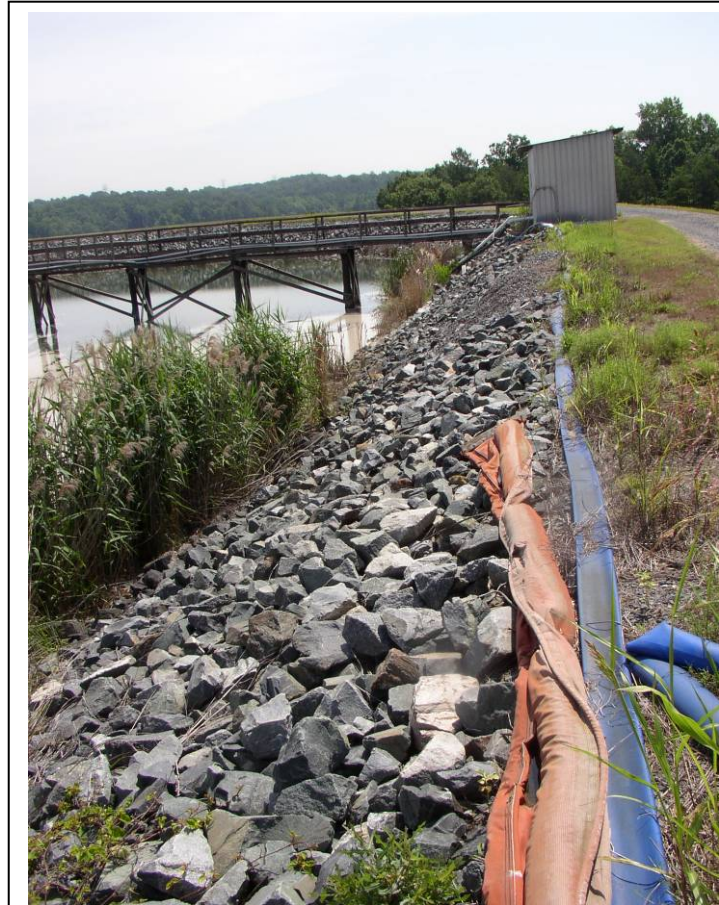
#3 Upstream Slope & Bridge to Drop Inlet Structure

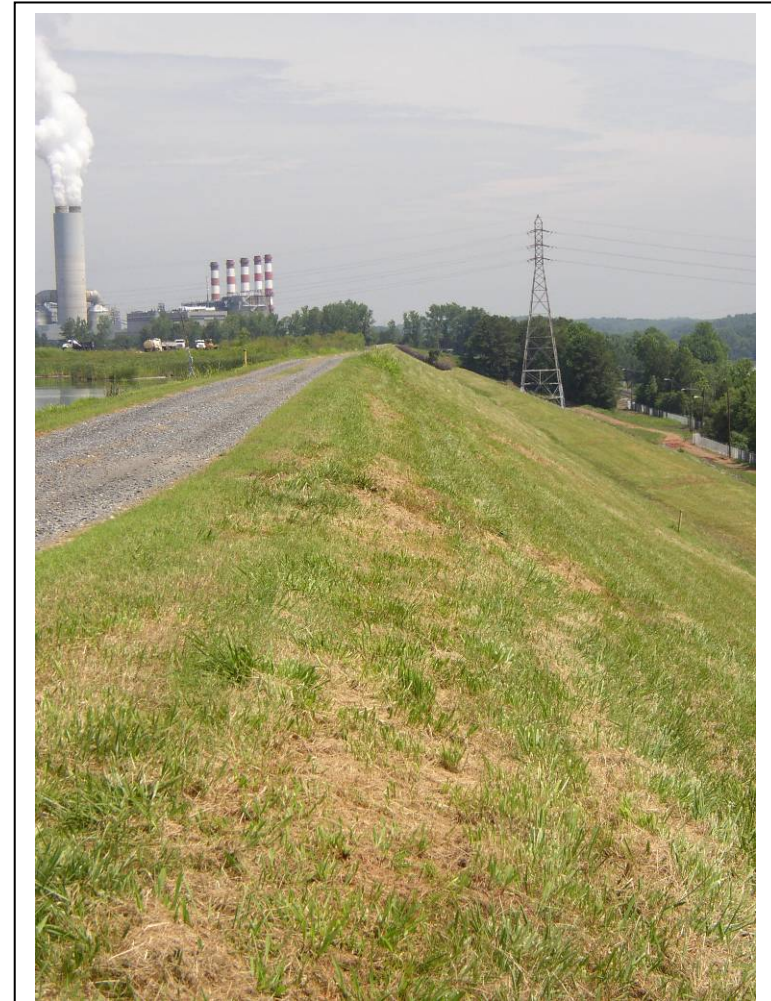
#6 Crest & Downstream Slope of East Dike

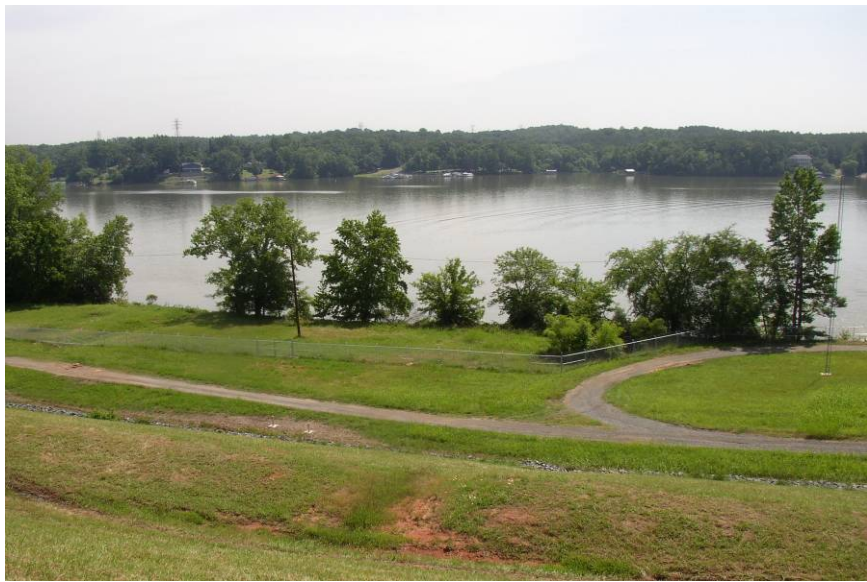
**#7 Downstream Berm & Toe Area of East Dike – Southern Portion
Lake Wylie at Downstream Toe**

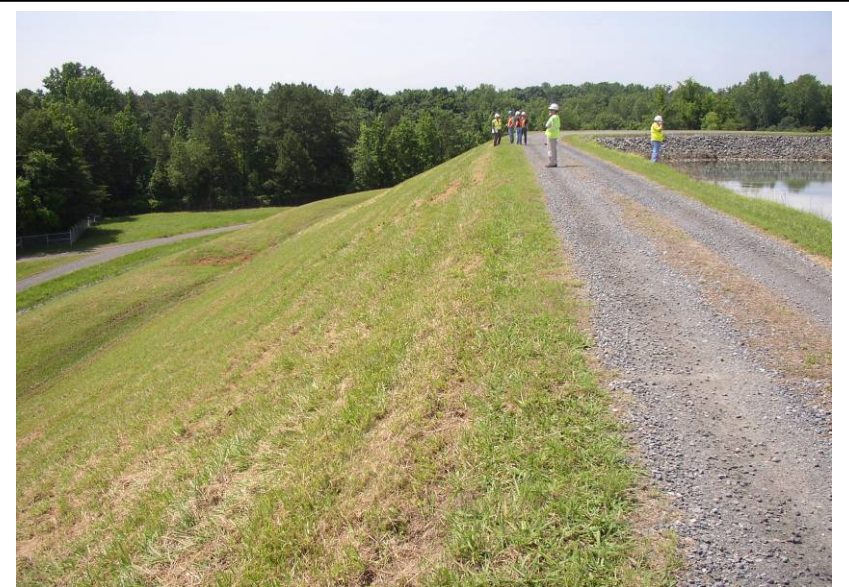
**#9 Southern Portion of Crest & Downstream Slope of East Dike –
Note Pooled Water on Berm**

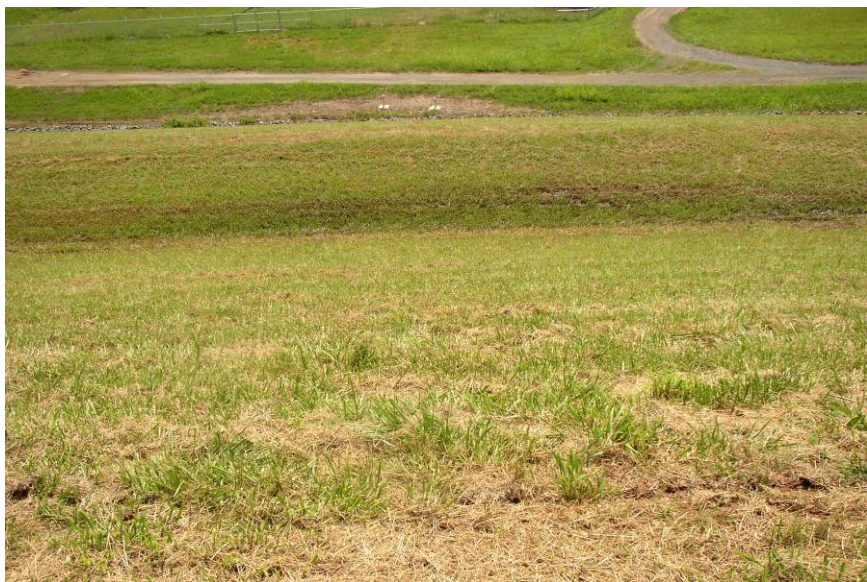
#8 Ponded Water on Bench of Downstream Stability Berm of East Dike

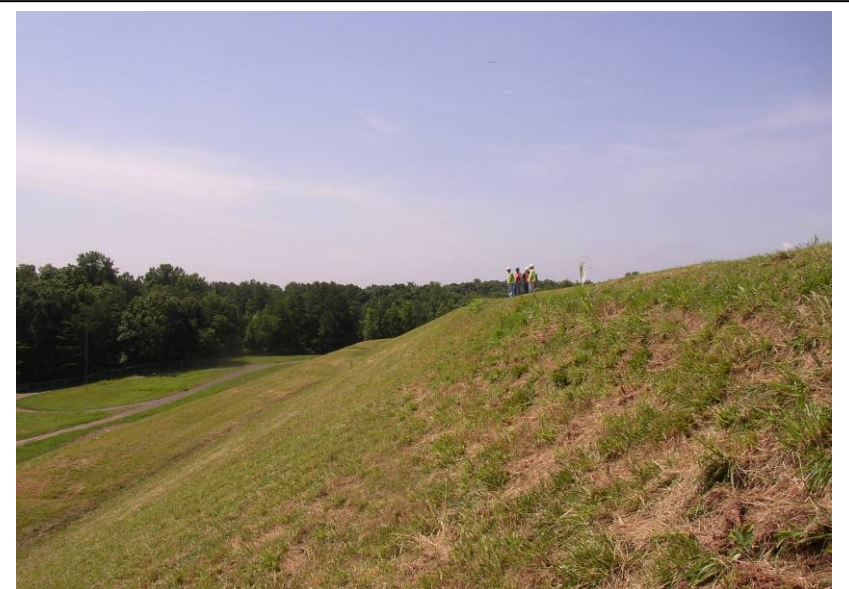
Minor scarps have occurred on the upper part of the downstream slope. These scarps are located several feet below the crest and are attributed to shallow slip failures within the upper layers of soil. The scarps remain on the embankment, and appear to have caused minor bulging in the lower section of the 2H:1V slope (above the stability berm). They are reportedly periodically addressed as maintenance items.

#10 Southern Downstream Slope of East Dike - Note Local Scarps in Upper Slope

2. Engineered maintenance repairs of the scarps should be undertaken and a monitoring program implemented to detect potential stability or seepage issues.

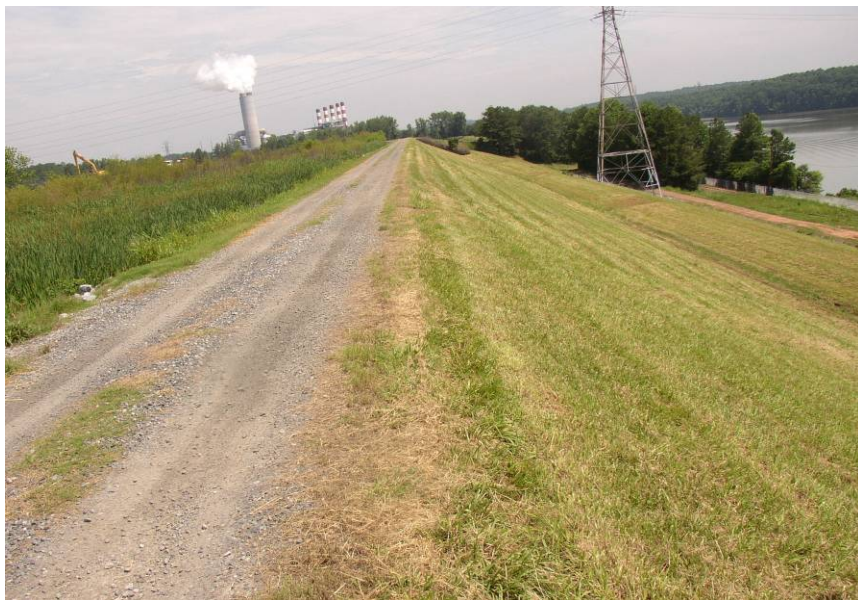
**#12 North End of East Dike: Cell No. 3
Note Cell is Full to Design Grade – Elev. 640 or above**

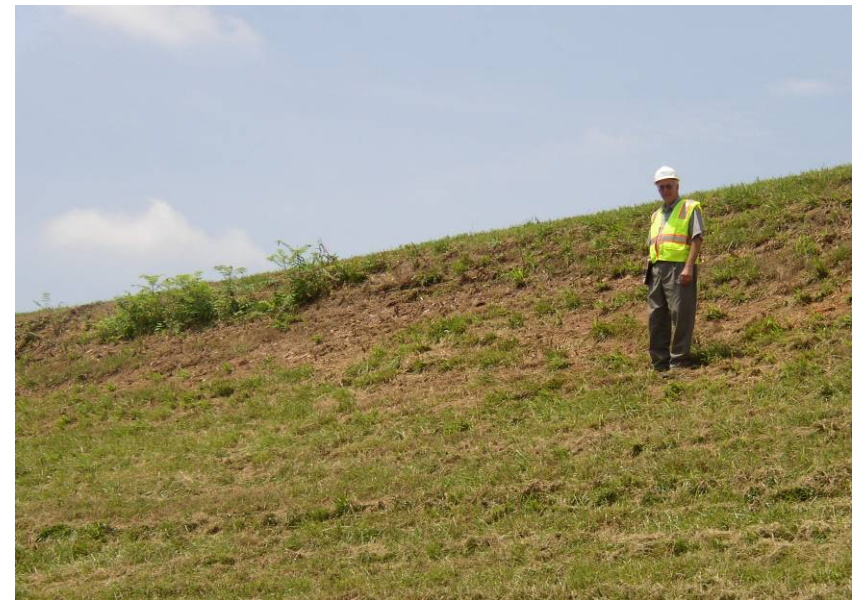
#25 Scarp on Upper Portion of Downstream Slope of East Dike

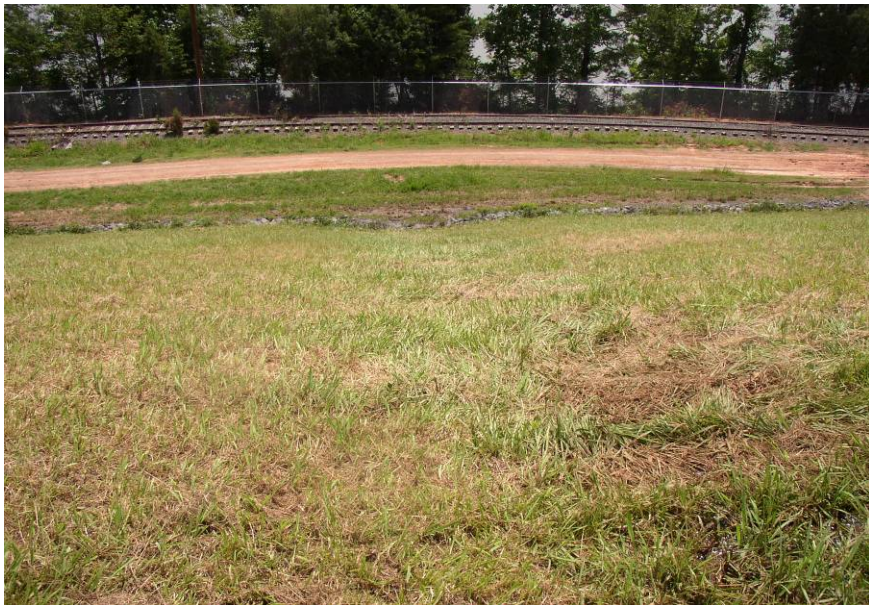
#24 Note Seepage/Ponded Surface Water at Downstream Toe of North Dike

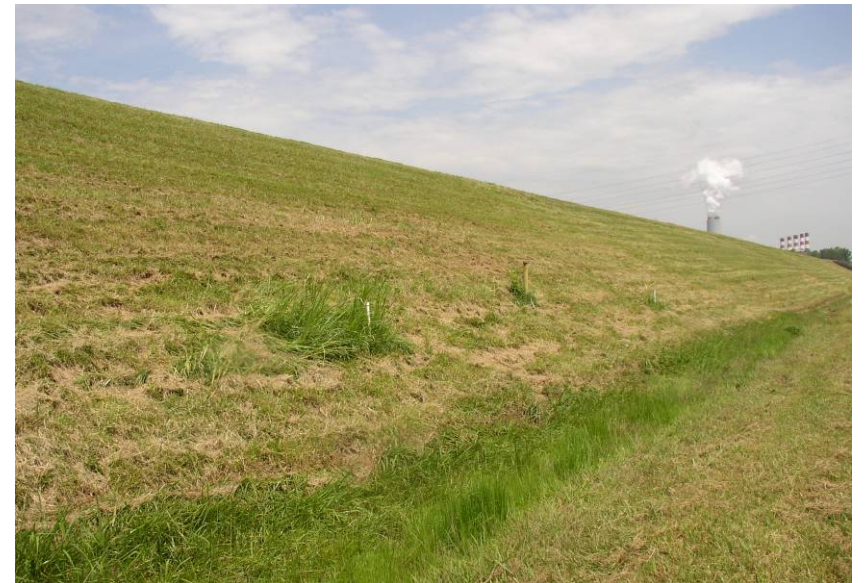
#26 Piezometers and Observation Wells Along Toe Stability Berm at South End of East Dike. (Note Standing Water at Toe)

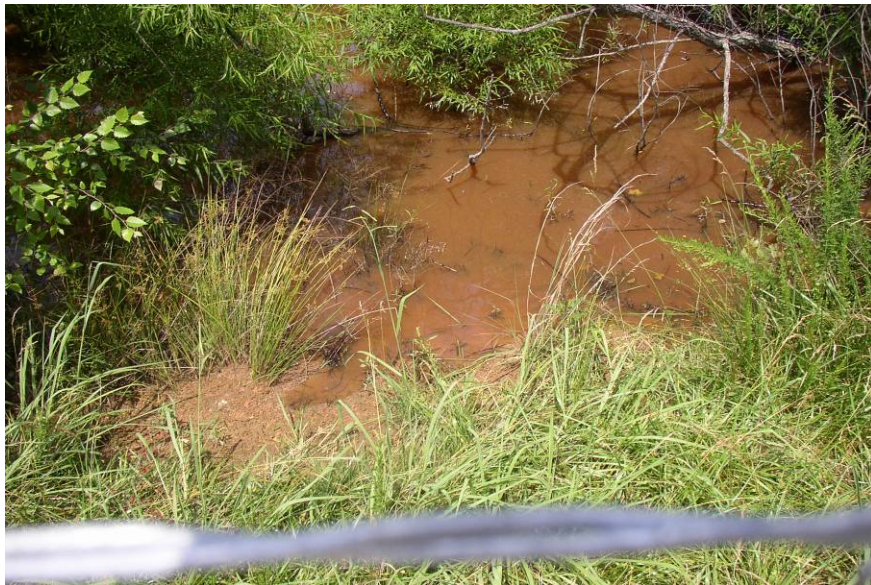
#32 Poned Surface Water East of Downstream Toe Near Outlet

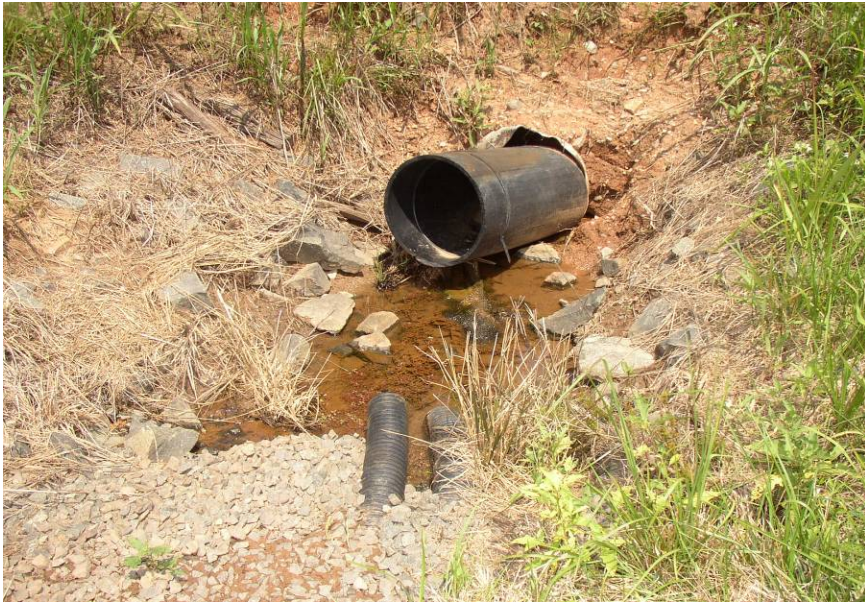
#35 Seepage Collection Area Near Maximum Section of Downstream Toe of East Dike

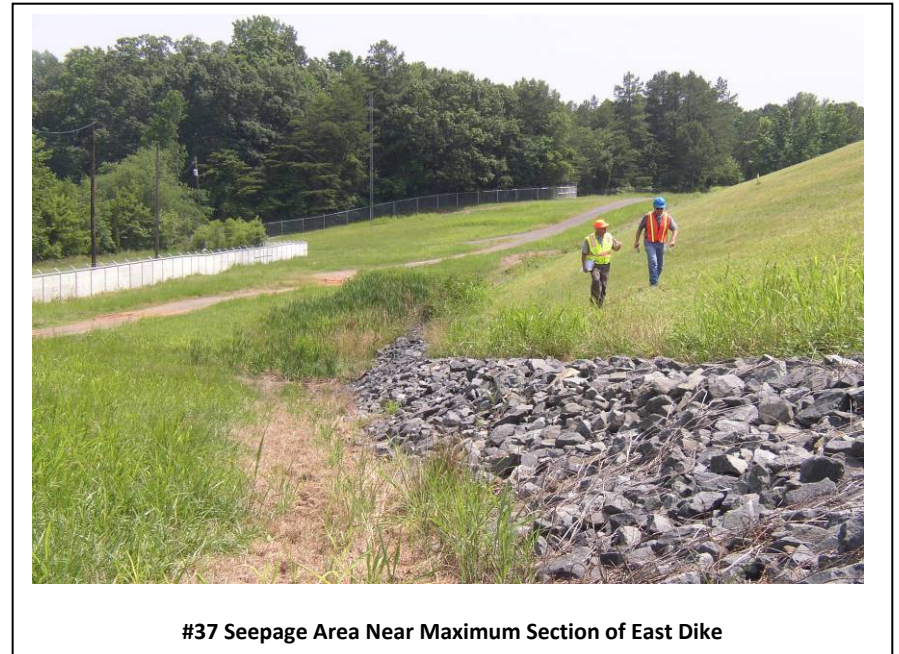
#37 Seepage Area Near Maximum Section of East Dike

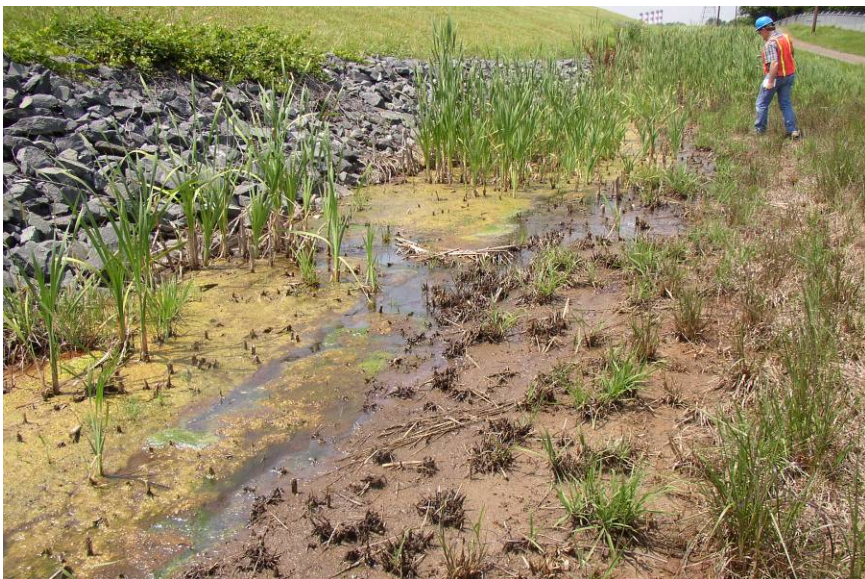
#36 Local Minor Seepage & Standing Drainage Flow at Downstream Toe of South End at East Dike

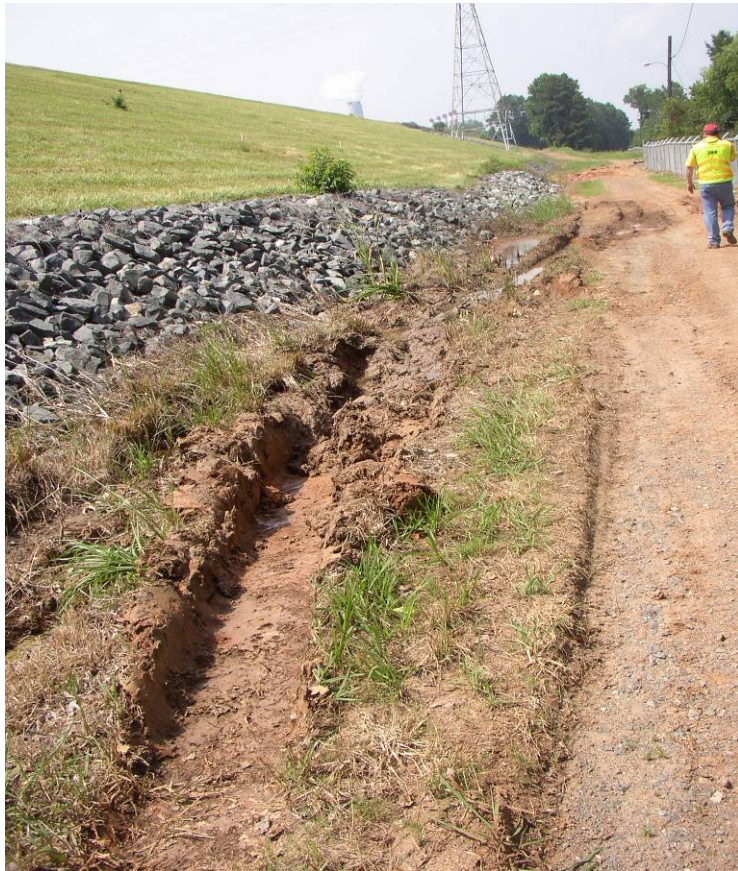
**#38 Downstream Toe of East Dike Access Road –
Rutting from Construction Equipment**

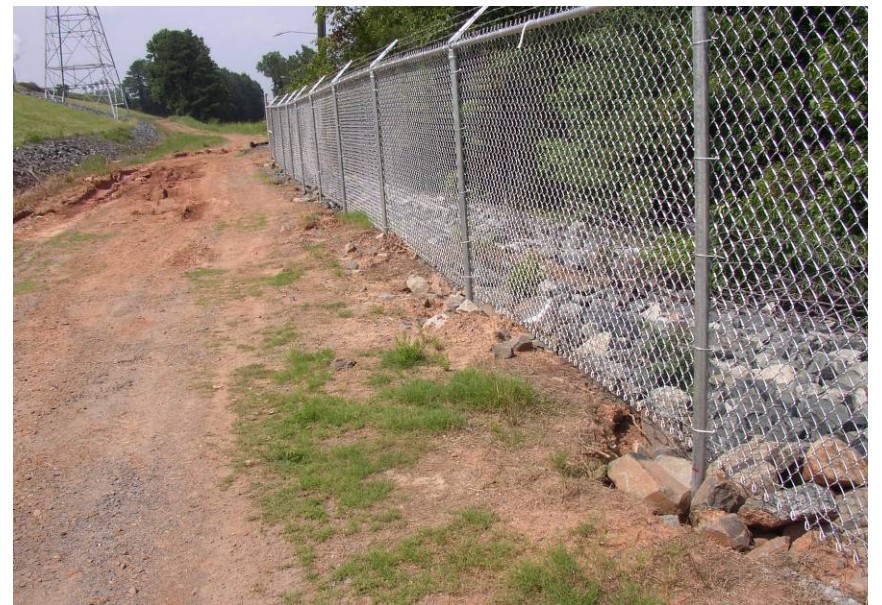
**#39 Local Erosion / Rutting of Downstream Toe Road.
Near Central Portion of East Dike**

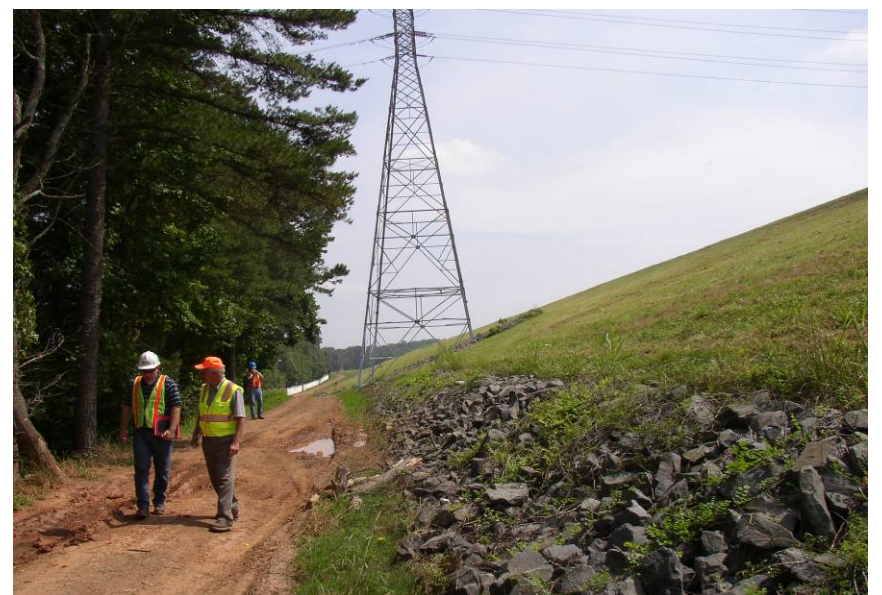
#40 Downstream Toe Road at North End of East Dike - Erosion

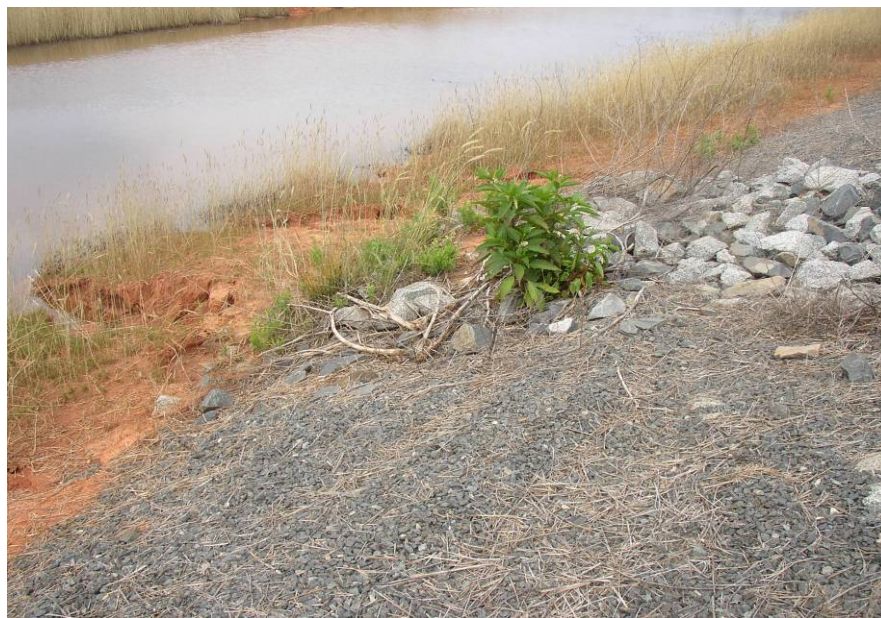
#46 Local Erosion @ Toe of Crushed Stone Drainage Material

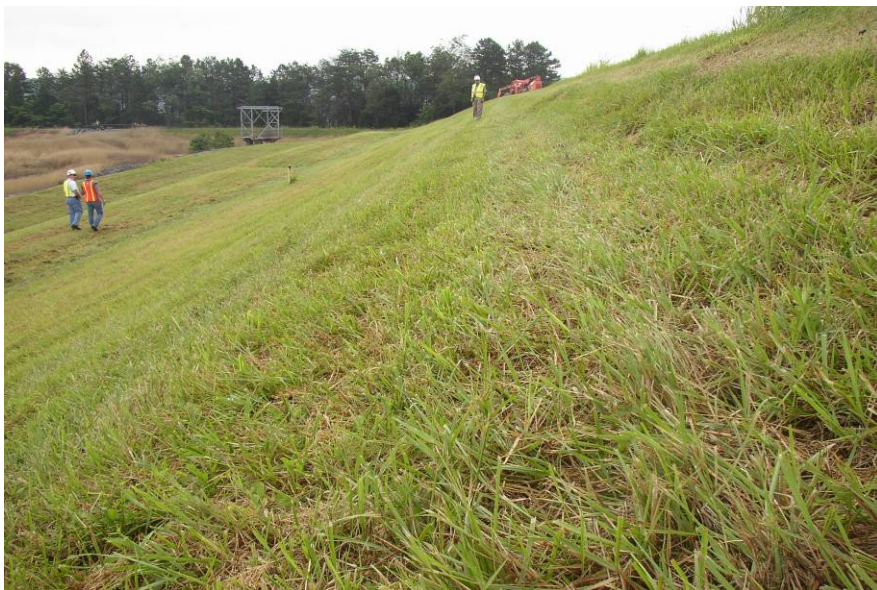
Minor scarps have historically been observed on the upper part of the downstream slope. These scarps are located several feet below the crest and are attributed to shallow slip failures within the upper layers of soil. The scarps remain on the embankment, and appear to have caused minor bulging in the lower section of the 2H:1V slope (above the stability berm). The ongoing construction activity in Cell 1 has also created ruts on the downstream slope at the western end of the North Dike.

#54 Downstream Slope of North Dike (Note Evidence of Prior Scarps)

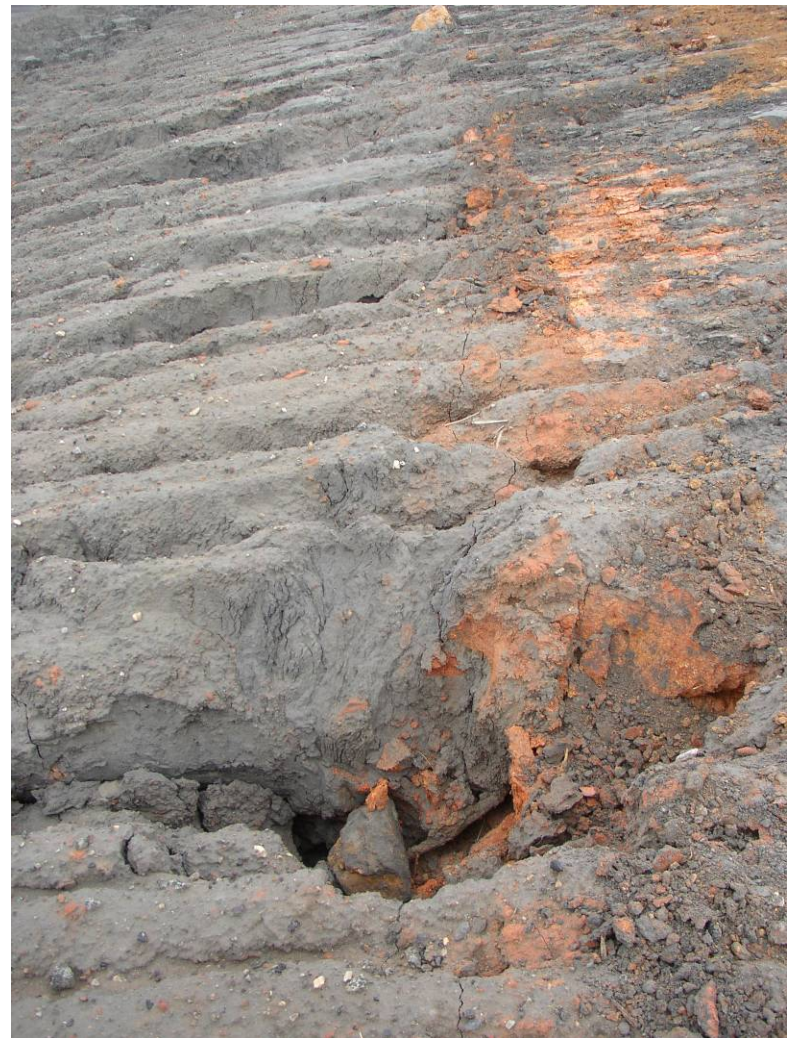
#59 Erosion in Ashfill in Upstream Excavated Slope of Cell 3

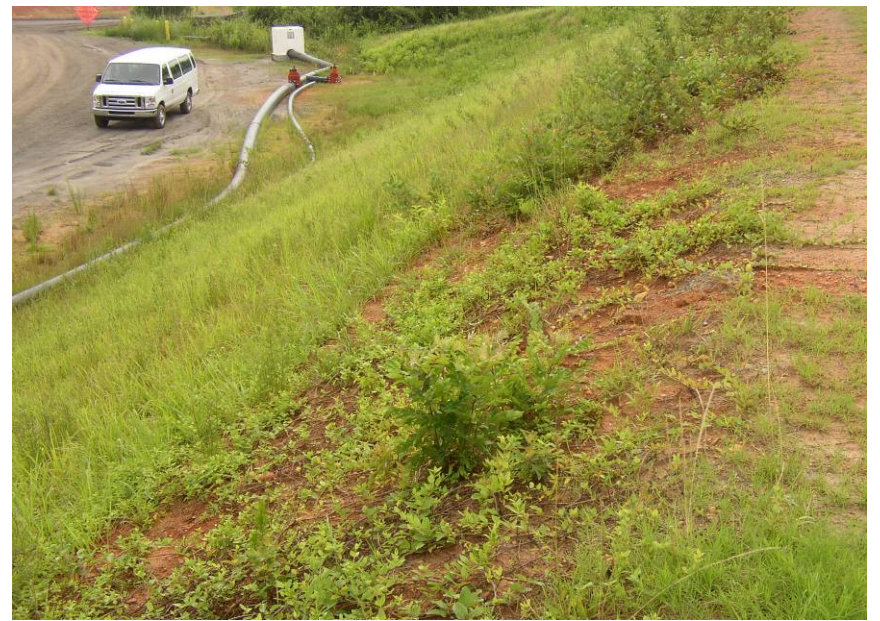
#66 Local Erosion Near Crest of North Dike

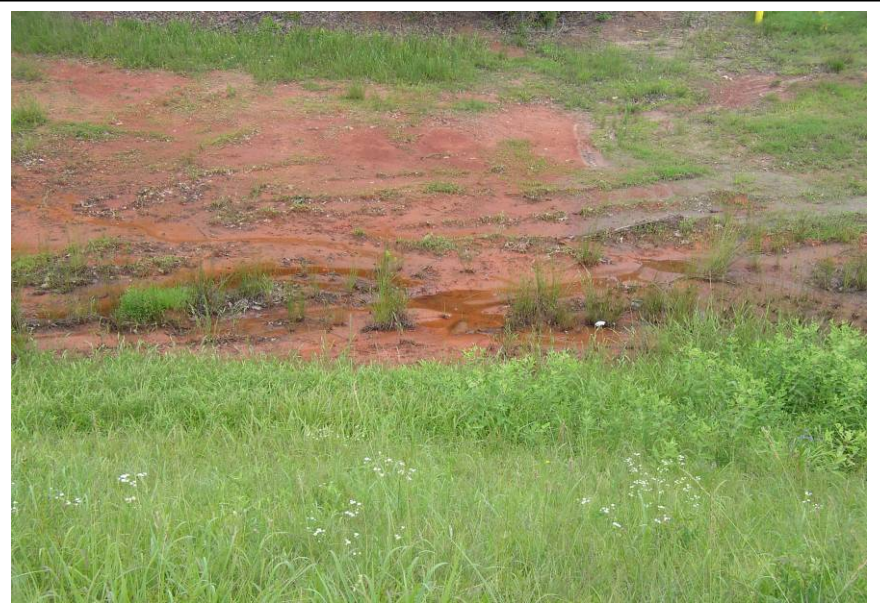
#67 Erosion at Downstream Slope of North Dike

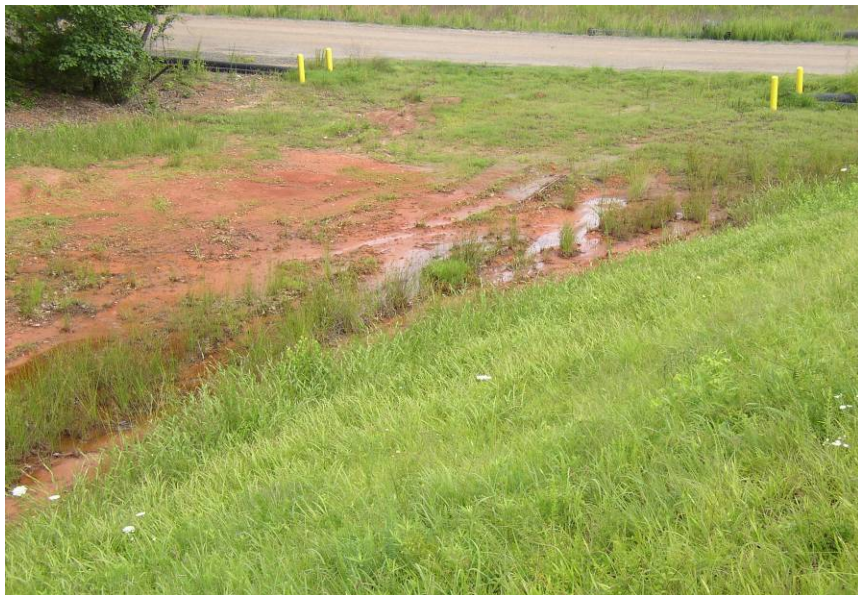
#69 Ponded Surface Drainage & Seepage Near Transmission Tower at West End of North Dike

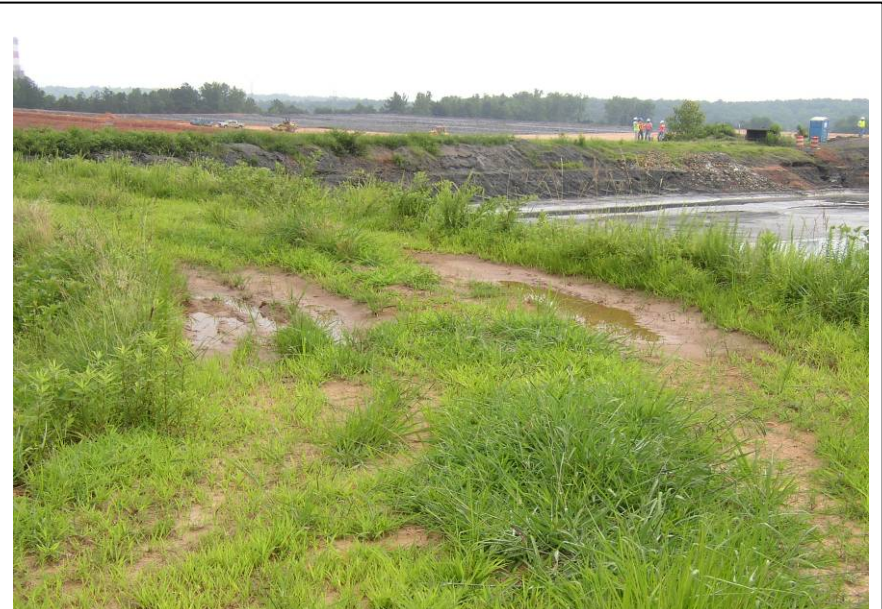
#71 Rutting in Crest at West End of North Dike

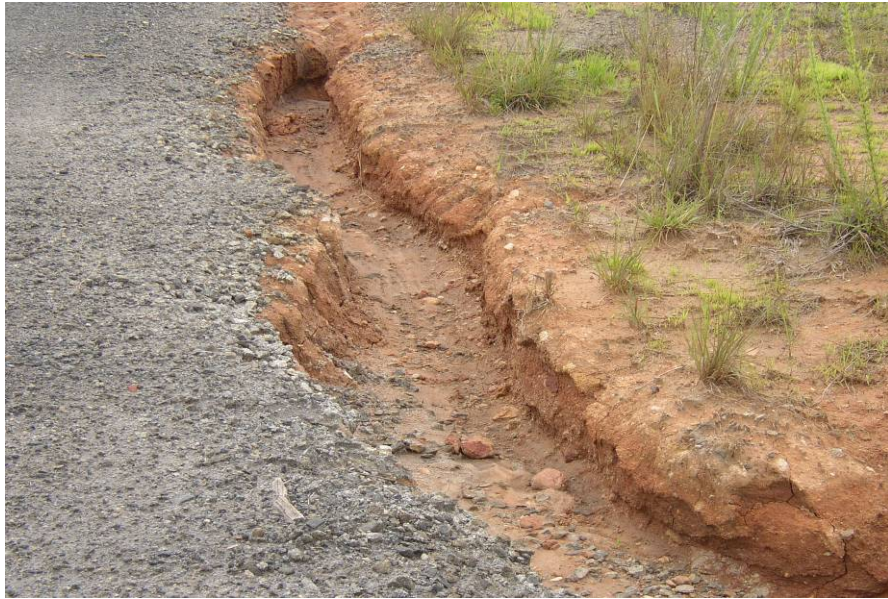
#76 Erosion Adjacent to Road Along Downstream Toe of North Dike
