**CCW IMPOUNDMENTS
INSPECTION REPORT**

**GORGAS STEAM PLANT
WALKER COUNTY,
ALABAMA**

**PROJECT No. 09-4157
SEPTEMBER 2009**

**CCW IMPOUNDMENT ASSESSMENT REPORT
WILLIAM CRAWFORD GORGAS ELECTRIC
GENERATING PLANT
WALKER COUNTY, ALABAMA
PROJECT NO. 09-4157**

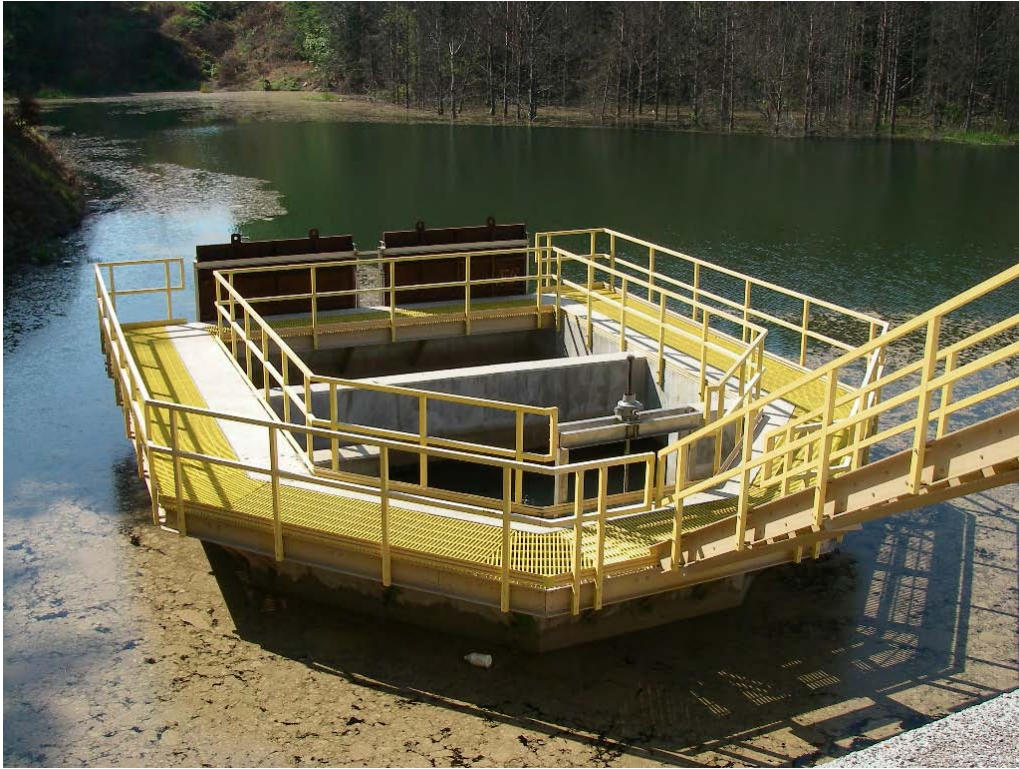
PHOTO 1: RATTLESNAKE DAM WEIR FLOW INTAKE STRUCTURE

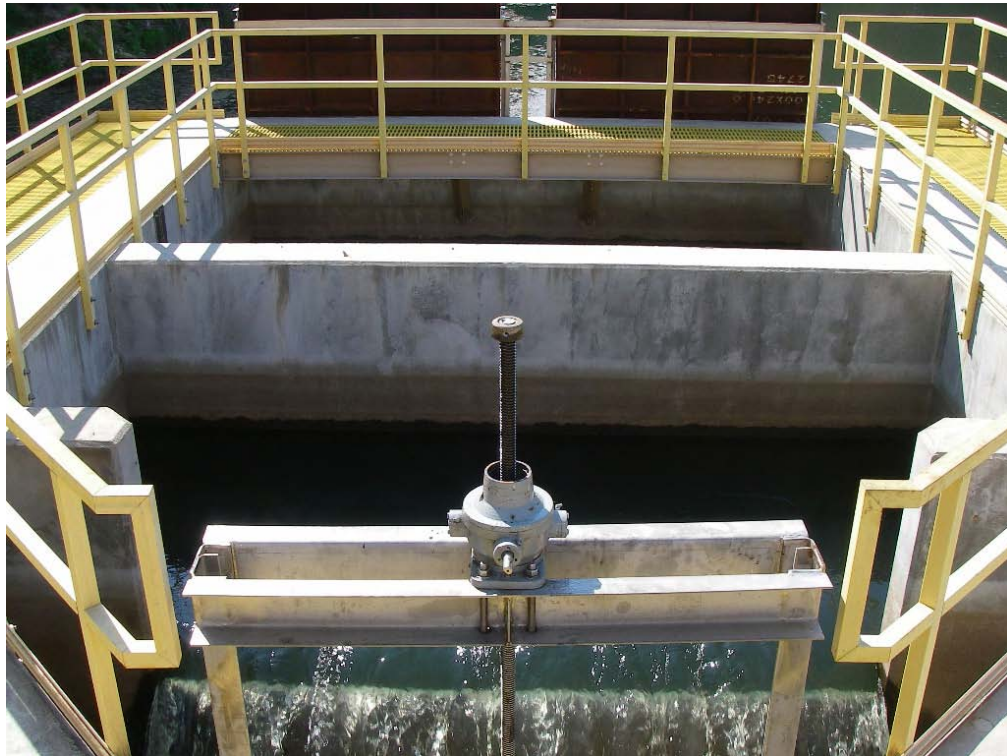
The weir intake structure is a new reinforced concrete structure in excellent condition. This structure outlets into a 48-inch diameter corrugated metal pipe that carries decant water down the hill to the NPDES permitted release point. The release point is under water; therefore observation of the water at the point of discharge was not visible. Water at the point of entry was clear water. (*See Photo 2*).

PHOTO 2: CLOSEUP OF WEIR INTAKE

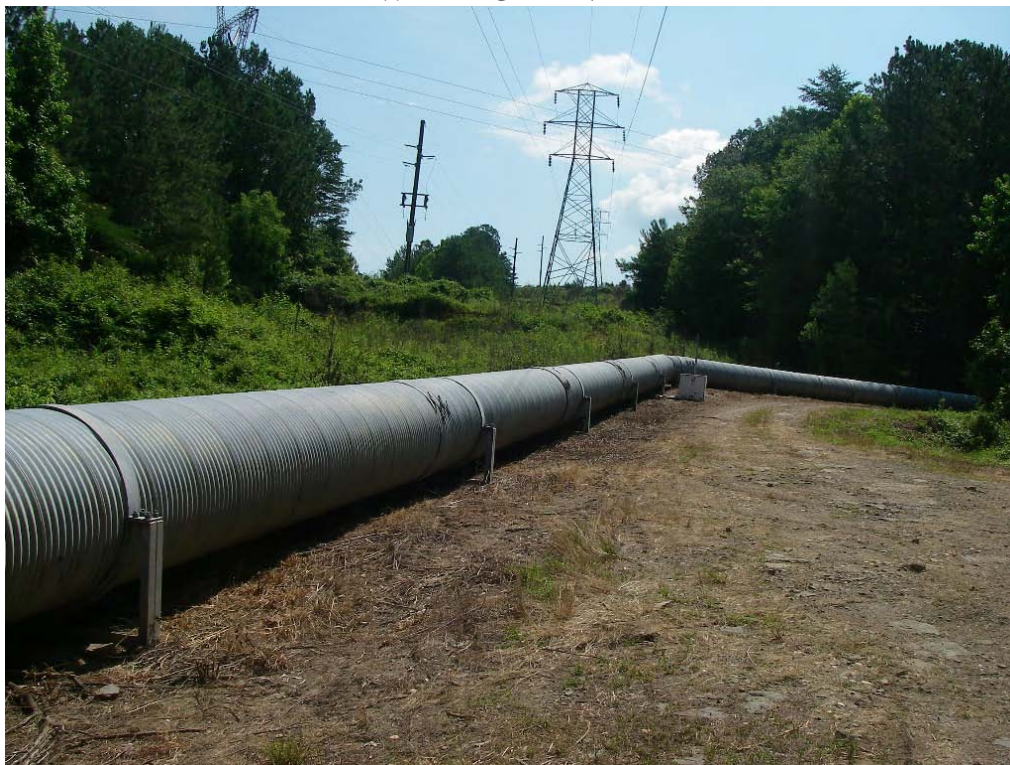
PHOTO 27: DISCHARGE LINE FROM RATTLESNAKE DAM TO BLACK WARRIOR RIVER

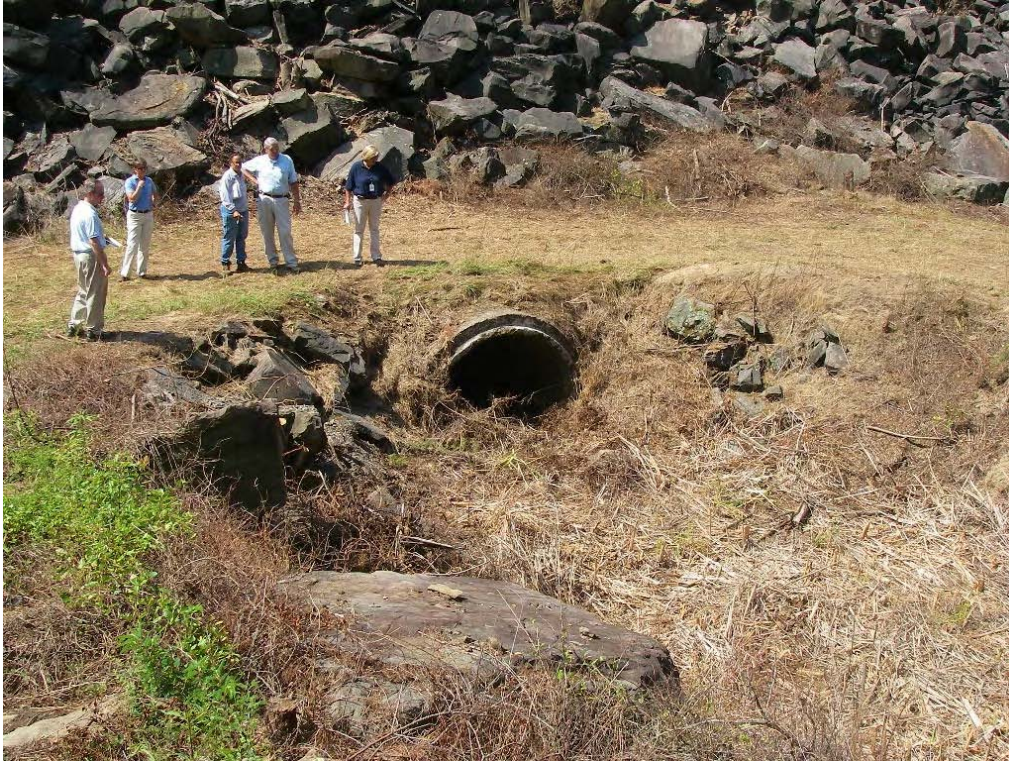
PHOTO 15: ORIGINAL BYPASS CHANNEL & CULVERT (ABANDONED, LOOKING S)

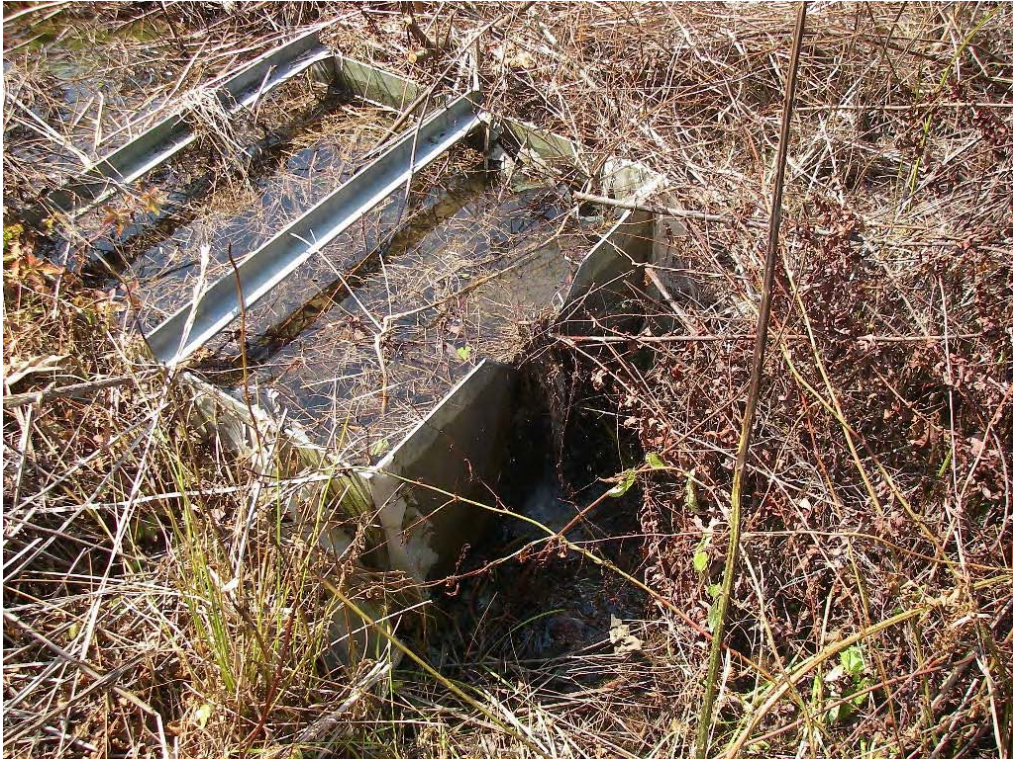
The downstream toe is generally grassed and clear of trees and heavy vegetation, with the exception of areas of tall brush in areas difficult to reach with tractor mowers. Seepage was noted below the toe in the left abutment area. The area around the pond in the center portion of the dam appears to be continuously wet from seepage and tailwater from the river. The pond was built during the initial dam construction. Wet areas and standing

PHOTO 18: OVERGROWN SEEPAGE MEASUREMENT WEIR

In conjunction with Recommendation No. 1, the existing weir box at the toe of the downstream slope of Rattlesnake Dam should be cleaned out and repositioned, or replaced with a larger weir if necessary, to collect the seepage flow along the downstream toe observed at the time of inspection. As much of the seepage currently visible should be collected as possible and the small ditch creating the current flow path should be kept as clear as possible to facilitate observations of changes in volume, turbidity, or location of new seeps. Such information, along with the flow measured at the box should be recorded as a part of Recommendation No. 1, so that seepage trends can be established and reviewed easily. In the event of increased seepage flows, the installation of additional instrumentation and a more involved monitoring program may be warranted.

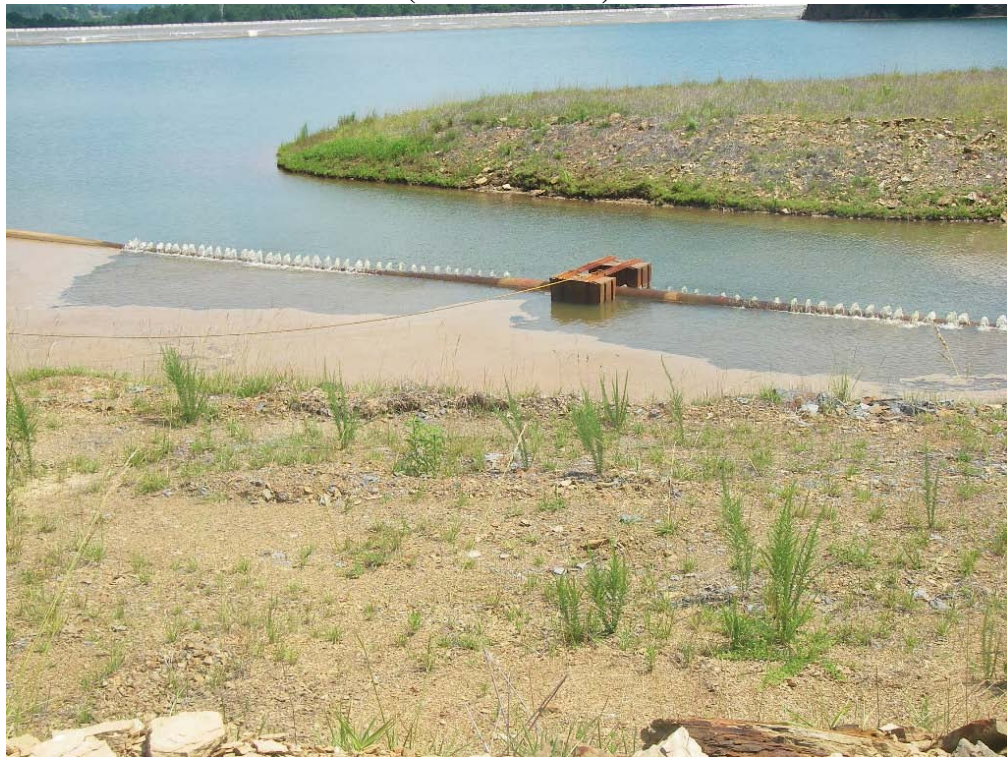
**PHOTO 32: BUBBLER AERATION LINE AT INTERMEDIATE DIKE
(LOOKING E)**

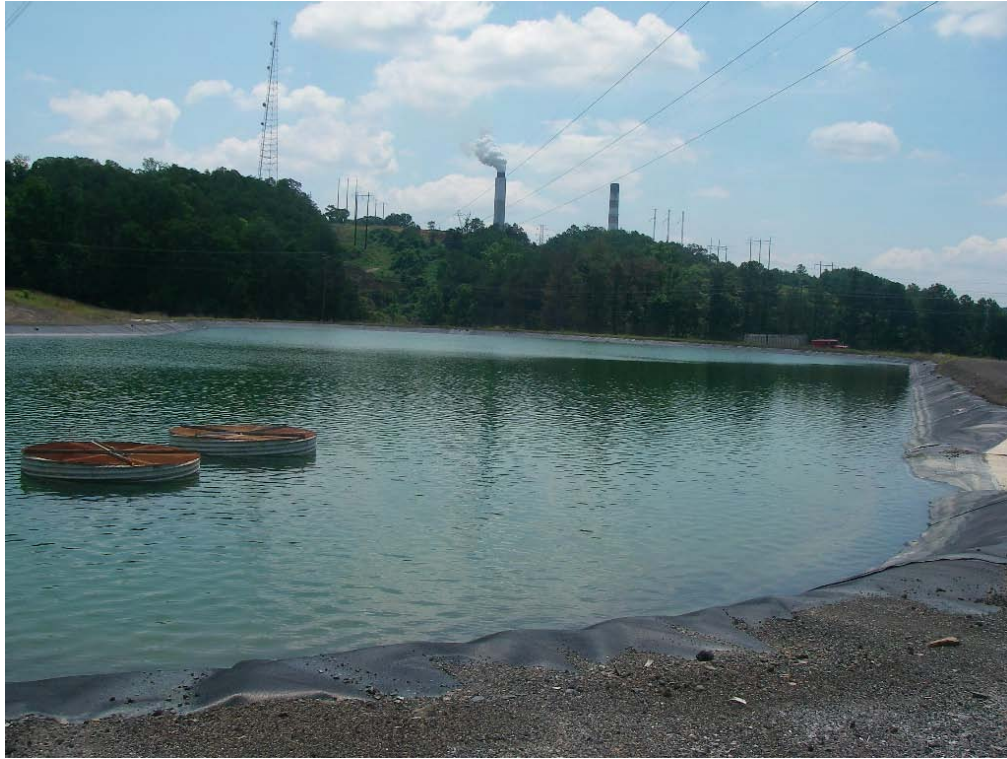
PHOTO 35: DECANT PIPES IN SEDIMENT BASIN

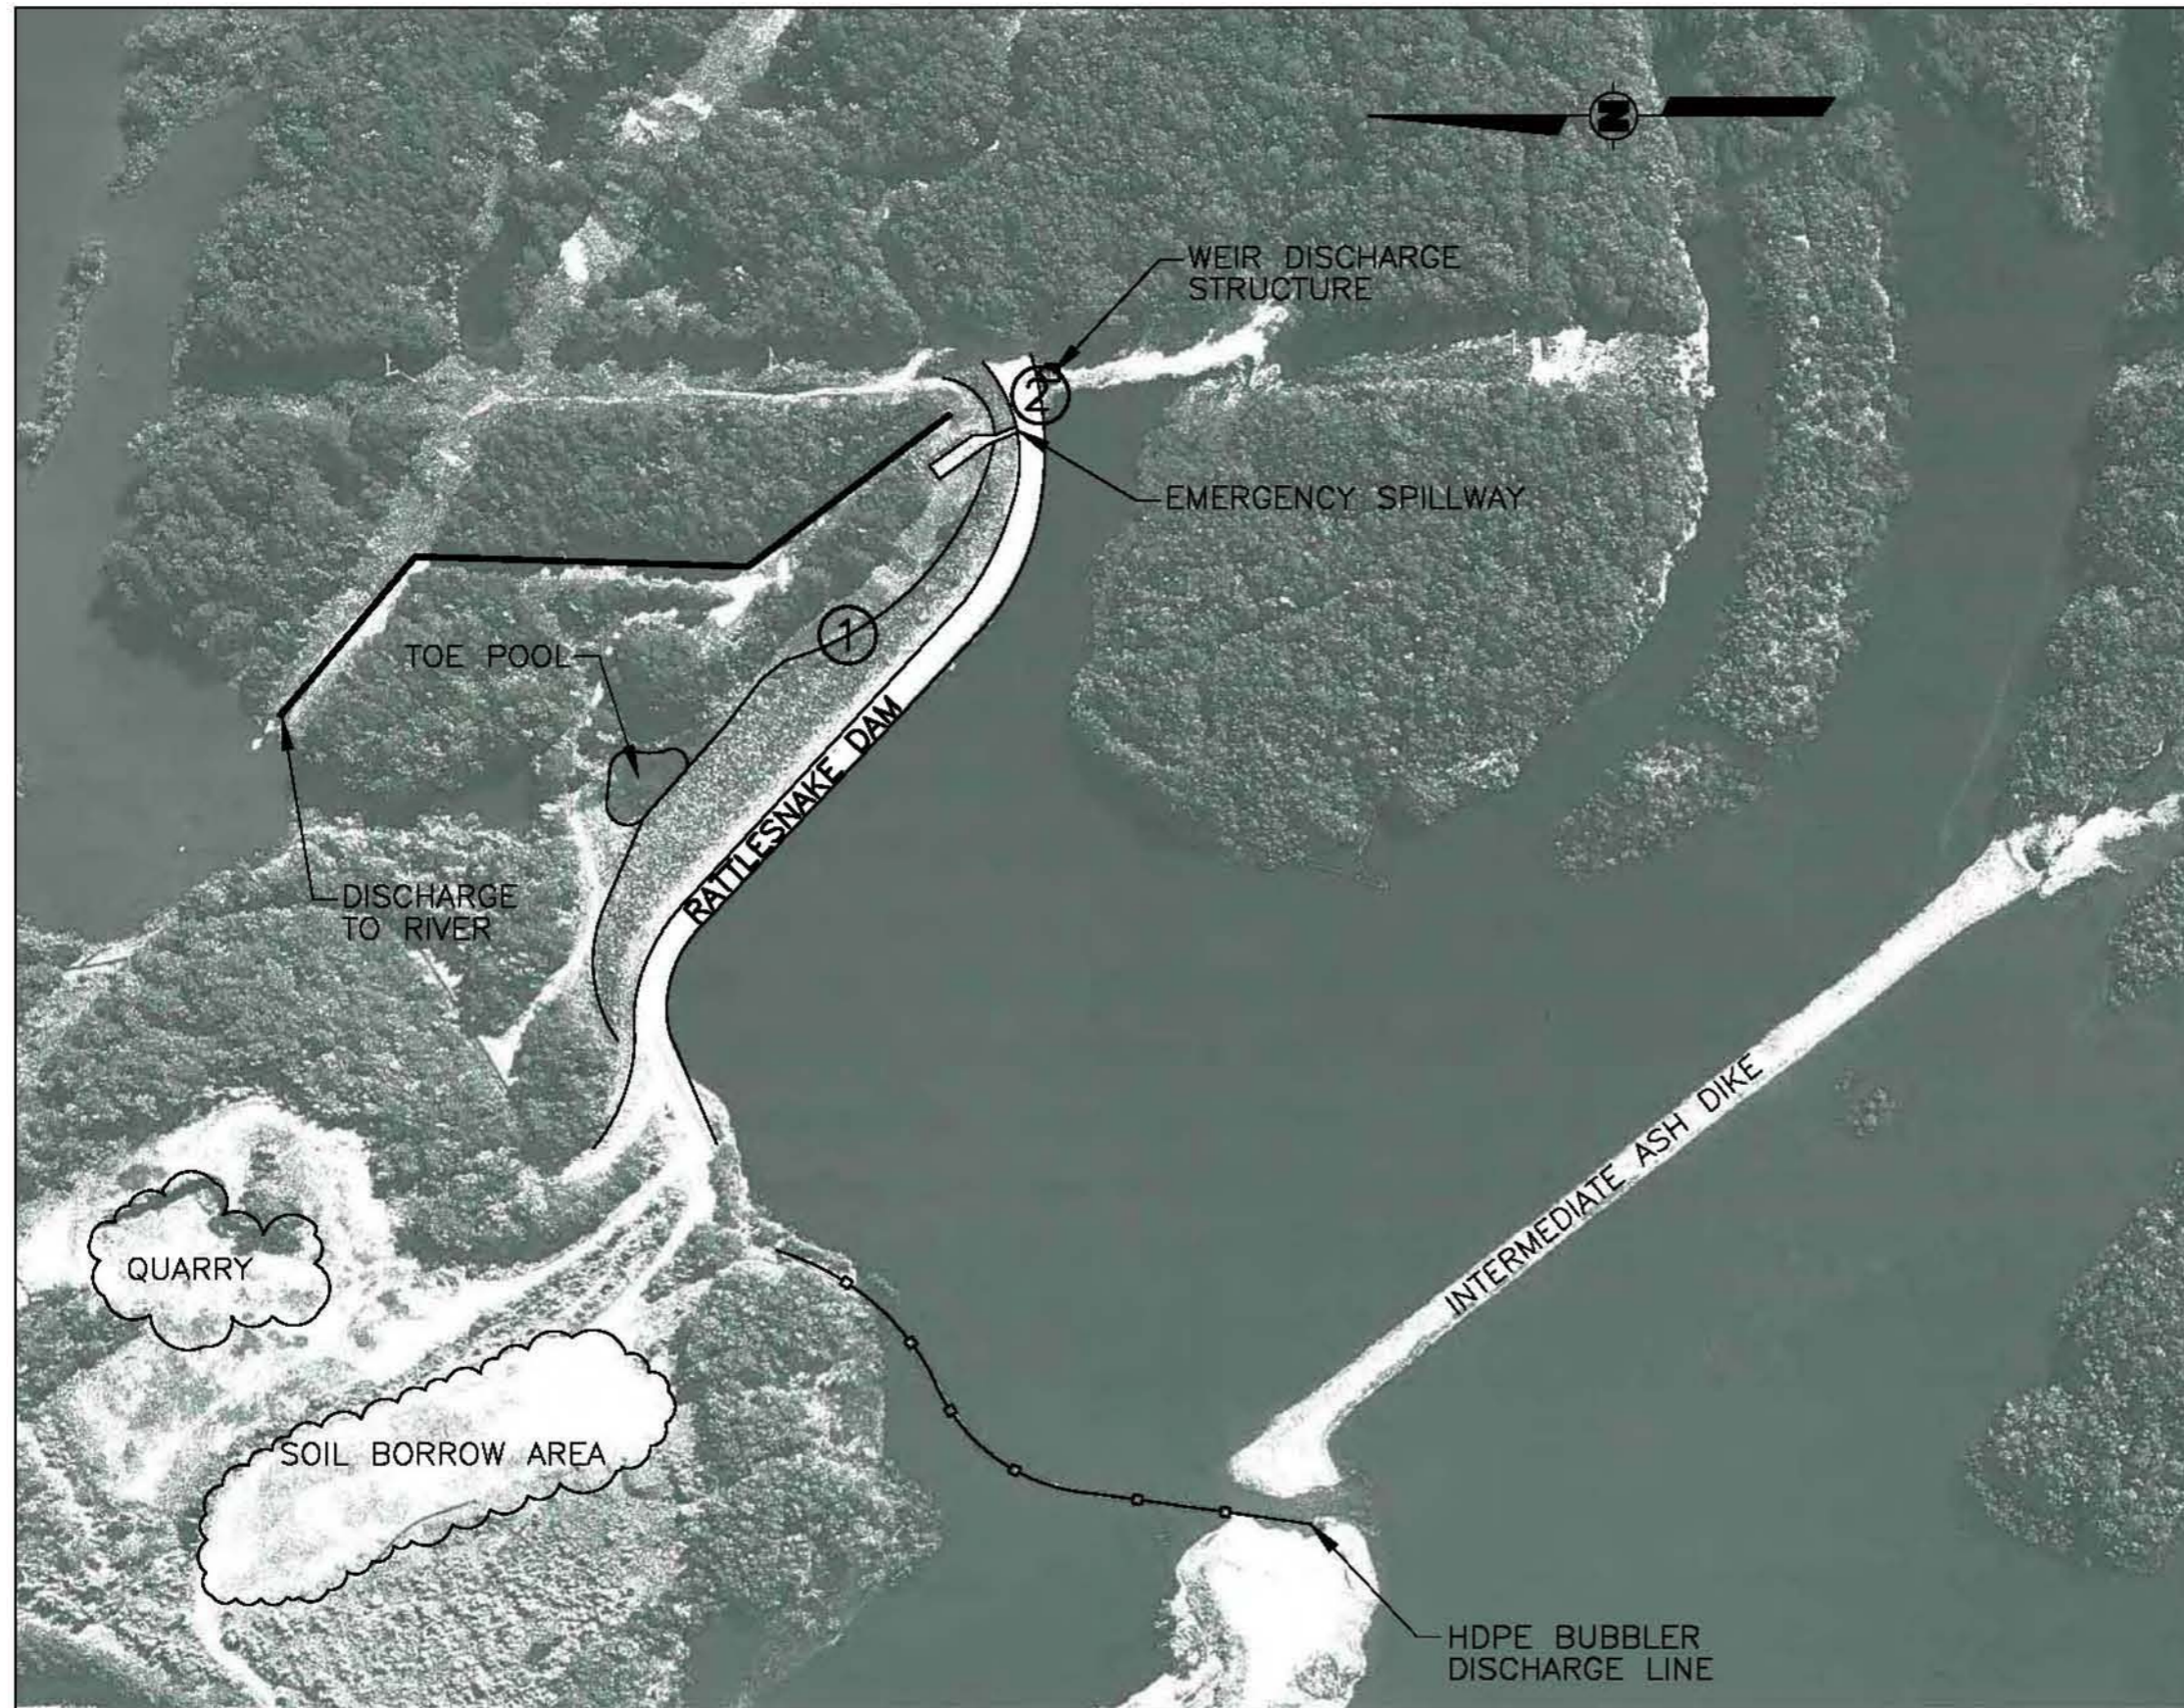
FIGURE 2
RATTLESNAKE HOLLOW
ASH POND AND FEATURES
GORGAS PLANT
DAM SAFETY INSPECTION
PREPARED FOR

- ① APPROXIMATE LOCATION OF SEEPAGE FROM TOE.
- ② CRACKING IN RCC FACING BLOCK NOTED HERE.
