**Bottom Ash Pond – Trimble County
Station Assessment Report**

**Lockheed Martin
Contractor for the USEPA**

September 2009

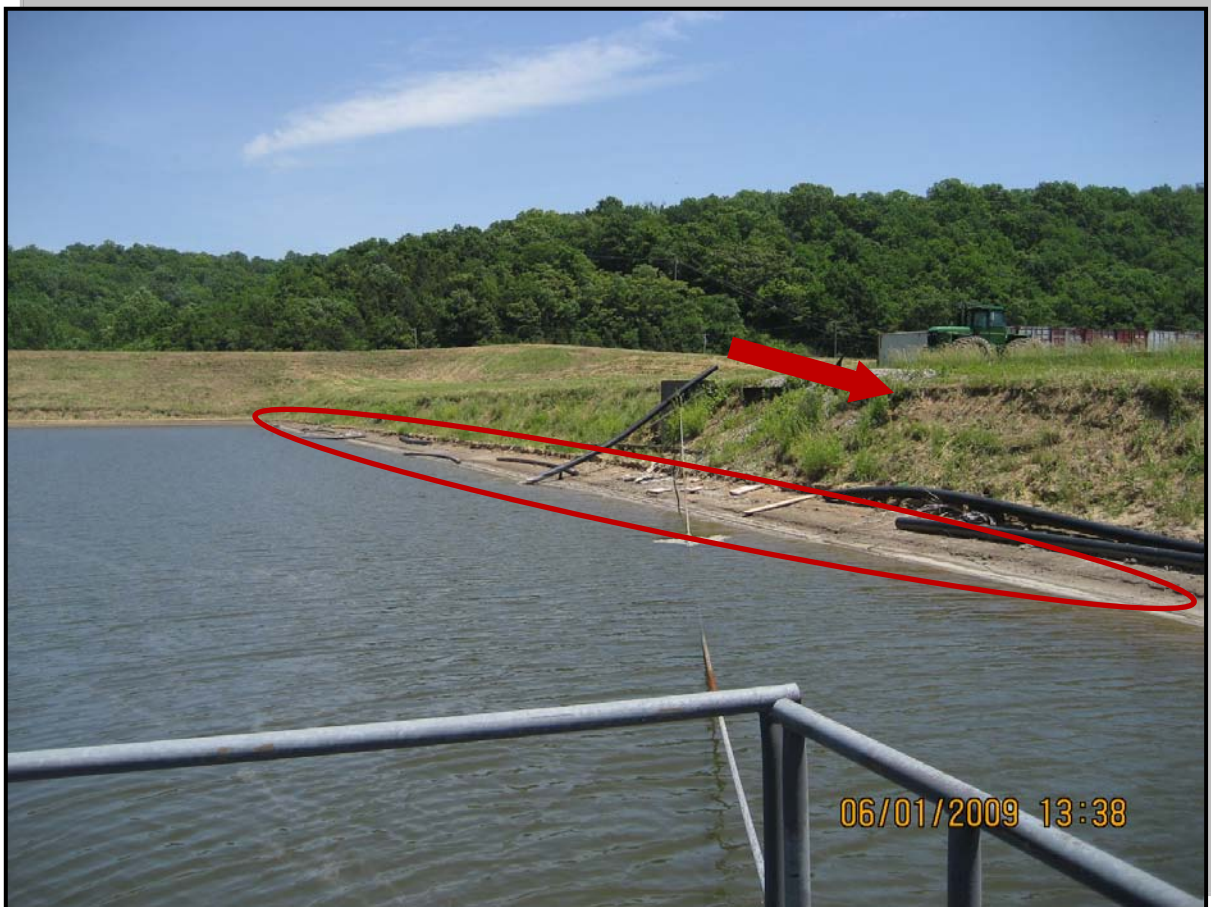
Wave action erosion was observed on the unarmored upstream slopes of both the south and east embankment and was more noticeable with the lower pool elevation. This erosion and some minor gully erosion occurring near the influent/effluent piping were the only deficiencies found on the upstream slope.

Photo 2 – View of South Dike with erosion and sloughing of upstream slope freeboard caused by wave action

1. Upstream slope – repair eroded and sloughed areas near the top of the east and south embankments. Repairs should be completed in accordance with an engineered design. Consider armoring of upper portion of interior eastern and southern slopes to protect against wave action erosion.

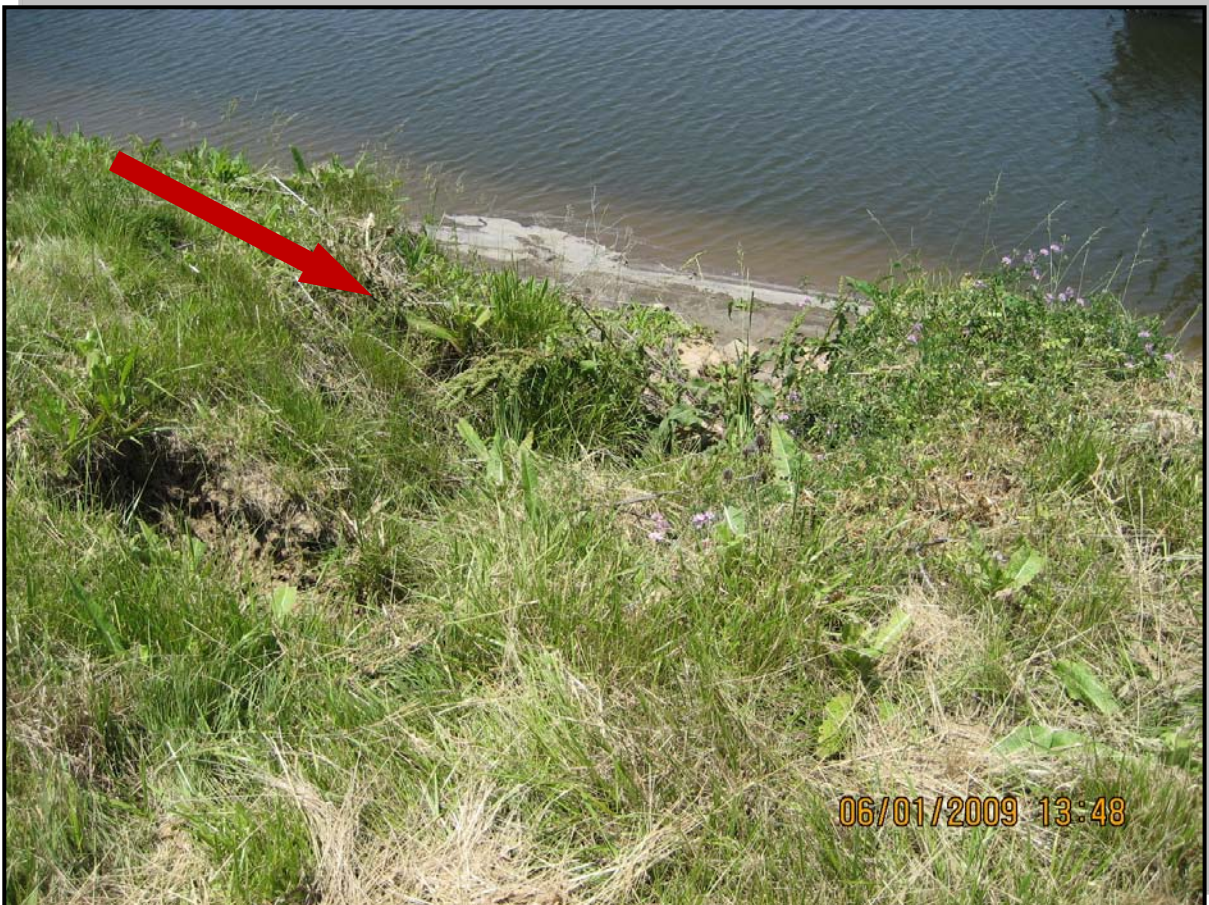
Photo 4 – View of typical erosion gullies in freeboard area along upstream slope near Floating Dock

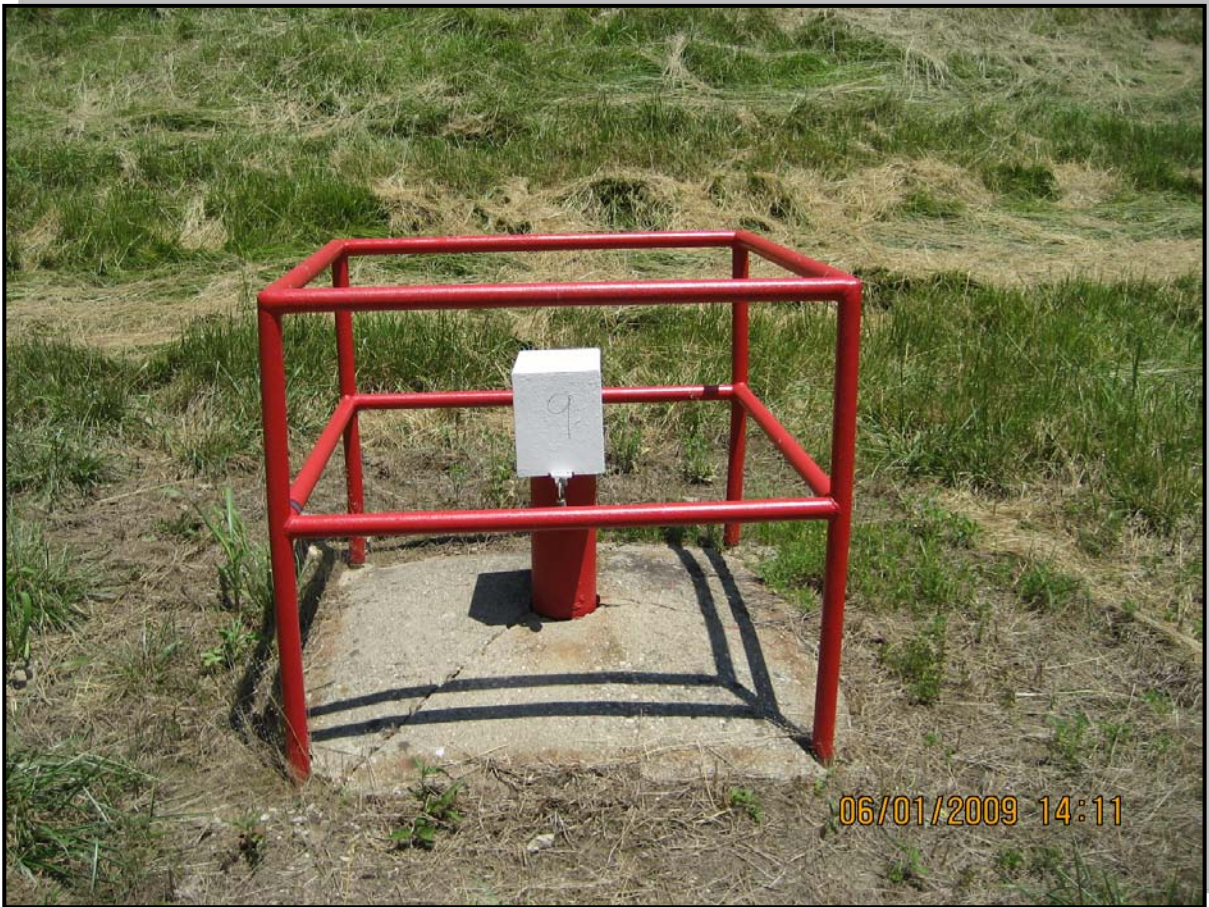
Several groundwater monitoring wells were observed and originally placed around the BAP because the original intent was to have a landfill at the premises for the CCW in lieu of the “wet management unit”. While the KDEP requires groundwater monitoring for landfills, they do not require monitoring wells for surface water impoundments. Several piezometers were observed along the east dike but were only installed for the analysis and design of the vertical extension project and are now mostly abandoned.

Photo 7 – Typical view of groundwater monitoring well (Not used for seepage or pore pressure monitoring)

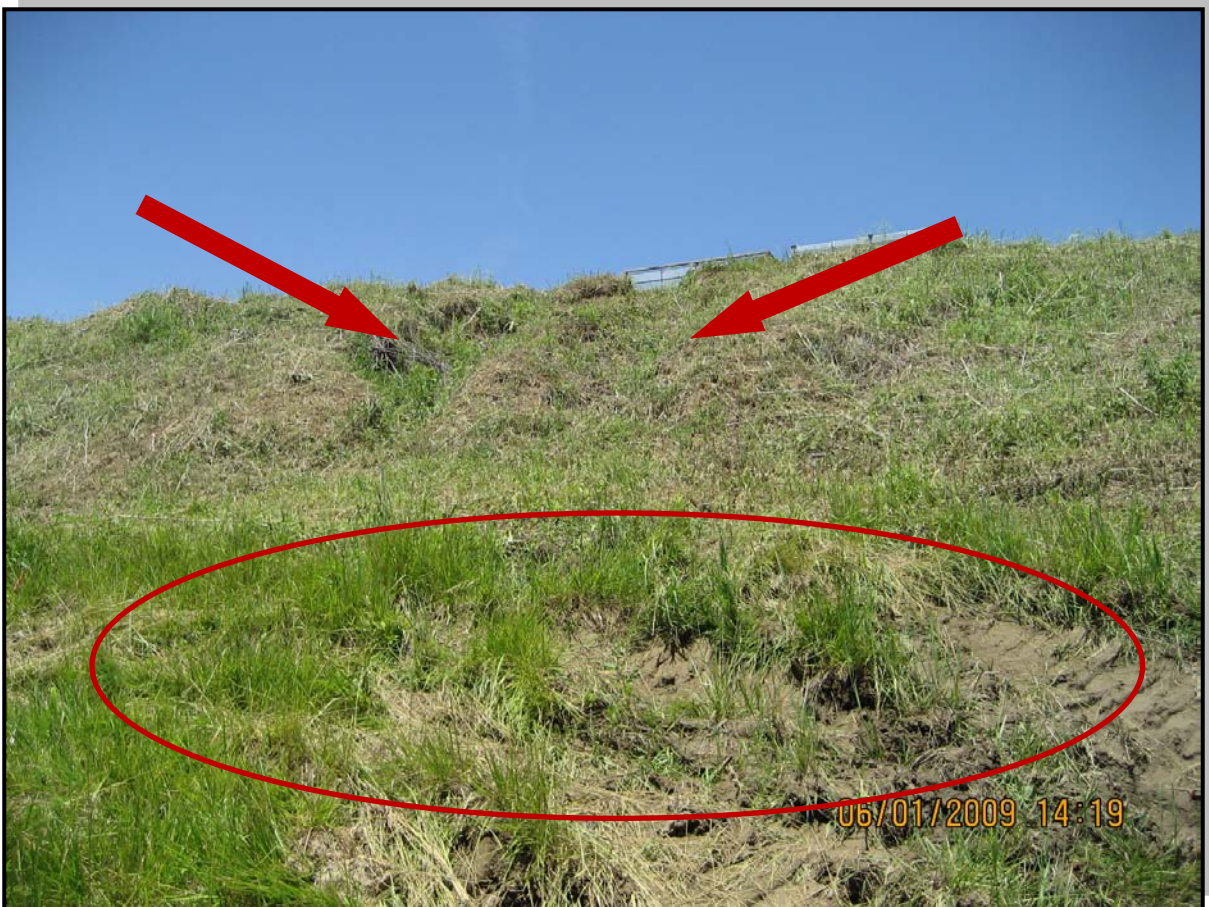
Several erosion gullies were observed on the downstream slopes of the west and north embankments. This erosion appears to be occurring due to concentrated storm water discharge due to rutting of the crest by equipment and irregular grading of the crest toward the downstream slope.

Photo 8 – Typical erosion gullies along western downstream slope near inside curved slope of embankment

3. Downstream slopes – fill erosion gullies on the downstream slopes of the north, east, and west embankments. Repair sloughs, and re-grade irregular areas of slopes to avoid concentrated runoff channels or saturation of portions of slope. Repairs should be performed in accordance with an engineered design. Avoid mowing during wet conditions to reduce rutting by heavy tractor, which may be causing some minor slope sloughing. Place turf reinforcement erosion control matting over repaired areas to reduce the potential for future erosion gullies.

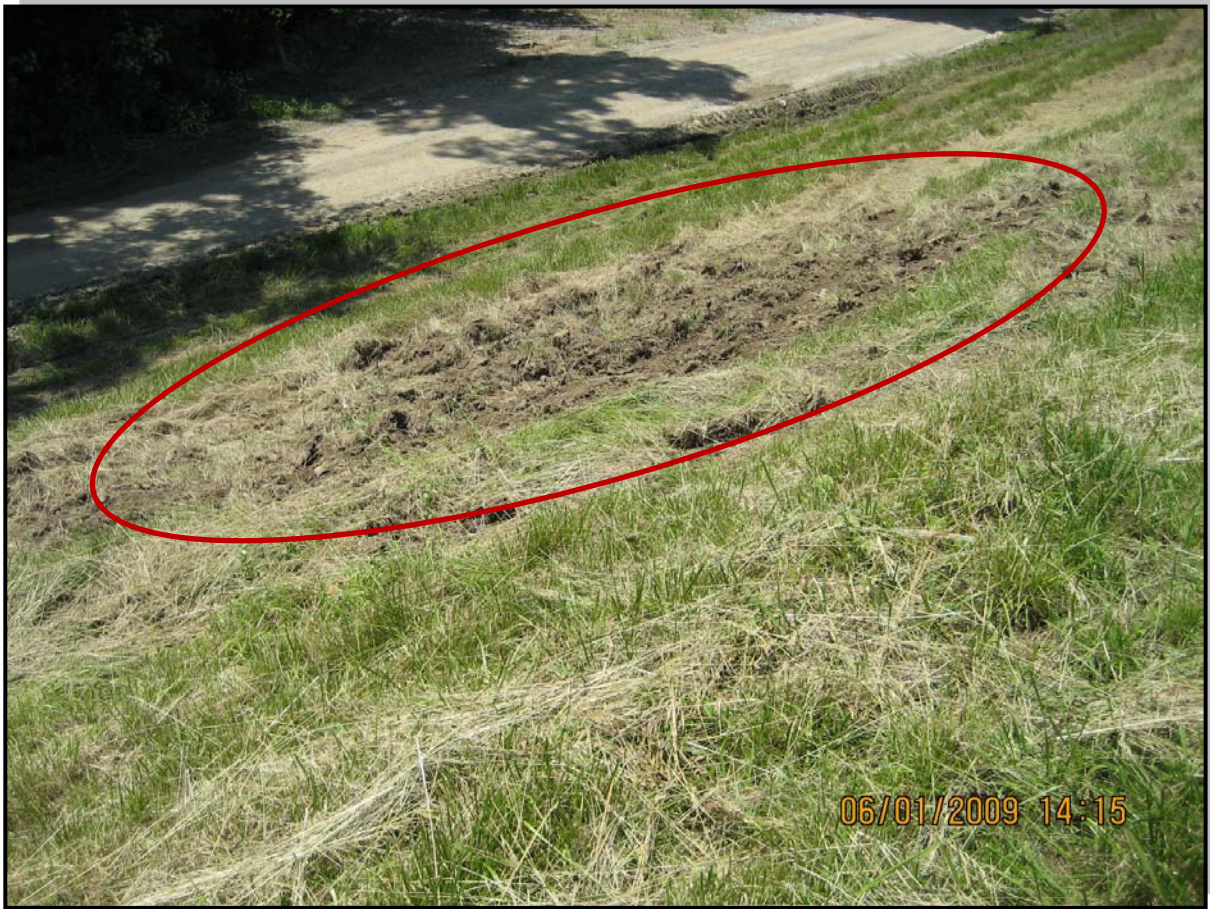
Photo 9 – Typical rutting and slope sloughing due to heavy mowing tractor, western downstream slope

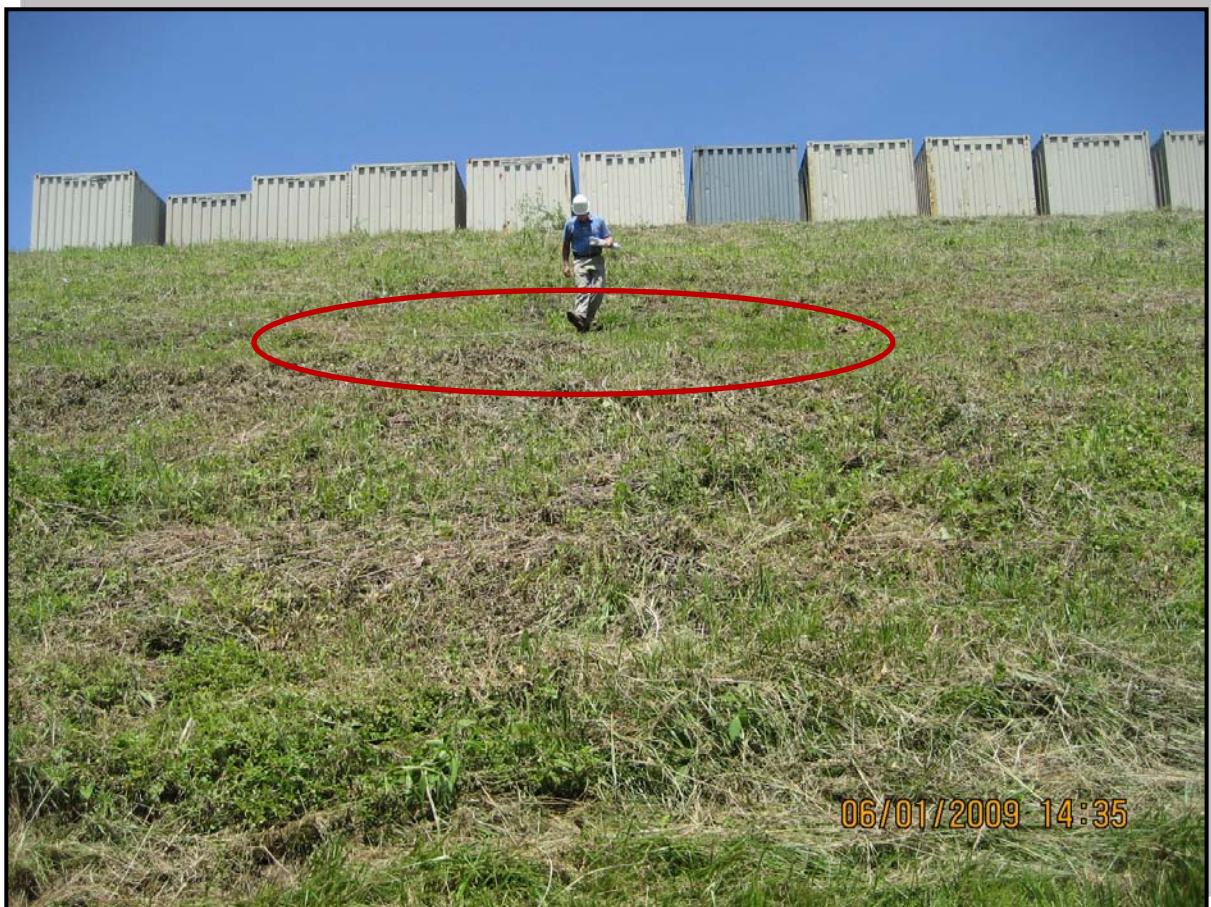
The downstream slope had recently been mowed, which allowed for better observation of the slope. Several shallow sloughs were noticed along the downstream slopes, but it was evident that they were old occurrences due to the vegetative growth around the sloughs. No new sloughs or depressions were found during this inspection.

Photo 10 – Old slough on western downstream slope

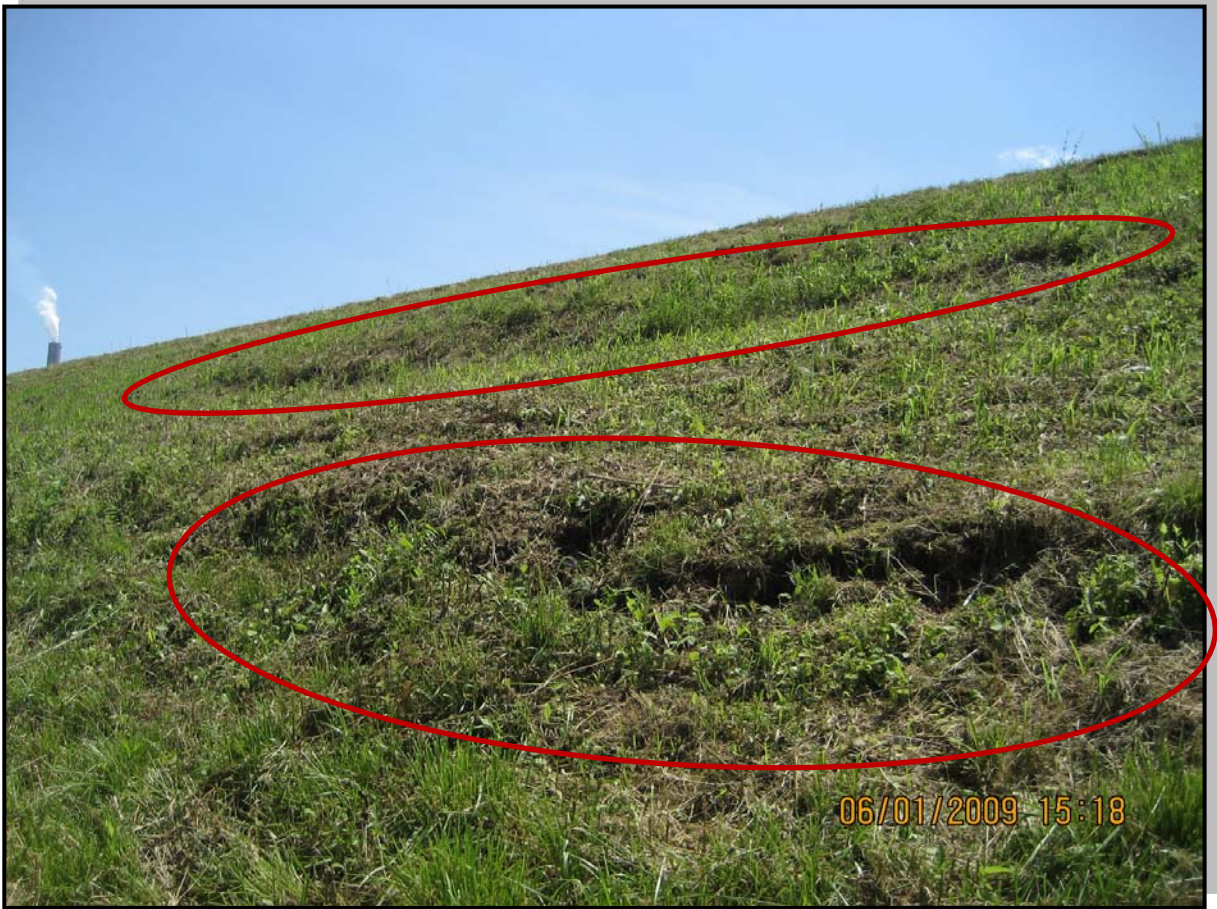
Photo 13 – Old slough on eastern downstream slope

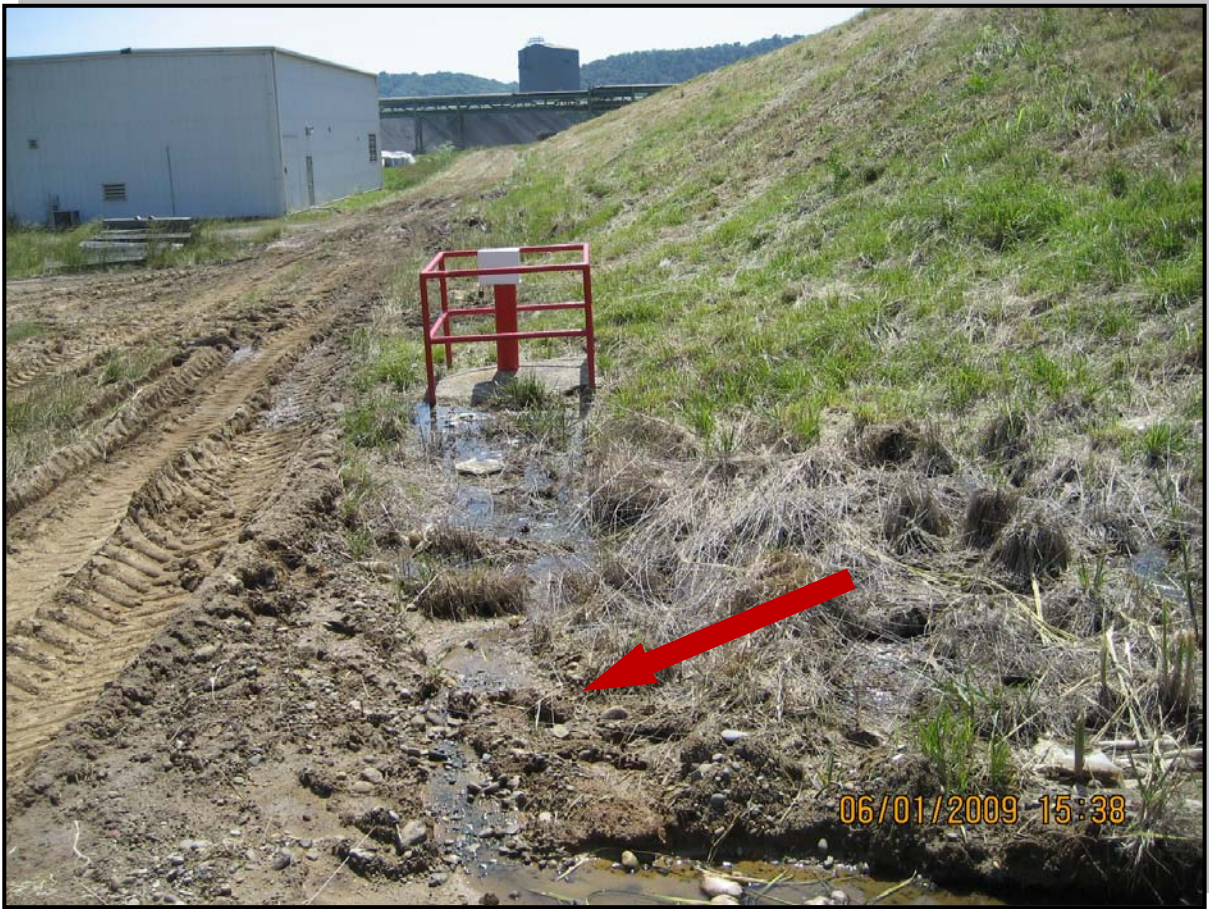
Based on the findings of the visual inspection and the records review conducted for this study, the Bottom Ash Pond at Trimble County Station located in Bedford, Kentucky appears to be in satisfactory condition and is well maintained. As described in the previous section, several minor maintenance items were observed, which do not currently impact the structural integrity of the BAP management unit, but should be addressed in the near future to avoid worsening conditions. These items include areas of erosion and shallow slope sloughing on both the upstream and downstream slopes. One small seepage location was noted on the toe of the south embankment.

Photo 15 – Wet Area or minor seepage at toe of south embankment possibly due to discharge from gravel toe drain (View looking west)

Although the minor seepage/wetness at the downstream toe of the south embankment is believed to be the result of controlled discharge from an engineered toe drain, this seepage area should be monitored for increased seepage volume, transport of fine-grained soils, or other changed conditions that may indicate a potential problem. Installation of a small gravel blanket drain in the area with an outlet channel or pipe would help to alleviate the poor drainage conditions in the area and provide a means to measure seepage flow rate at a convenient discharge point.

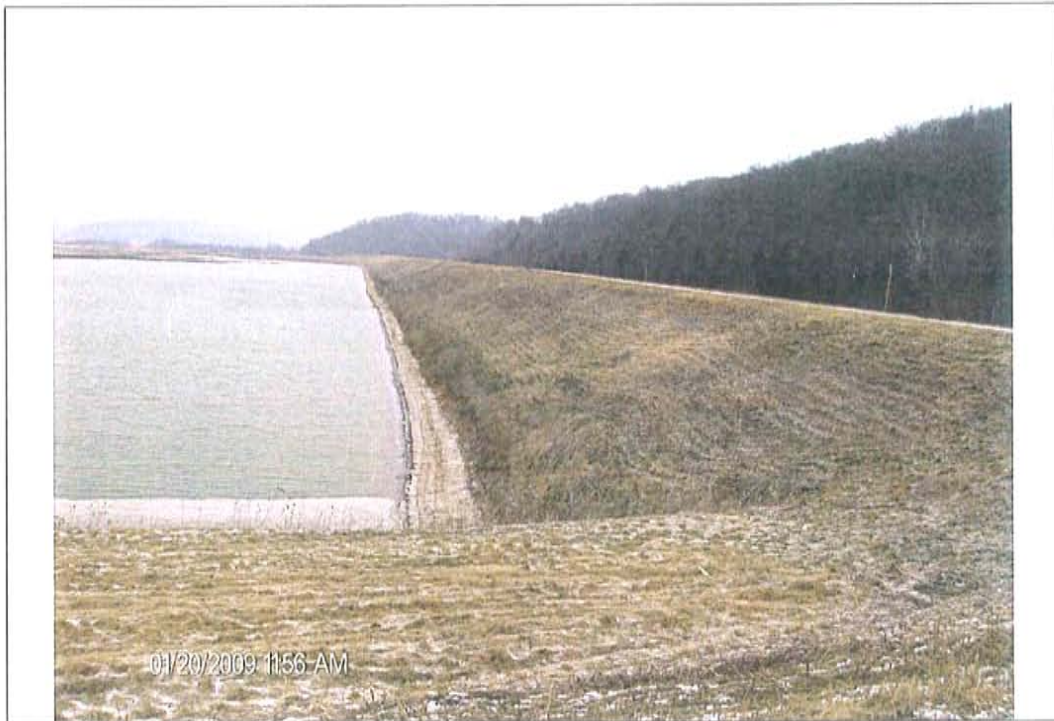
Photo #1: Wave erosion, East embankment, downstream slope, looking North

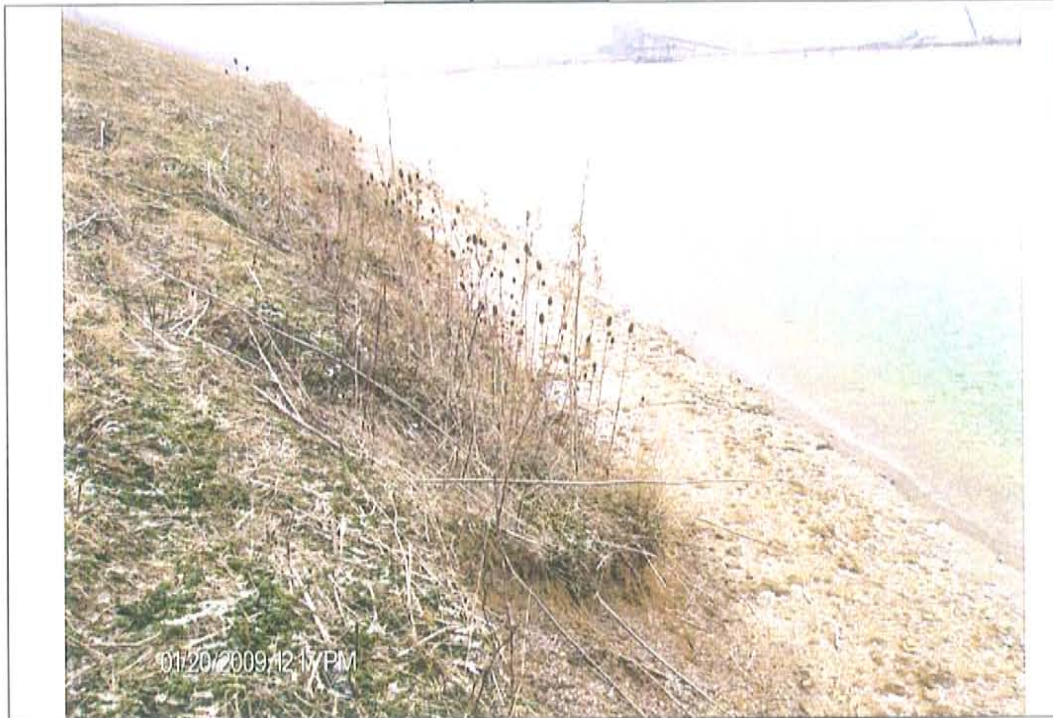
Photo #5: Wave erosion, steep drop near water surface, East embankment, upstream slope, directly across from bottom ash reclaim, looking South

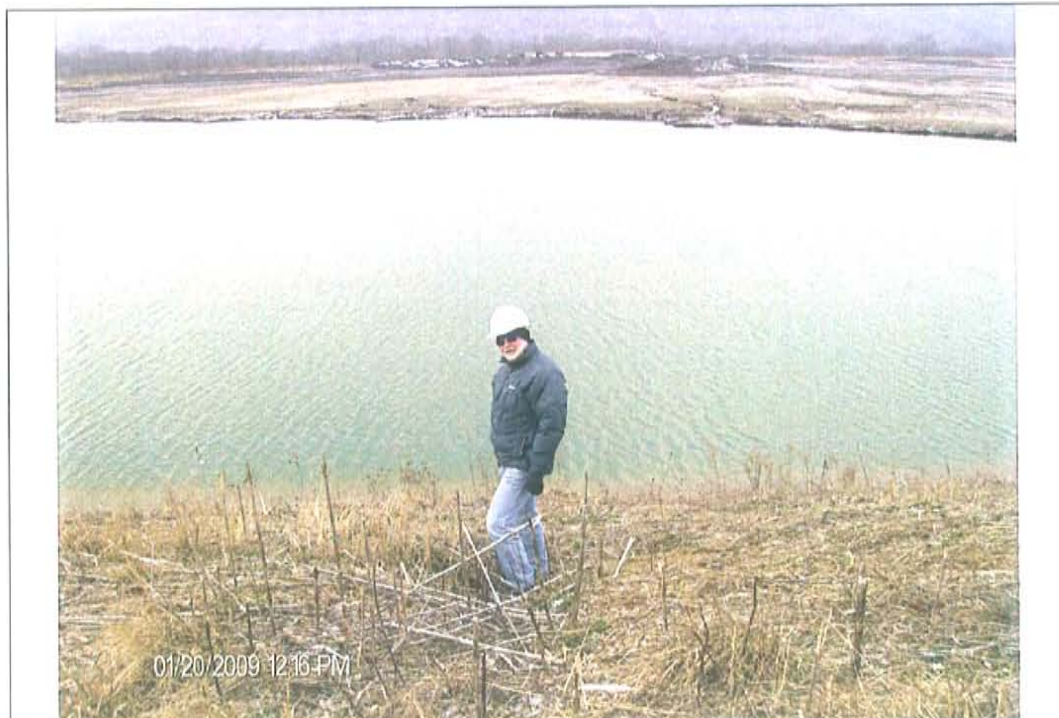
Photo #6: Appears to be filled in gully, East embankment, upstream slope, directly across from bottom ash reclaim, looking West

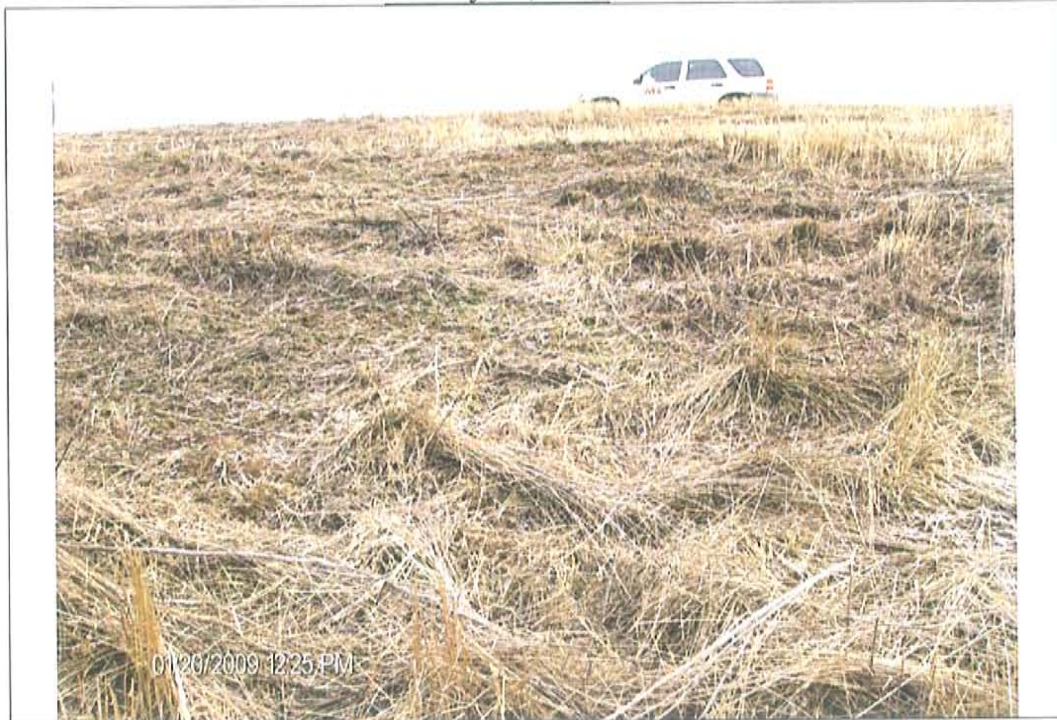
Photo #7: Old slough, East embankment, downstream slope, looking East near NE corner of pond

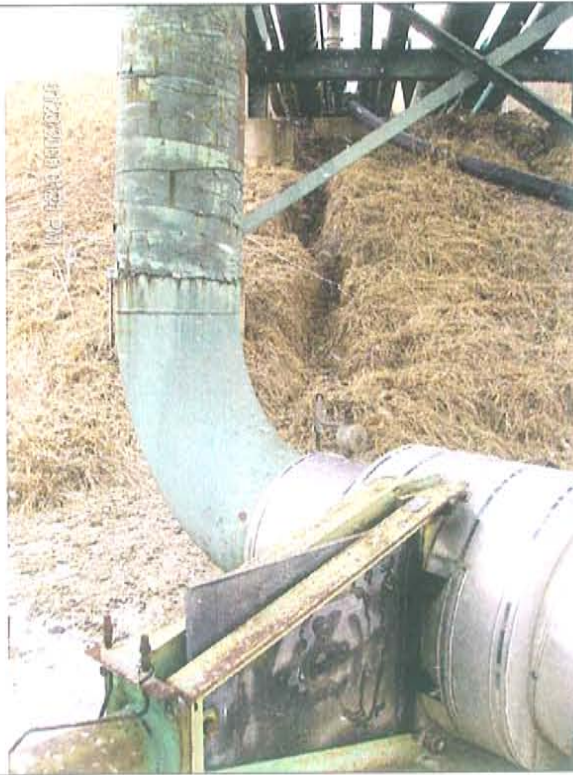
Photo #10: Minor erosion below piping, South embankment downstream slope
