MINERALS MANAGEMENT SERVICE

PIPELINE DAMAGE ASSESSMENT FROM HURRICANES
KATRINA AND RITA IN THE GULF OF MEXICO

REPORT NO. 448 14183

DET NORSKE VERITAS

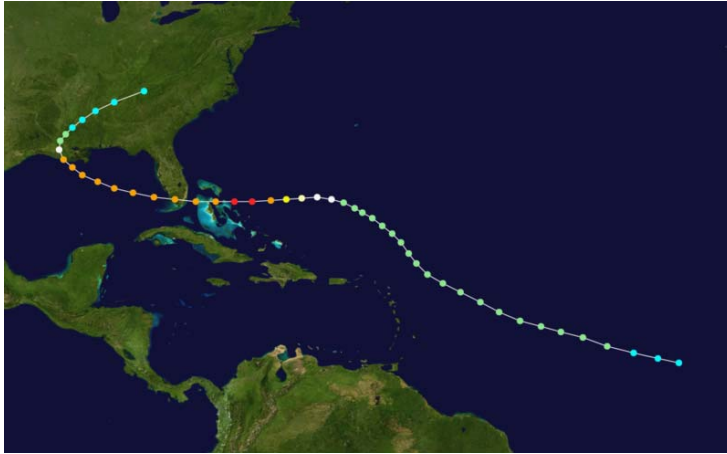
Figure 6 – Path of Hurricane Andrew

Hurricane Andrew. Hurricane Andrew was a category-4 level storm with sustained winds up to 140 miles per hour and significant wave heights estimated to be at 35-40 feet. Hurricane Andrew passed to the west of the Mississippi Delta, with its path overlaying some 700 structures, felling 22, and damaging to some degree about 65 others. Consequently, the westward path of Hurricane Andrew, shown in Figure 6 resulted in few pipelines being damaged by mudslides in this hurricane event.

Hurricane Andrew damage to offshore pipelines was studied by Southwest Research Institute, and a Final Report was produced under MMS Contract No. 14-35-0001-30748 for the MMS Technical Assessment and Research Branch in March of 1995. Hurricane Andrew passed through the Gulf of Mexico in August 1992, following the path shown in Figure 6. About 36 major platforms and 145 satellite well jackets and caissons were damaged and

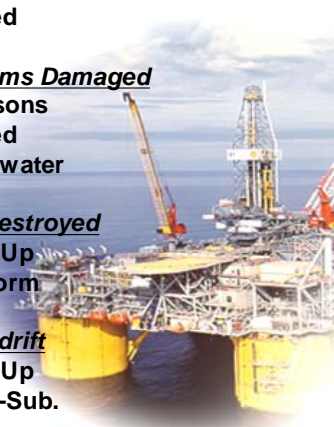
The MMS data shown to the left provides a summary of the damages as of October 4, 2005, immediately after Hurricane Rita. While the numbers were very high, the percentage of failed platforms was typical of significant storm events previously studied as discussed earlier in this report. The details of the Platform pipeline damages are mapped on Map 4.

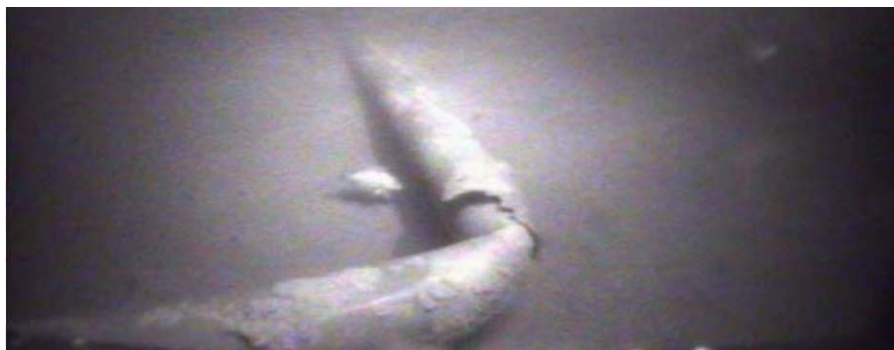
This category included four reports of lines that were kinked or dented. All appeared to be from outside forces with visible damage that would indicate impact or anchor drags,

Photo Courtesy of Shell – 2006 Hurricane Pipeline Presentation - Kinked Pipeline Example

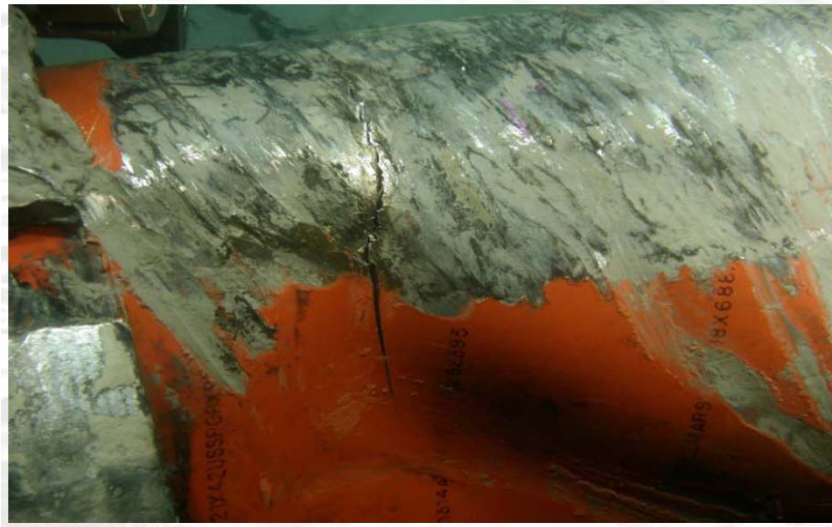
Figure 35 – MARS Pipeline Damage

While these standards do not directly address pipeline standards, they do address one of the pipeline damage categories that saw an increase in damages reported to pipelines when compared to prior events studied. The exact cause of pipelines dented, kinked, pulled apart, pulled up and otherwise impacted are unknown, but these categories of damage reports correlated with the general locations of the
