Assessment of Dam Safety
Coal Combustion Surface Impoundments (Task 3)
Final Report

Progress Energy Carolinas
Cape Fear Plant

Moncure, North Carolina

September 14, 2009

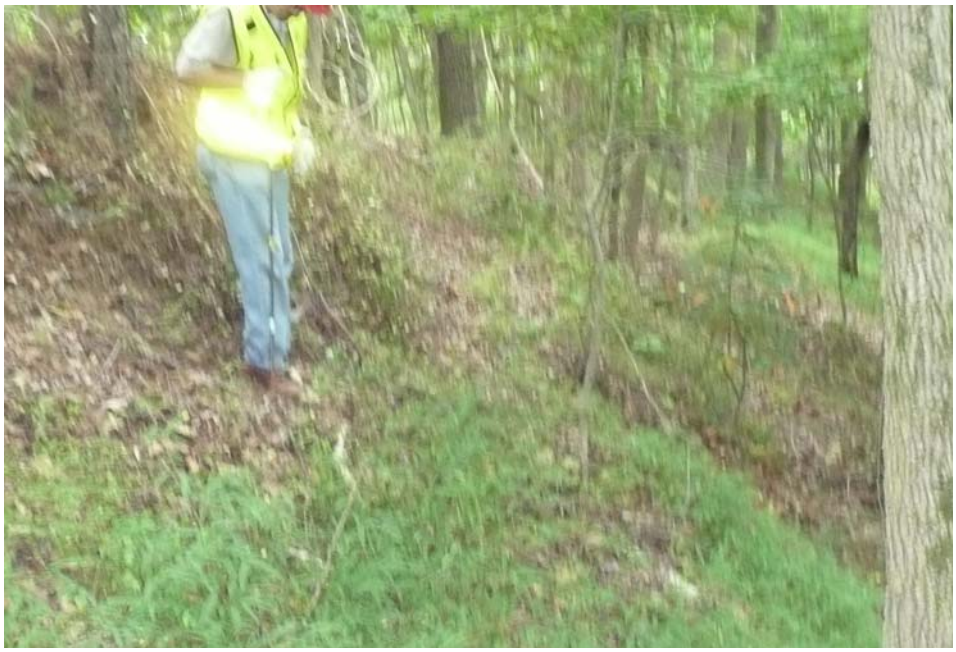
100

Typical of frequent areas of erosion on the downstream slopes of the 1956 Ash Pond Dikes.

Same location as the previous photo with a person for scale.

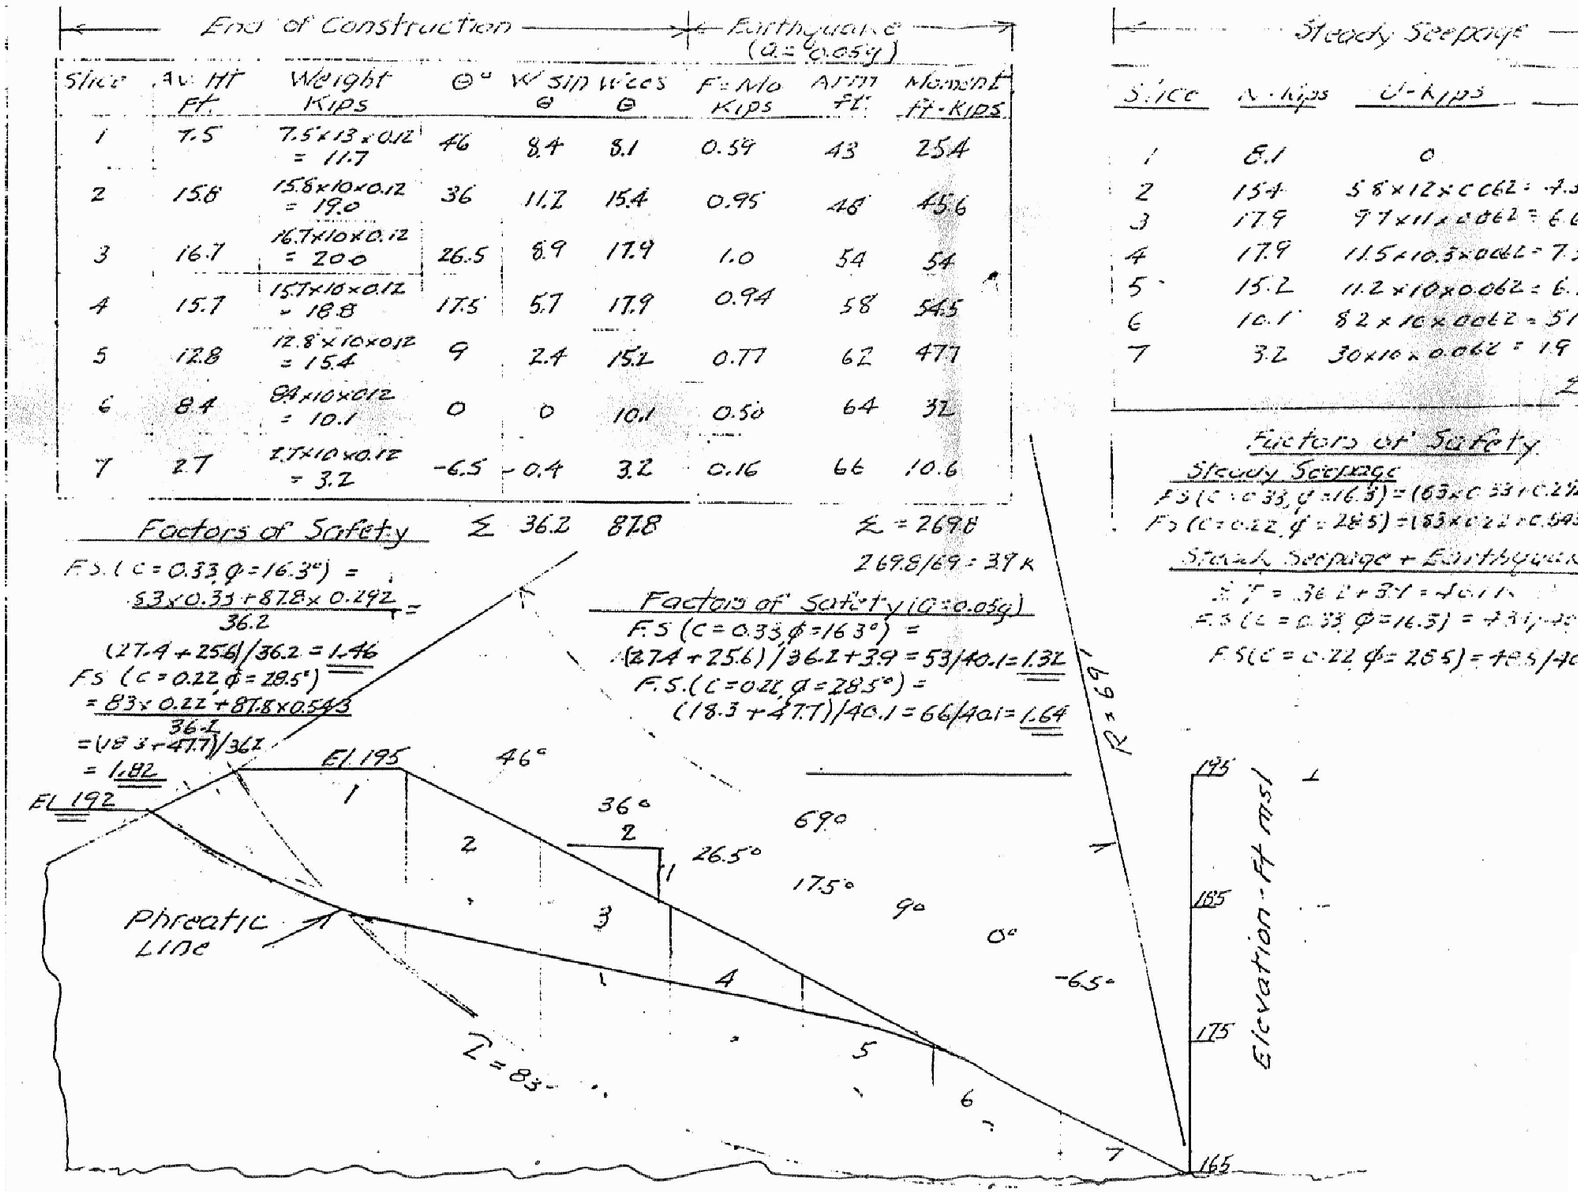
FIGURE 6

Laboratory testing was performed on borrow source material samples and average shear strength parameters for both the total stress and effective stress conditions were assumed for the analysis. The end of construction, downstream slope steady state, earthquake and steady state and earthquake loading conditions were analyzed and Table 4 provides a summary of the results and Figure 6 show details of the analysis.

Loading Condition	Shear Strength Assumptions	
	c = 330, phi = 16.3°	**c = 220, phi = 28.5°**
End of Construction	1.5	1.8
Steady State	1.2	1.3
Earthquake	1.3	1.6
Steady State & Earthquake	1.1	1.2

F.S (C = 0.33 φ = 16.3°) = 53 / 40.1 = 1.32

F.S (C = 0.22 φ = 28.5°) = 68.5 / 40.1 = 1.71

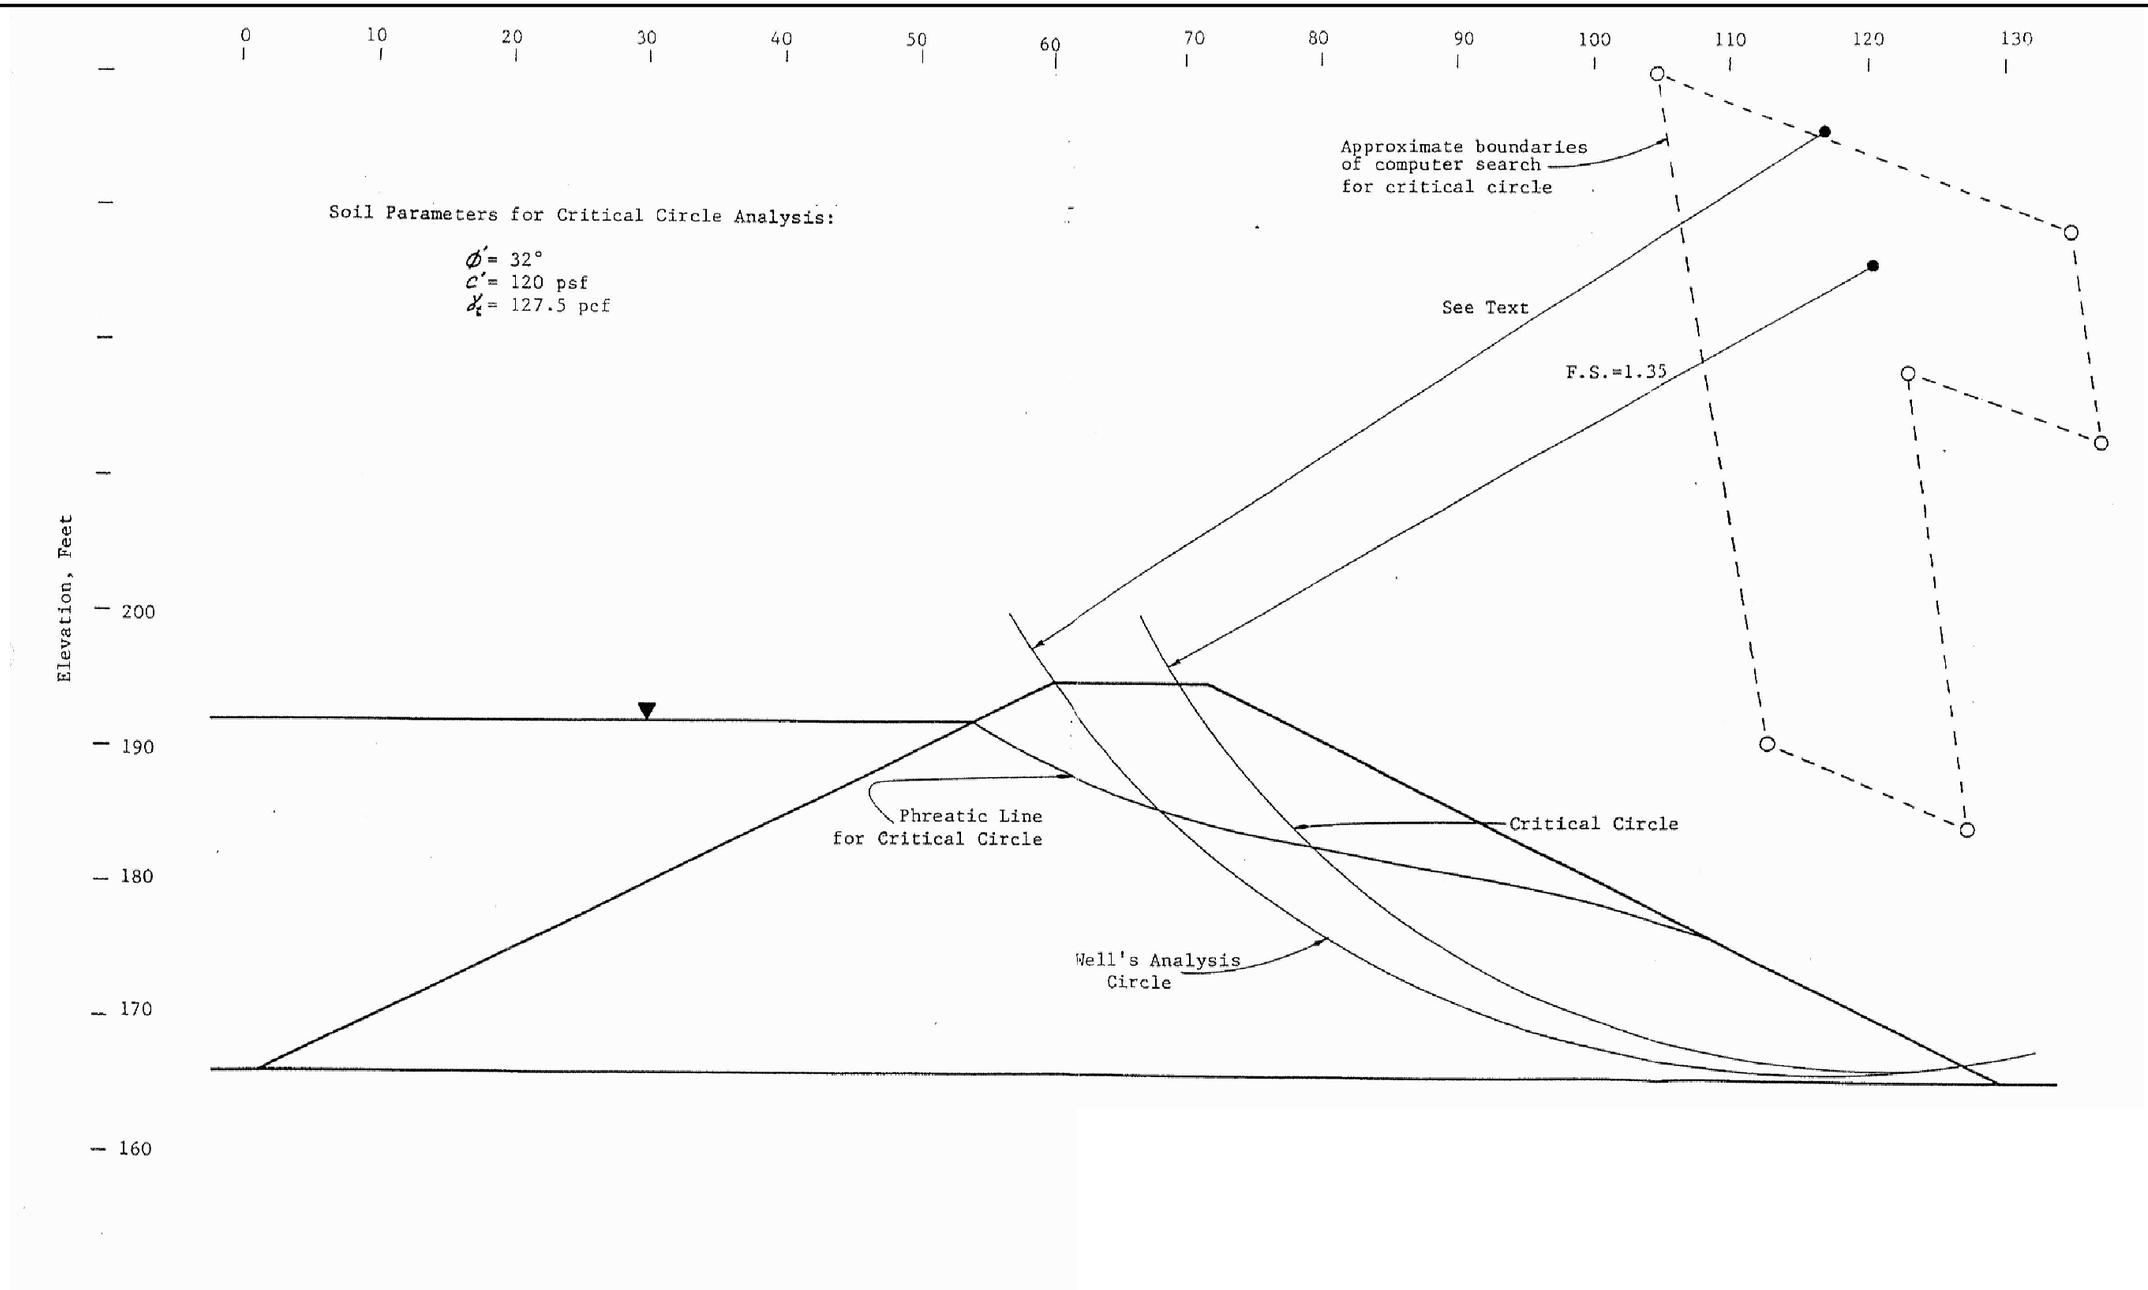
FIGURE 7

concluded that the dike, under steady state seepage conditions and effective strength parameters, had a factor of safety of 1.35 as shown in Figure 7. Although the factor of safety was less than the 1.5 recommended by the US ACOE, Law Engineering concluded that it "did not indicate a deficiency in the design or a threat to the safety of the structure."

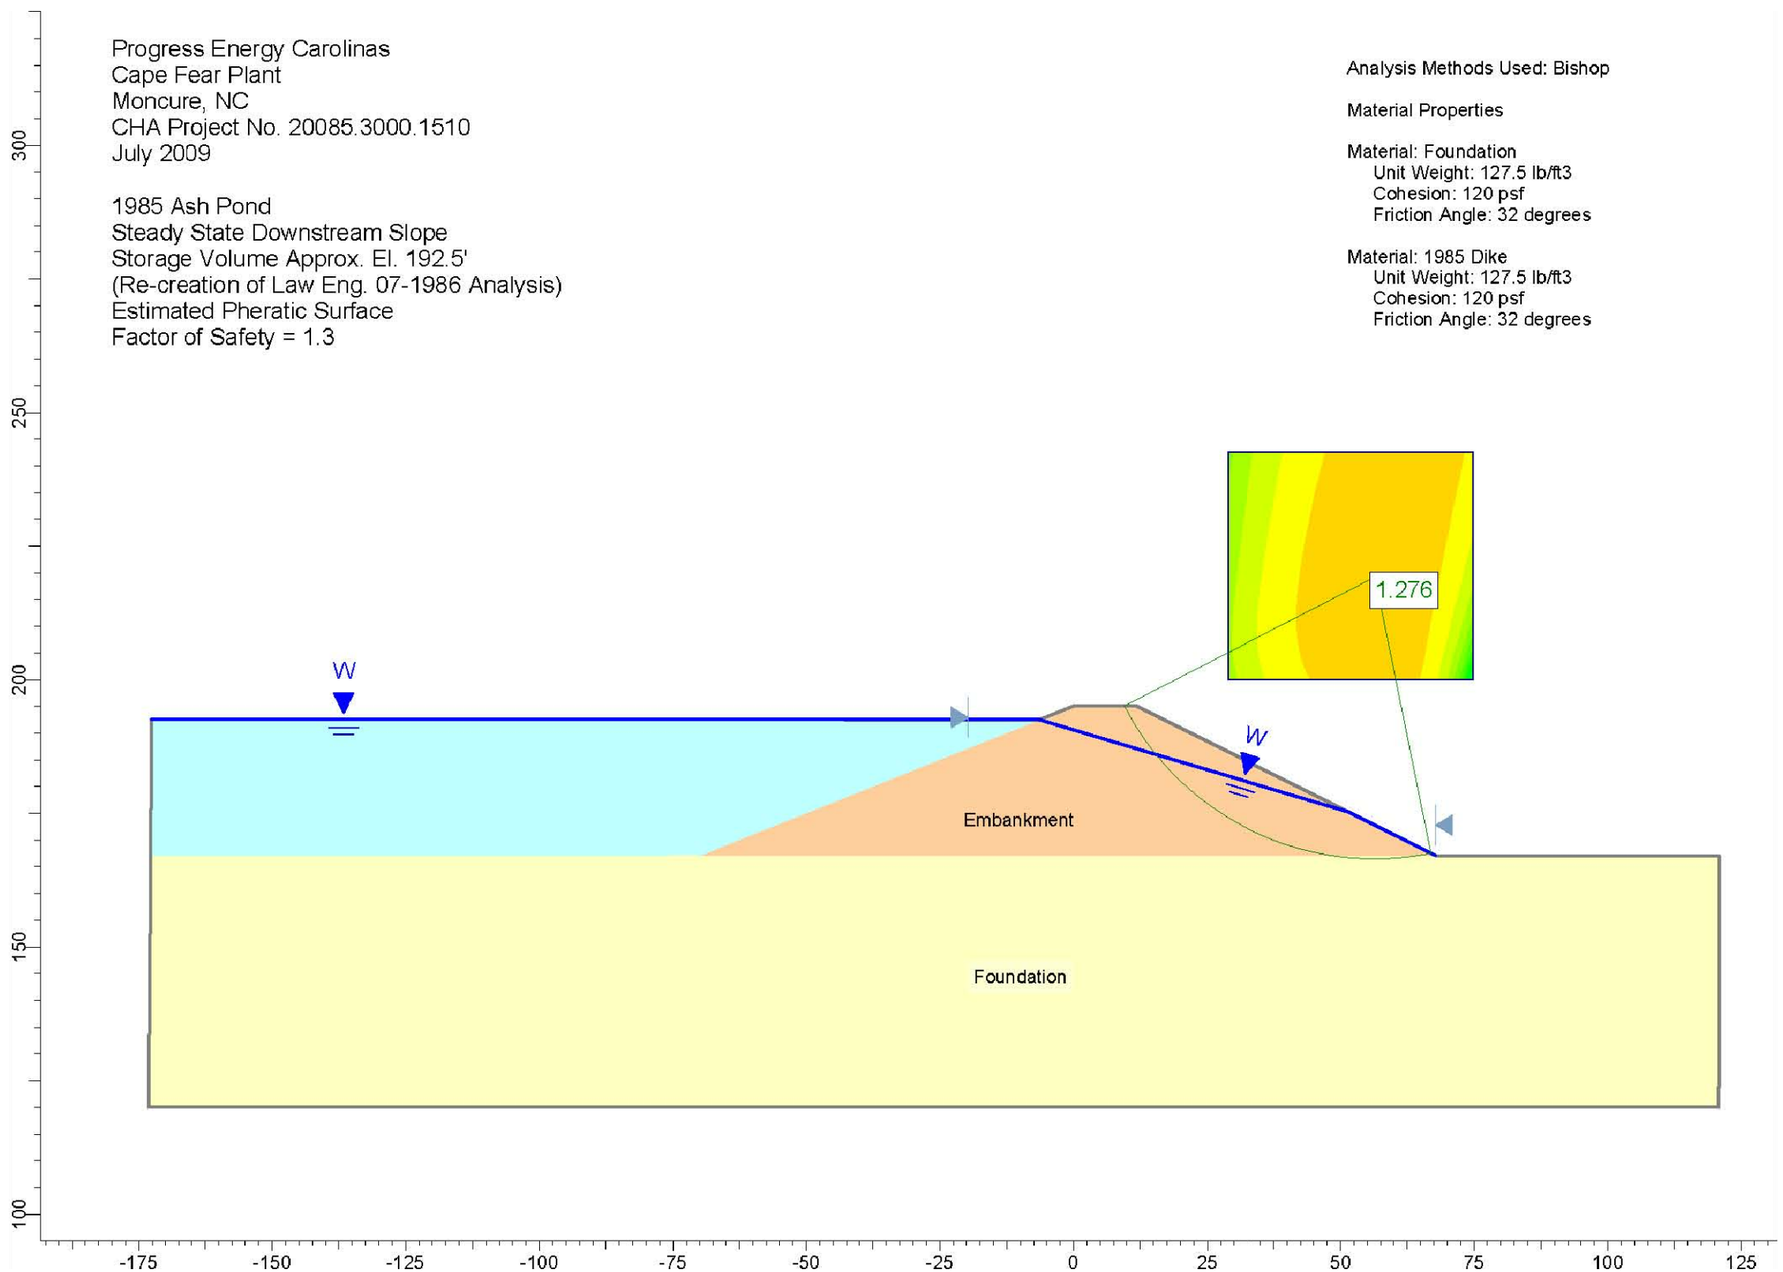
CROSS SECTION OF 1985 ASH POND
Cape Fear Plant
Progress Energy Carolinas
Moncure, North Carolina

Material: Foundation
Unit Weight: 127.5 lb/ft3
Cohesion: 120 psf
Friction Angle: 32 degrees

Material: 1985 Dike
Unit Weight: 127.5 lb/ft3
Cohesion: 120 psf
Friction Angle: 32 degrees

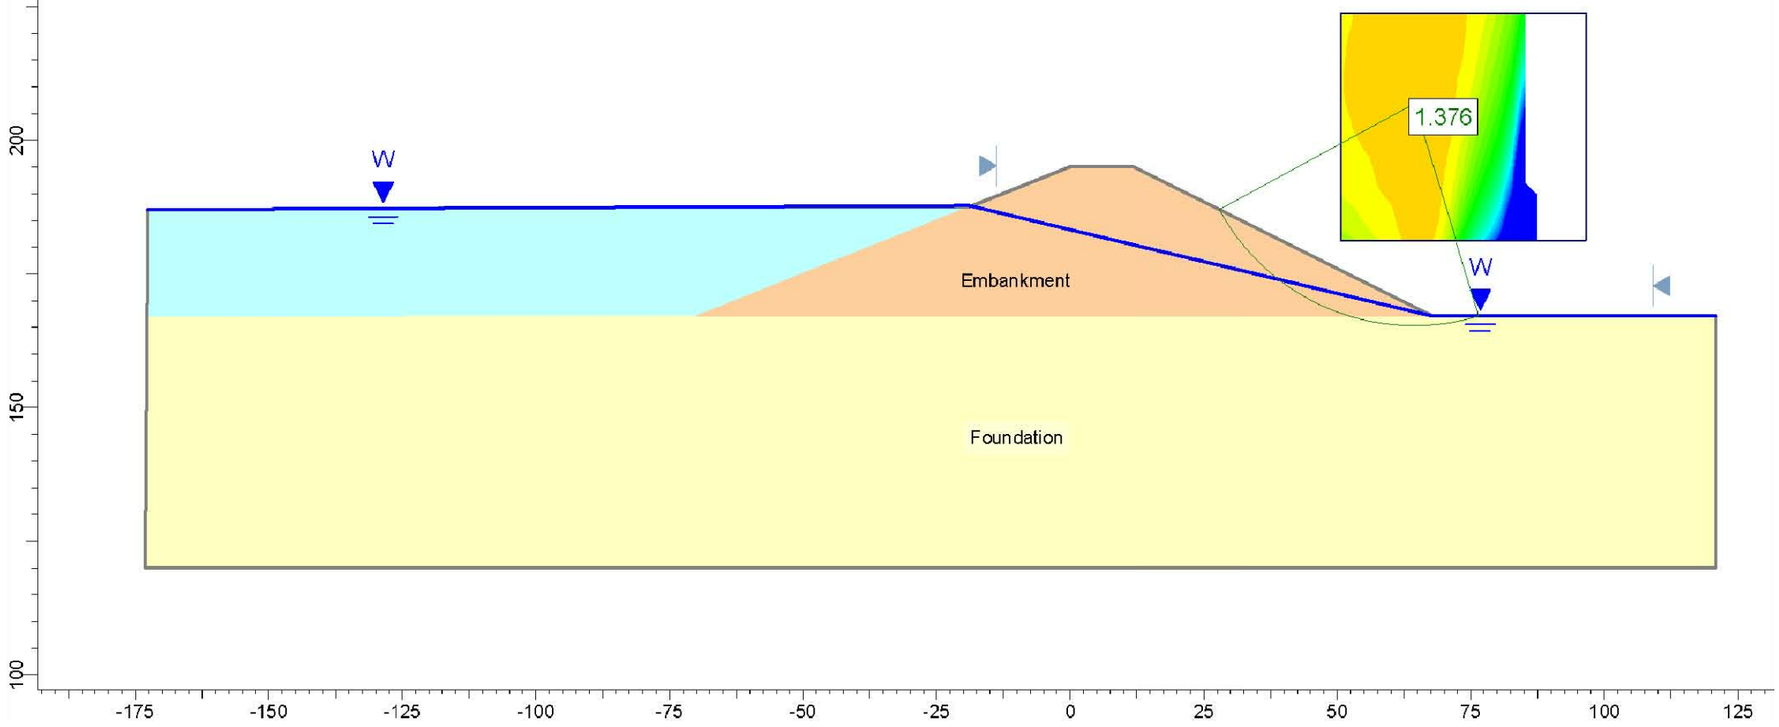
CROSS SECTION OF 1985 ASH POND
Cape Fear Plant
Progress Energy Carolinas
Moncure, North Carolina

Material: Foundation
Unit Weight: 120 lb/ft3
Cohesion: 0 psf
Friction Angle: 35 degrees

Material: 1985 Dike
Unit Weight: 120 lb/ft3
Cohesion: 0 psf
Friction Angle: 35 degrees
