September 16, 2009
GZA File No. 01.0170142.00

Re: Task 3 Dam Assessment Report
Project #0-381
Allen Steam Station Coal Ash Retention Dam
Belmont, North Carolina

EXECUTIVE SUMMARY

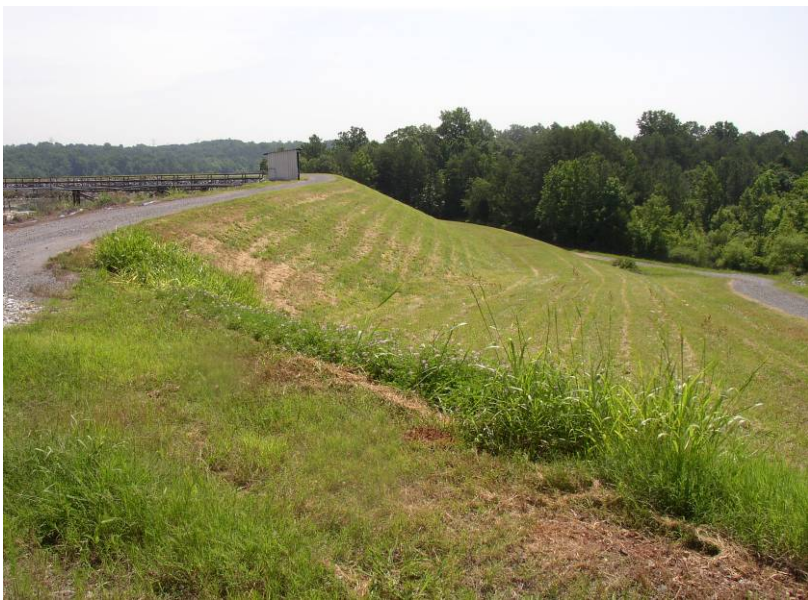
1 Southern Crest & Downstream Slope of East Dike – Local Reseeded Area

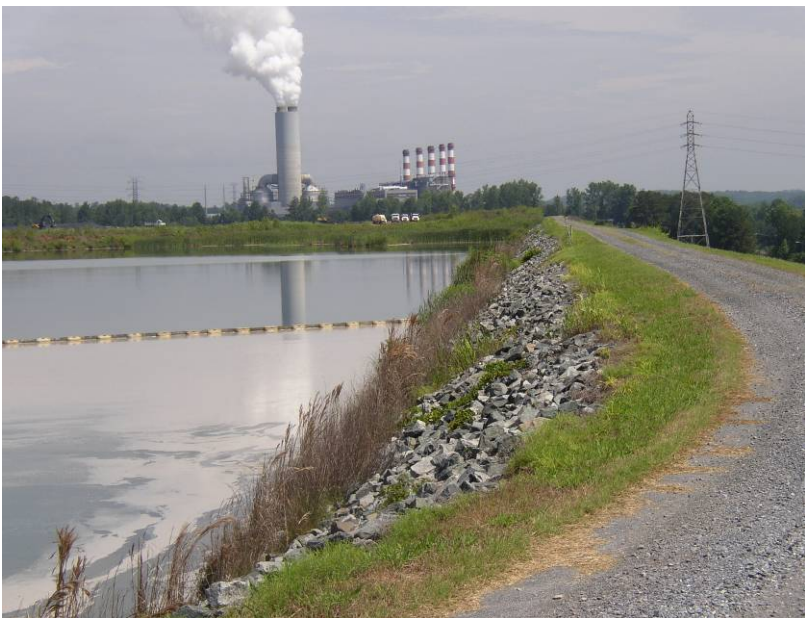
#5 Overview of Crest & Upstream Slope of East Dike – Polishing Cell

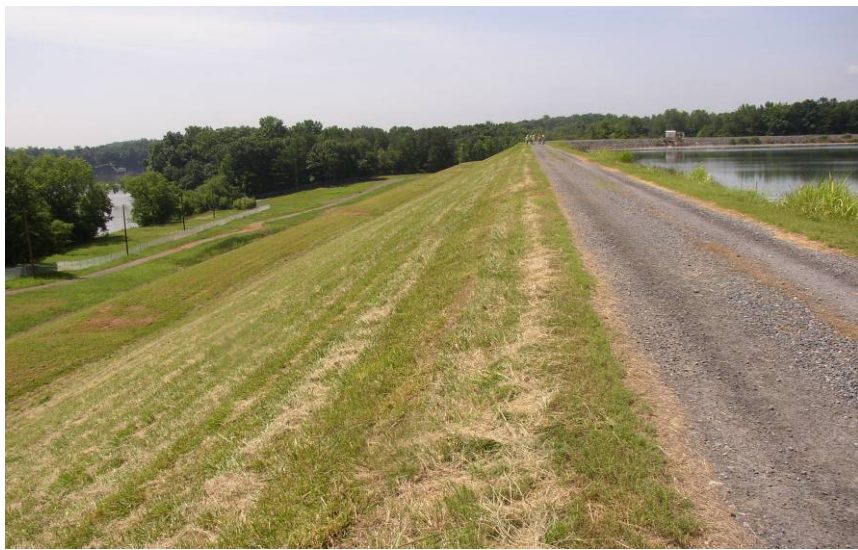
**#11 Maximum Section Portion of East Dike –
Note Wet Area at Toe and Local Berm Erosion**

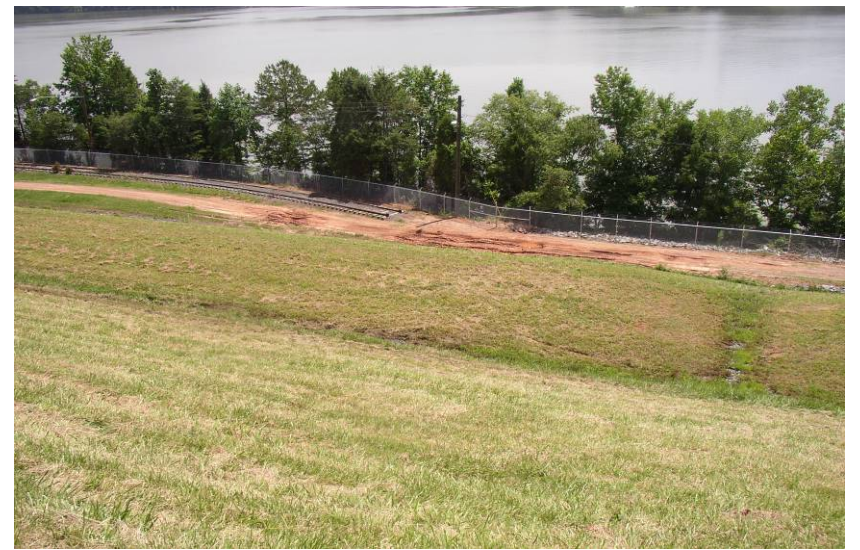
**#13 Eroded Area of Downstream Toe Road from Operations due to
Installation of Chain Link Fencing and Mowing**

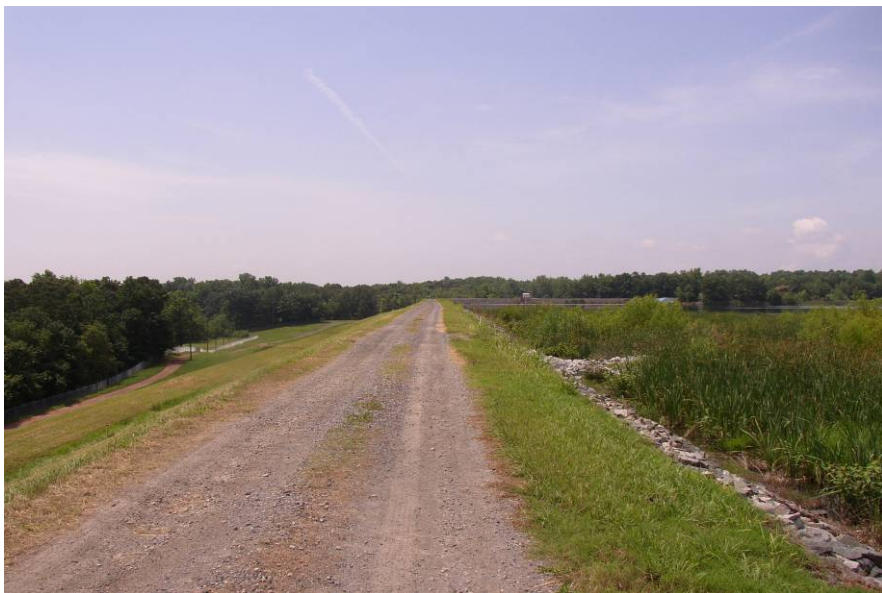
#15 Crest of East Dike Looking South - Satisfactory Alignment

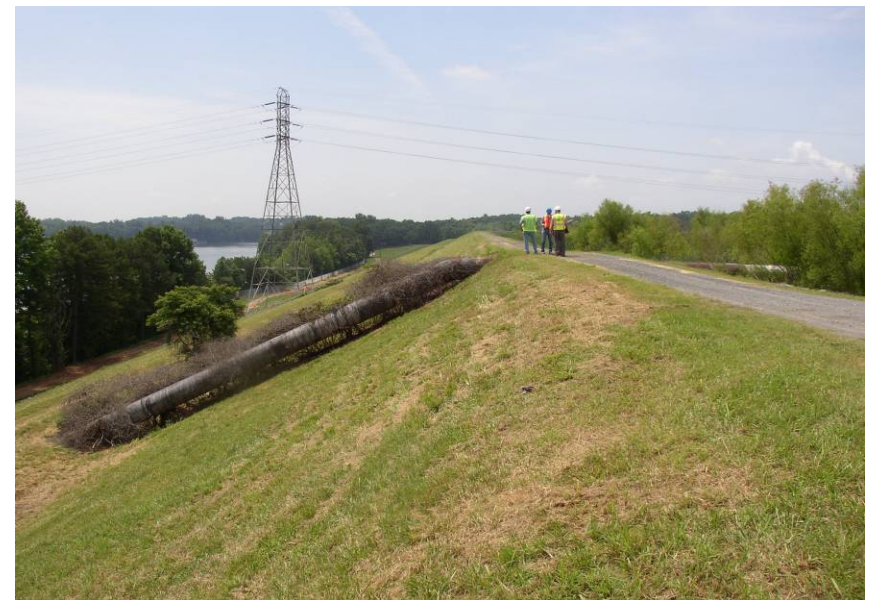
#17 Northern Portion of Downstream Slope of East Dike

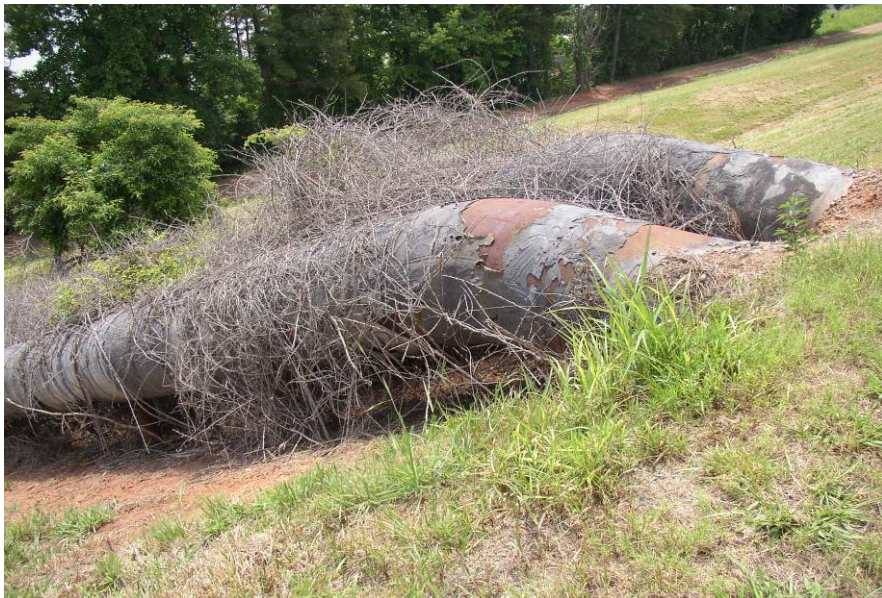
#16 Wastewater Sump Discharge Pipes @ Cell 3

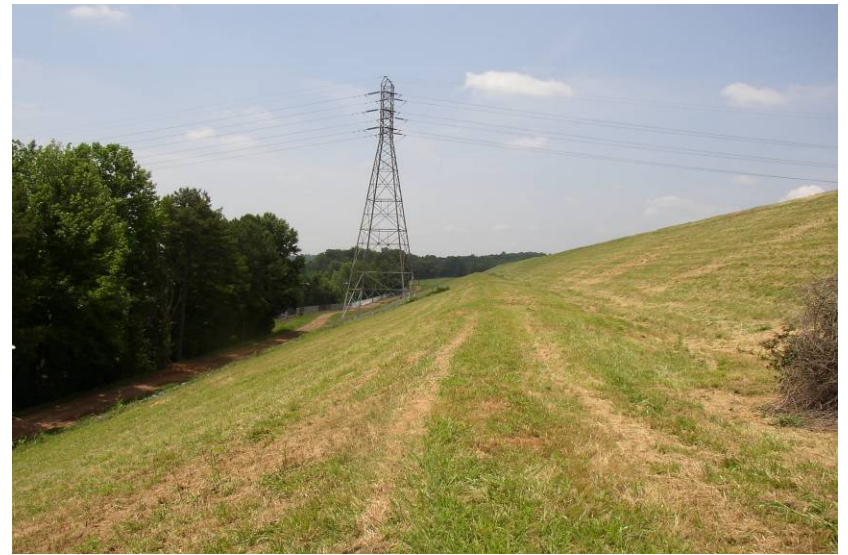
#21 Stability Berm at North End of East Dike

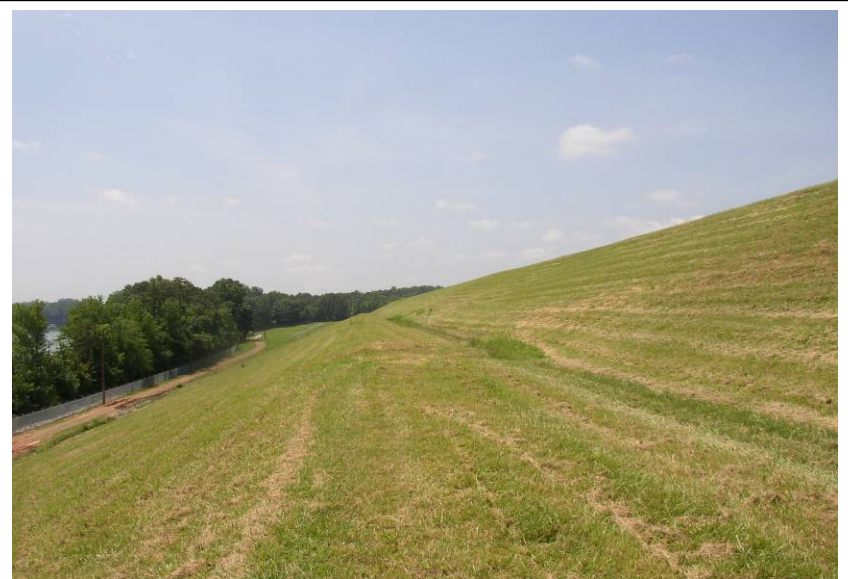
#22 Stability Berm and Downstream Slope of East Dike

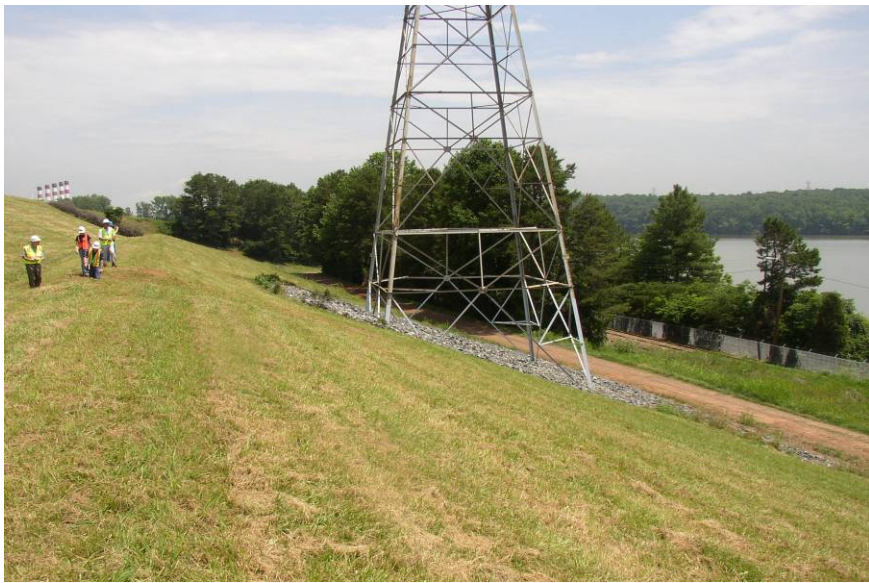
#23 Northern End of East Dike - Note Stability Berm Extends Over Transmission Tower

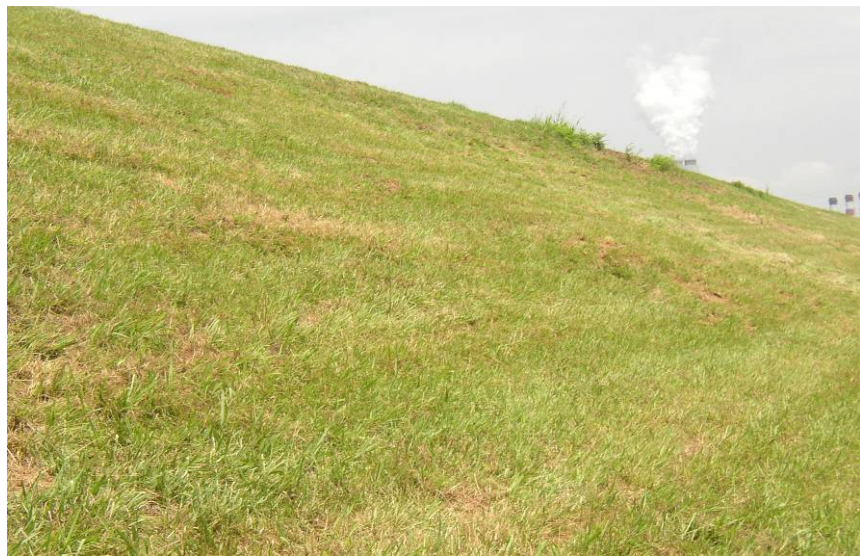
#27 Note Minor Bulging of Lower Portions – Upper Slope Above Stability Berm of East Dike

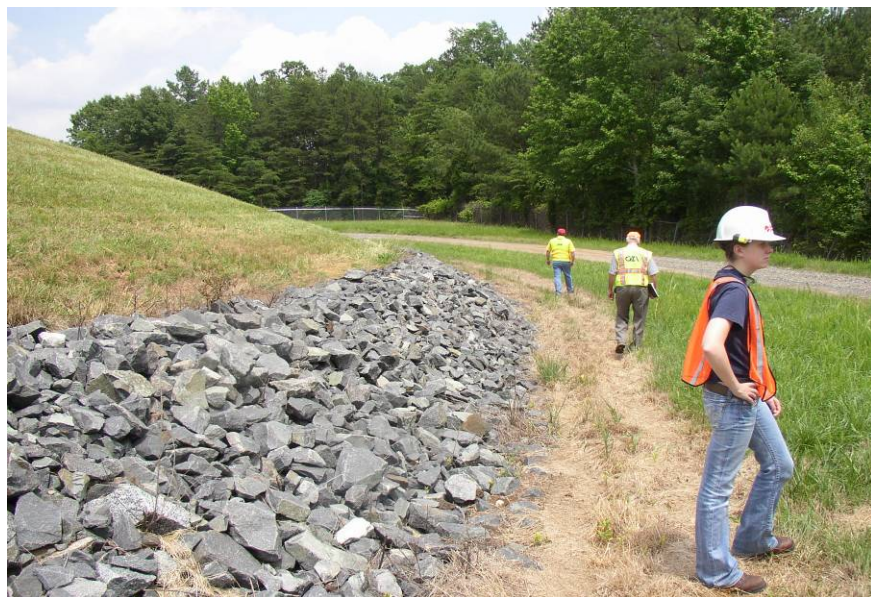
#28 Riprap at Downstream Toe of East Dike - Southern Portion

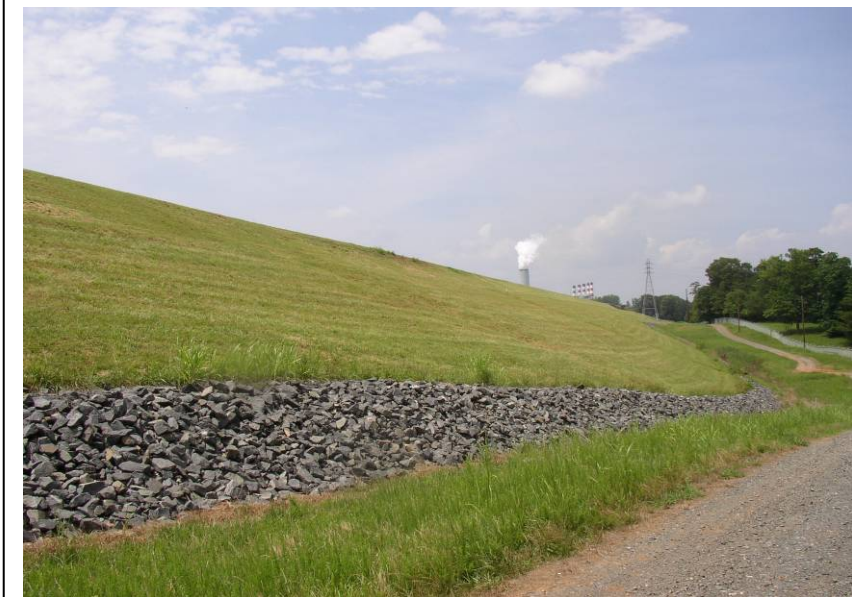
#30 Overview of Downstream Toe of East Dike Near Maximum Section

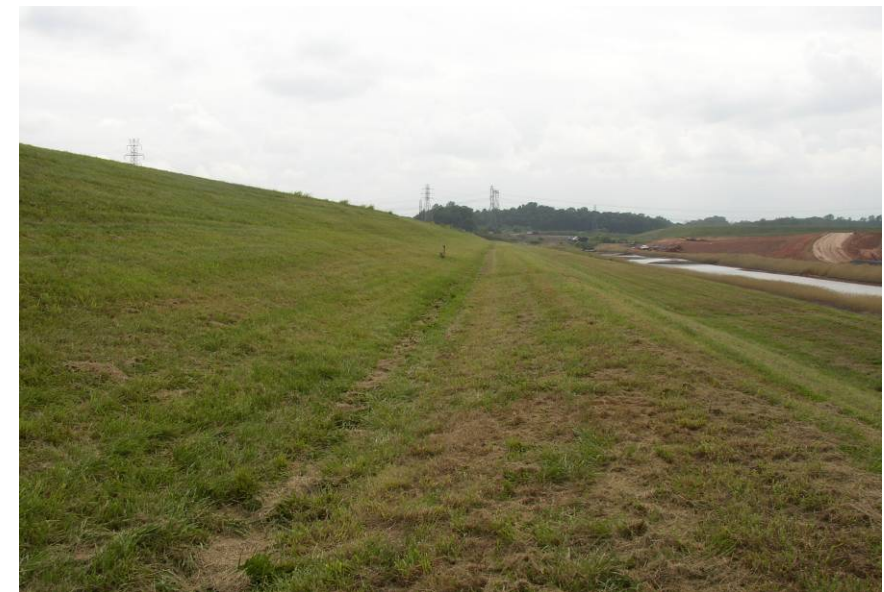
#44 Upper Berm of North Dike - 15 Feet Wide @ Elev. 630

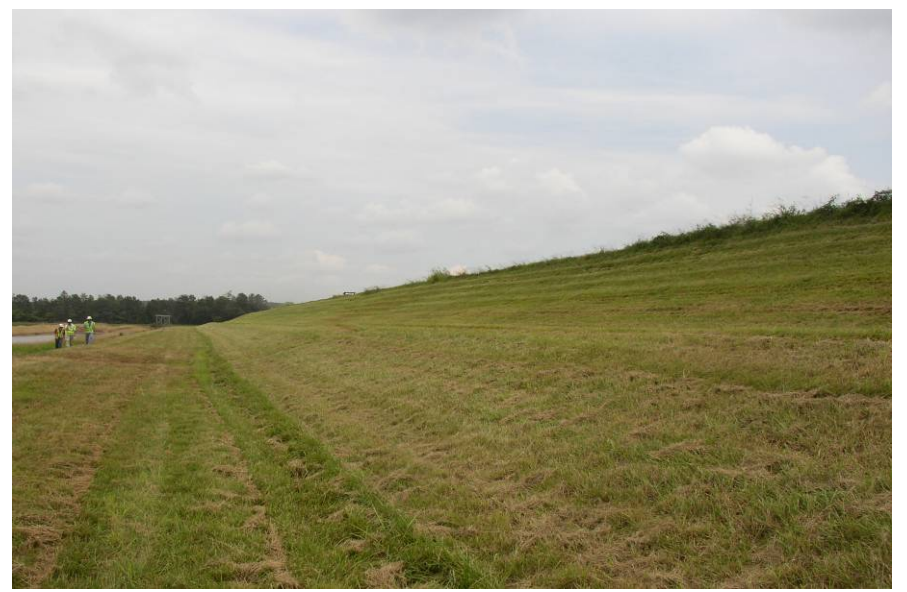
#47 Lower Berm of North Dike – 25-Foot-Wide Berm @ Elev. 625

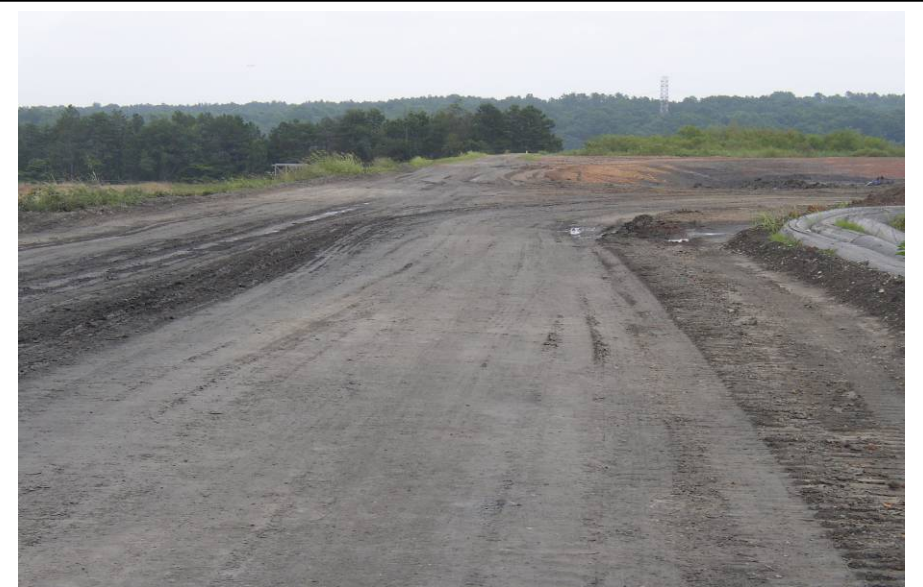
#51 Widened Crest in Cell 3 to Create Haul Road.
Width Increased from 15 to about 45 Feet.

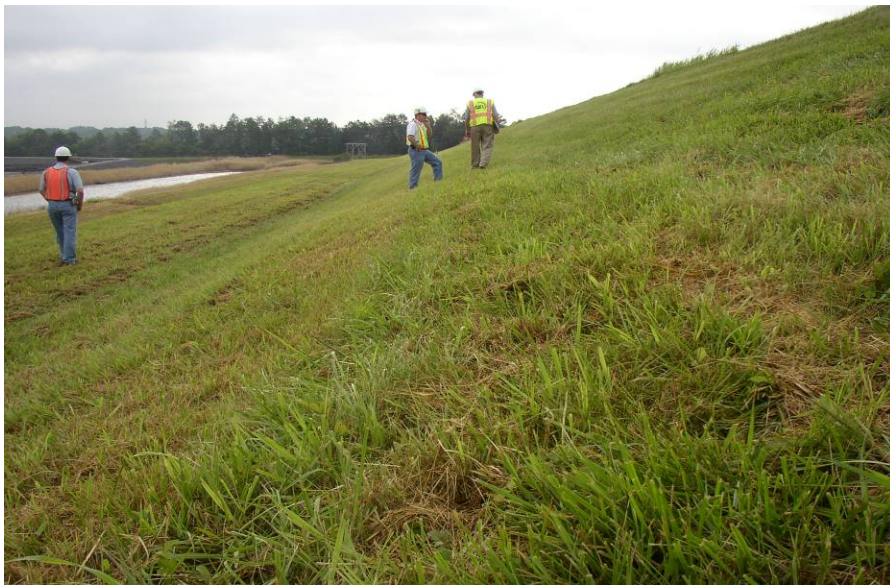
#53 Downstream Slope of North Dike (Central Area)

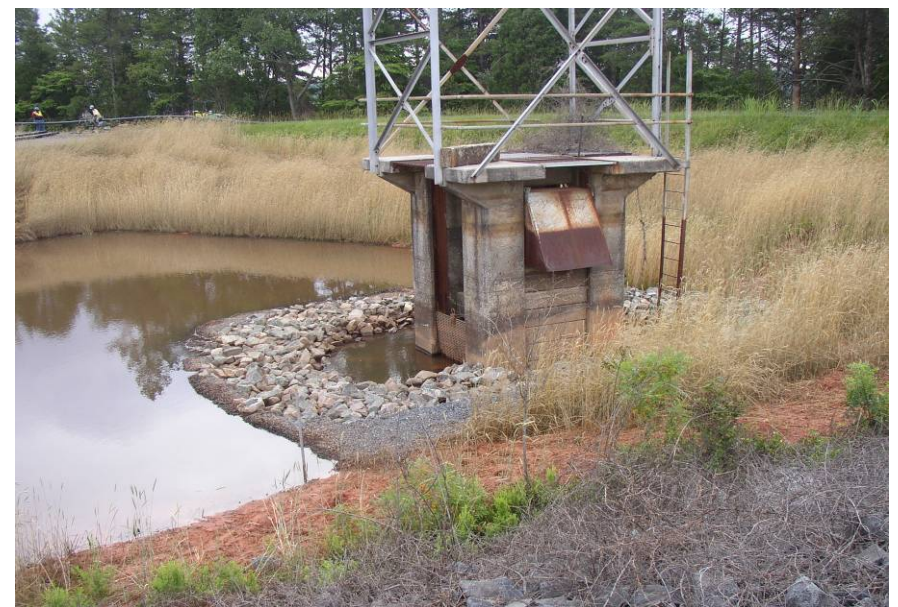
#55 Drop Inlet for Retained Ash Basin

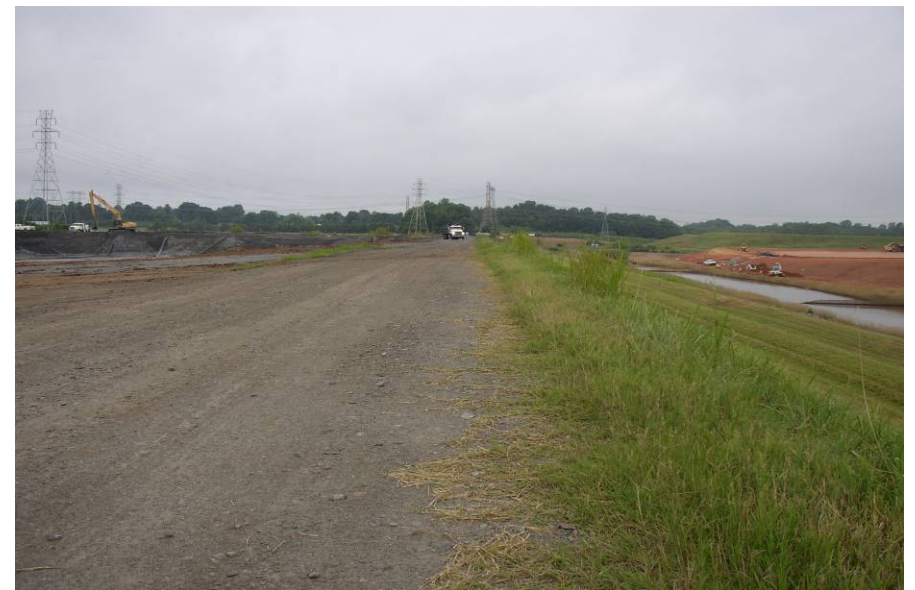
#56 Widened Upstream Crest (to 45 Feet) to Create Haul Road

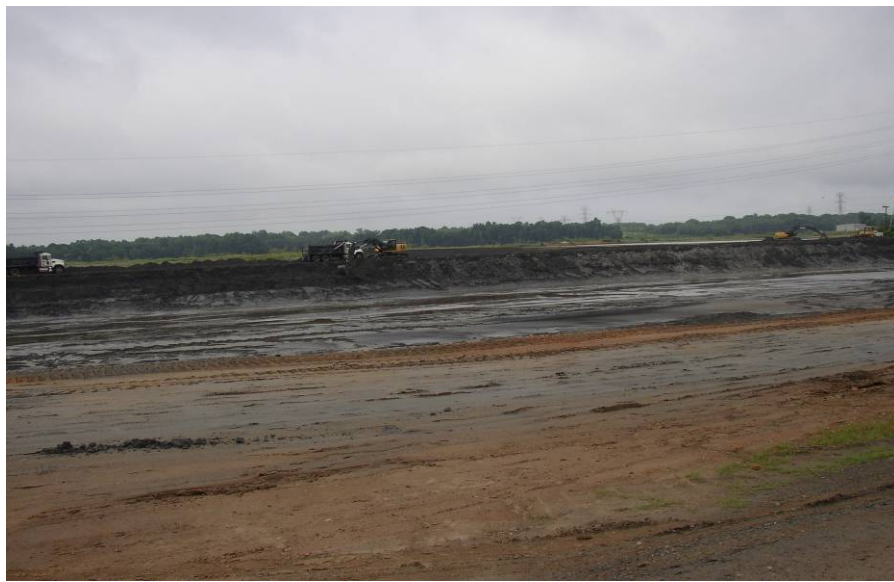
#57 Cell 3 Excavated to About 20-Foot Depth. No Water Impounded Due to Dewatering by Pumping.

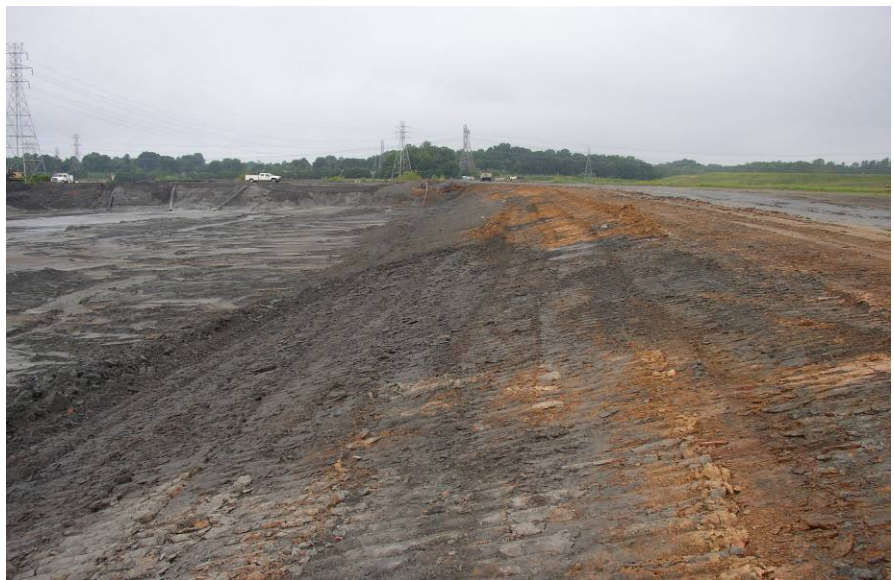
#58 Upstream Slope of Cell 3. Ash Excavated to Depth of About 20 Feet. No Water Impoundment

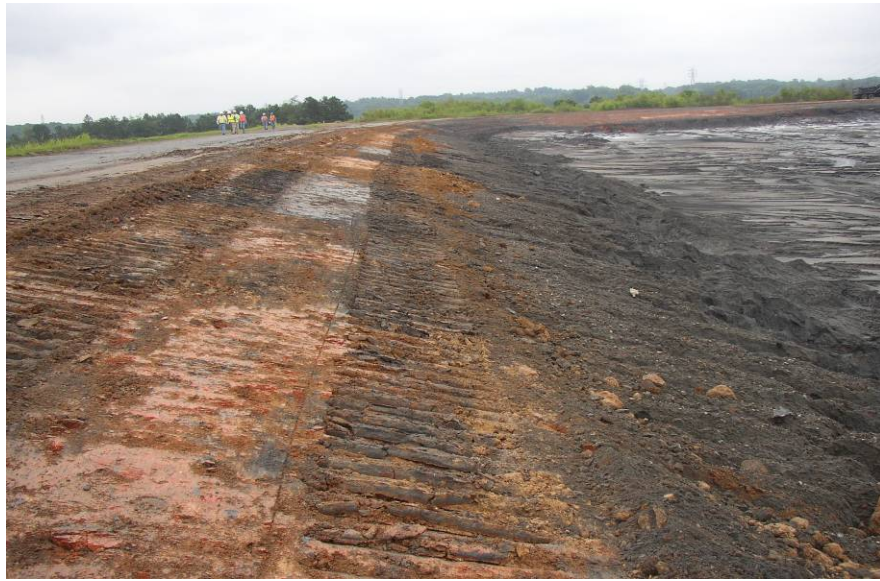
#60 Dewatered Cell 3, Ash Excavated to up to 20-Foot Depth

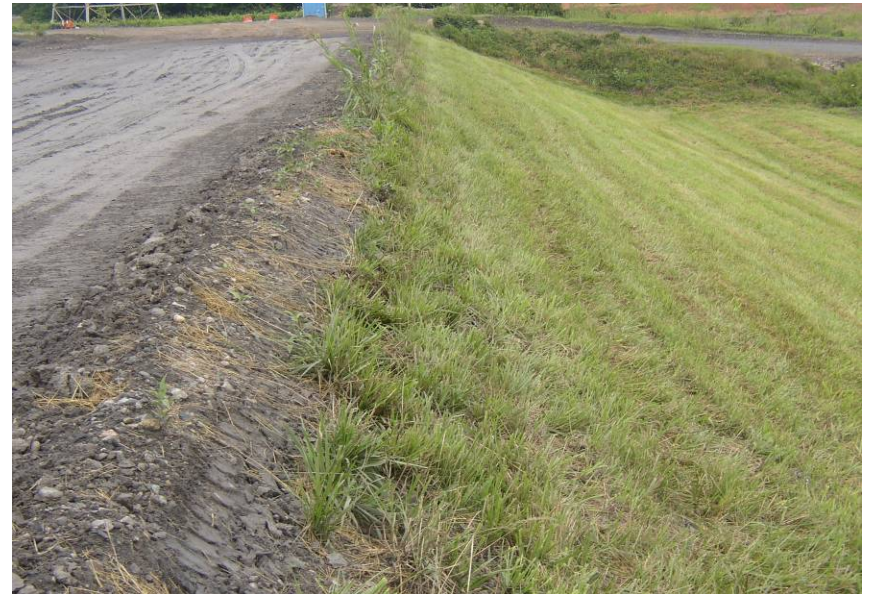
#62 Crest of Western Portion of North Dike

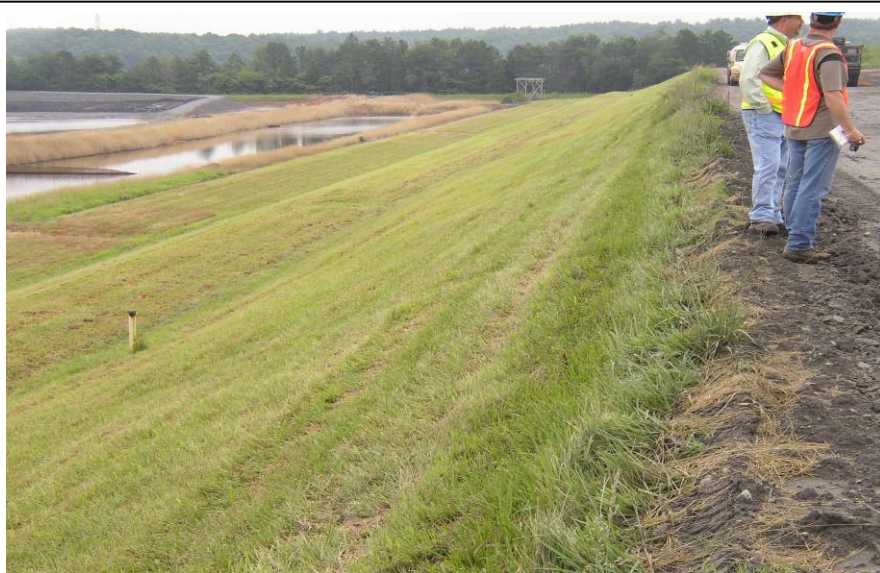
#61 Overview of Central Portion of North Dike

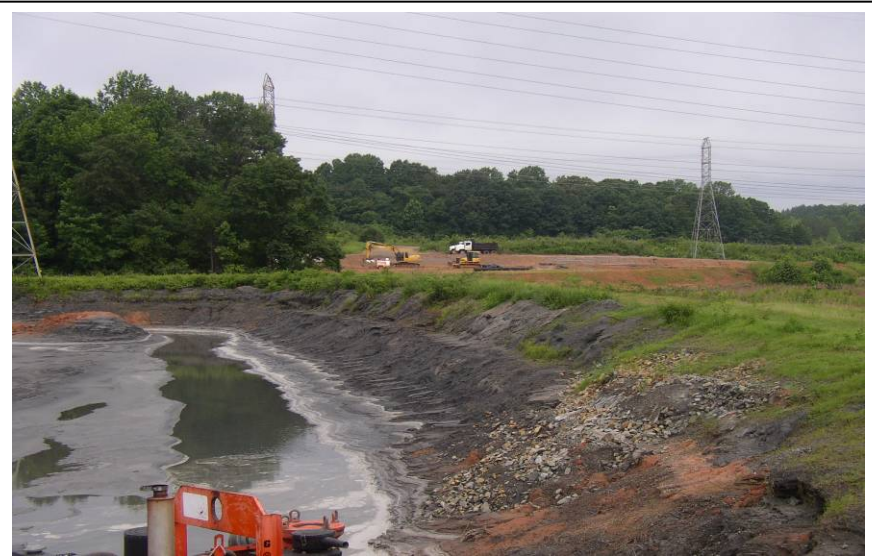
#63 Western Bend in North Dike at Cell 1 - Note Erosion in Upstream Slope of Ashfill

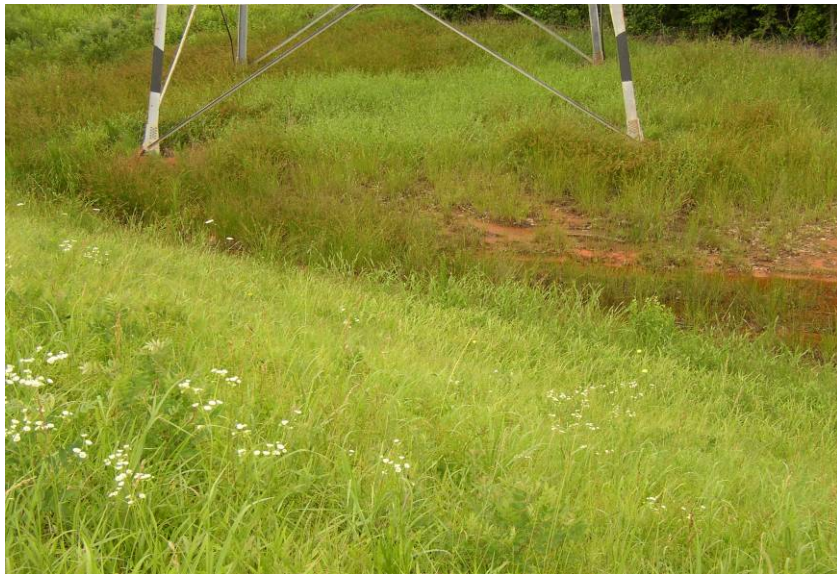
#68 Ponded Water Near Downstream Toe of North Dike

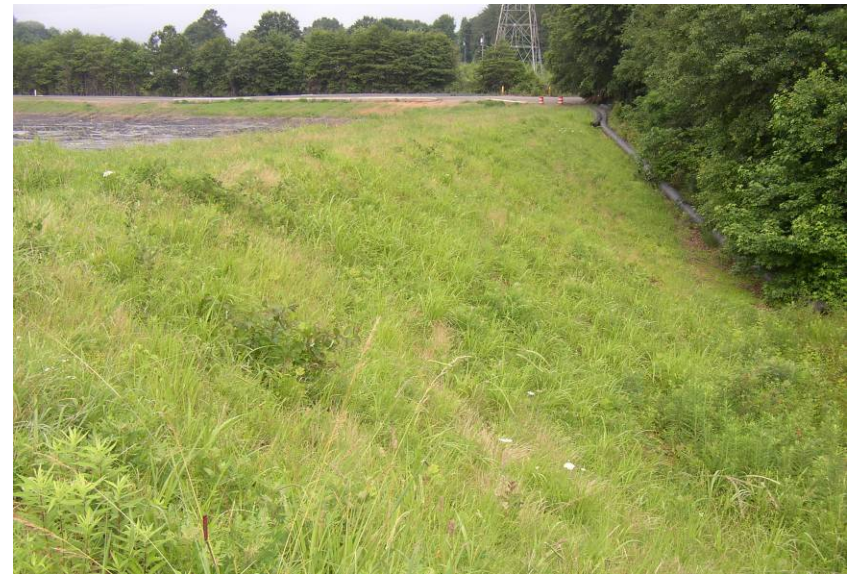
#70 Downstream Slope Near Western Limit of North Dike

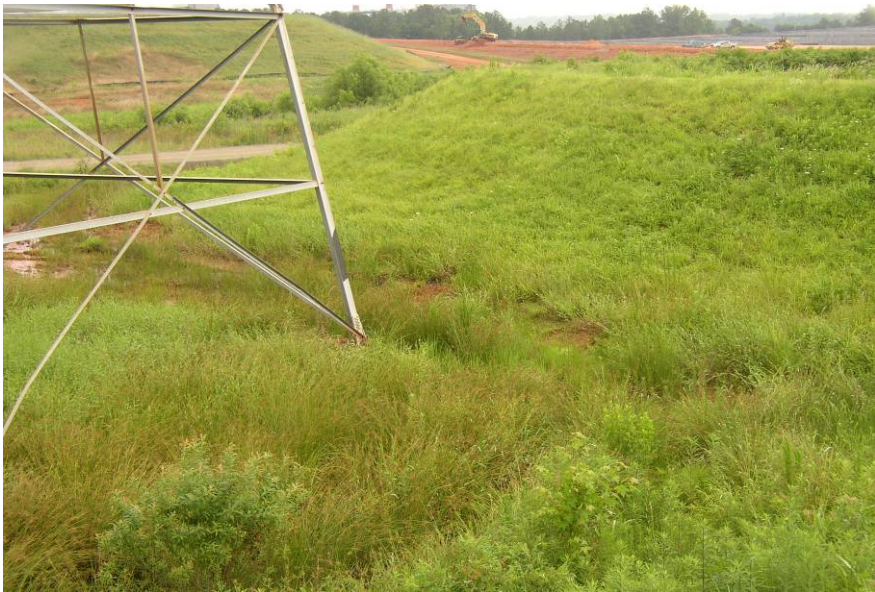
#72 Area to Improve Drainage at West End of North Dike

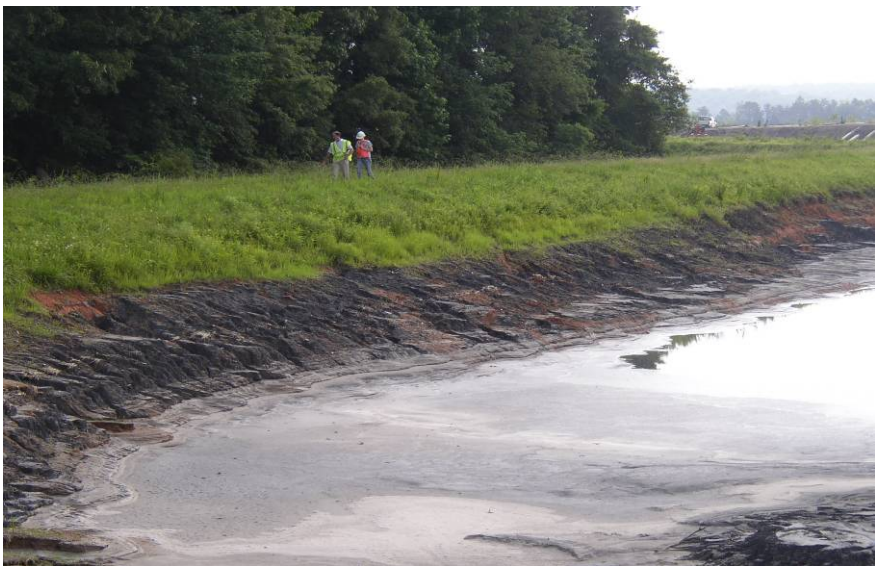
#73 Cell 1 Partially Excavated Ash on Upstream Side of Dike –
Note Surface Erosion on Dike Slope

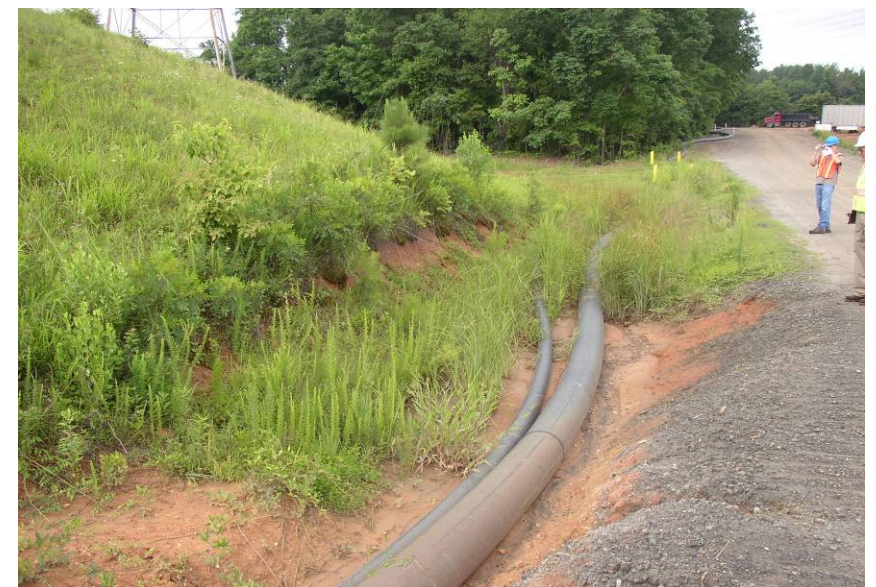
#75 Cut Into Downstream Toe of North Dike For Pipe Installation
