# USE OF SUBSTANDARD STEEL BY THE U.S. PIPELINE INDUSTRY 2007 TO 2009

# Plains Justice June 28, 2010

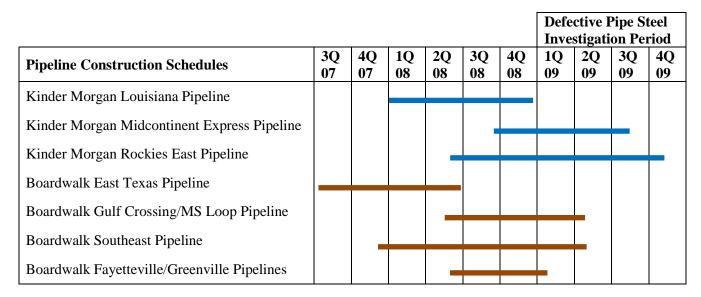
Between the third quarter of 2007 and the fourth quarter of 2009, Kinder Morgan Inc. and Boardwalk Pipeline Partners, L.P., constructed a number of new large, high-pressure natural gas pipelines. The approximate construction schedules for these pipelines are shown below.
