September 16, 2009
GZA File No. 01.0170142.00

Re: Task 3 Dam Assessment Report
Project #0-381
Allen Steam Station Coal Ash Retention Dam
Belmont, North Carolina

EXECUTIVE SUMMARY

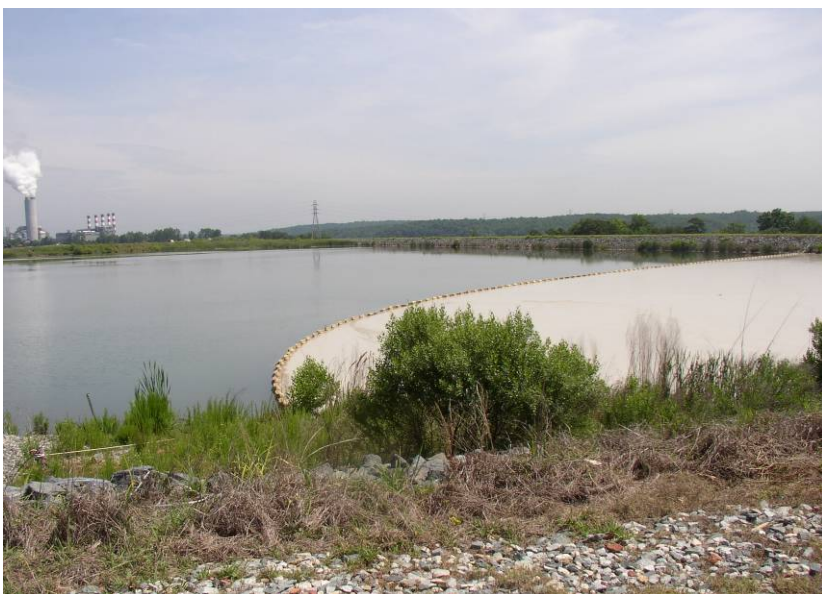
#2 Overview of Polishing Cell

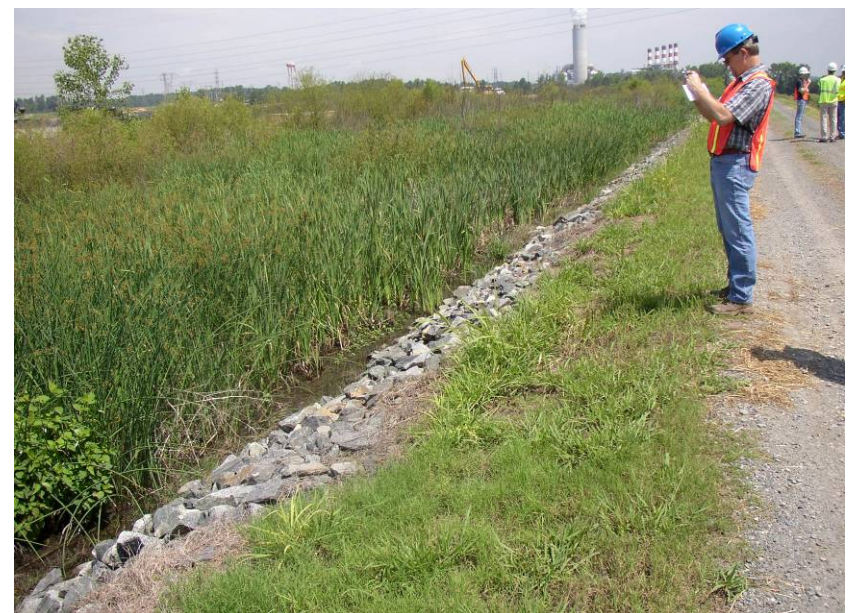
#14 Northern Ash Retention Cell 3

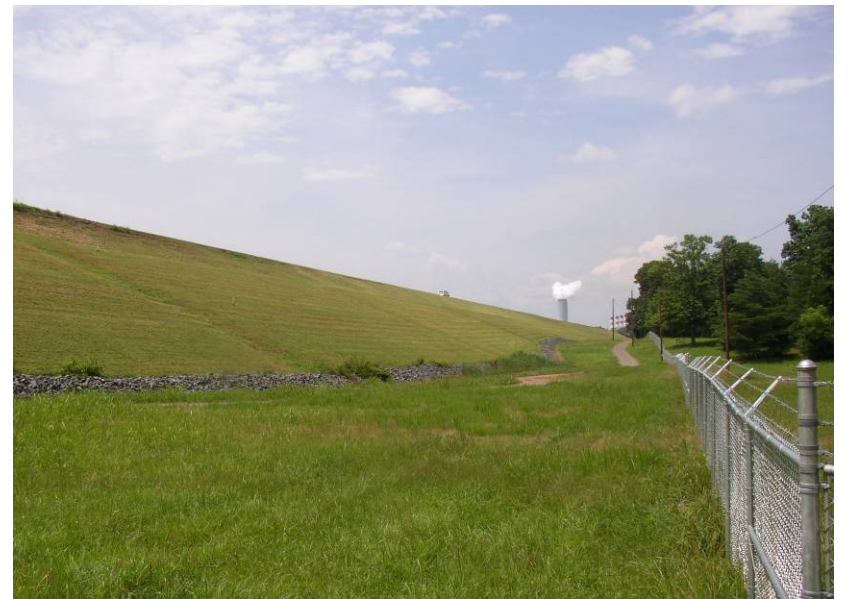
#33 Overview of Downstream Slope of East Dike – Maximum Section

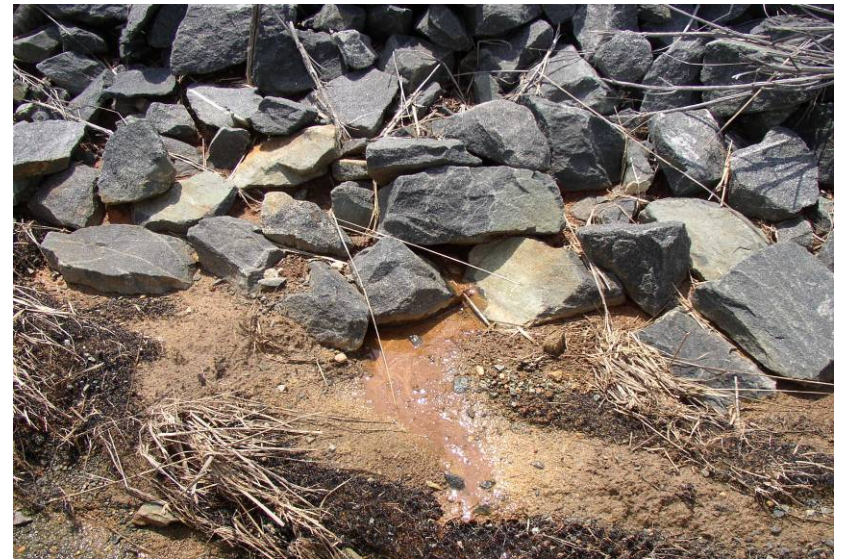
#34 Minor Local Clear Seepage Discharges from Downstream Rock Toe at South End of East Dike

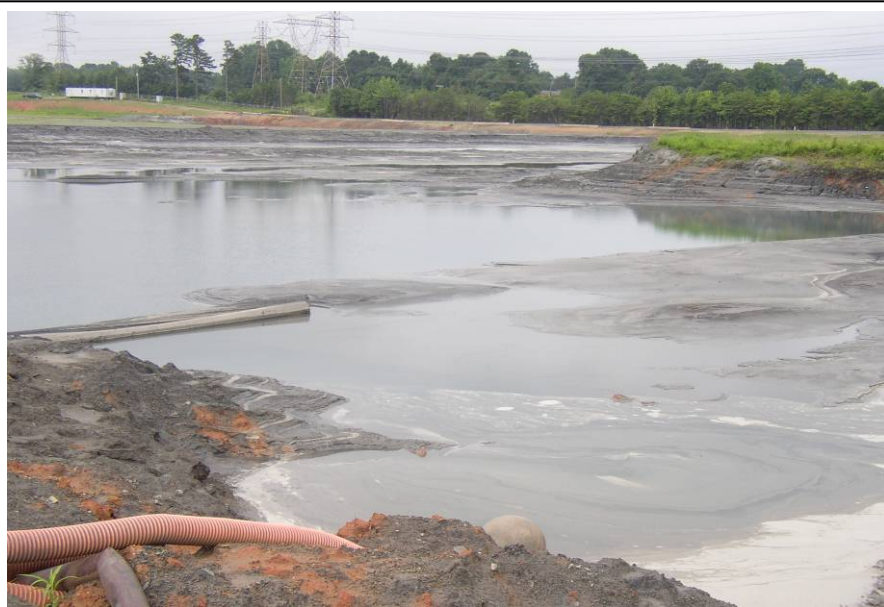
#64 Cell 1 Dewatering

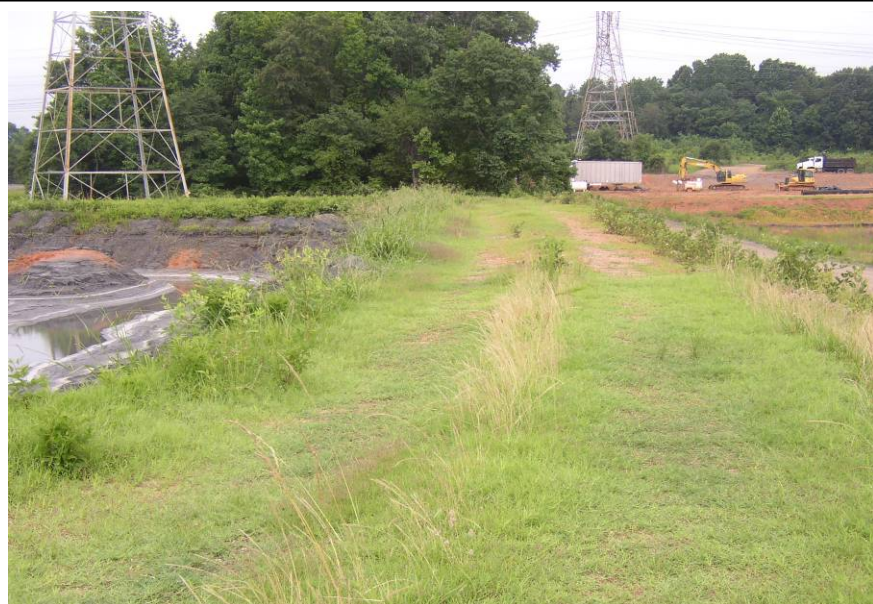
#65 Overview Crest of North Dike at West End

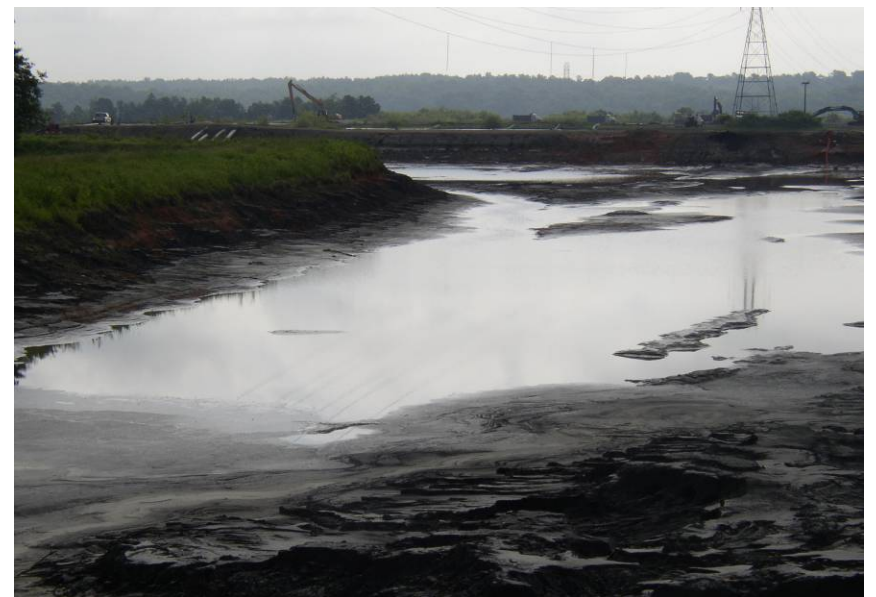
#74 Excavated Ash & Pool Elev. 635 in Cell 1
